RESIDENTIAL BUILDING SURVEY

Wormley, Surrey,
GU8

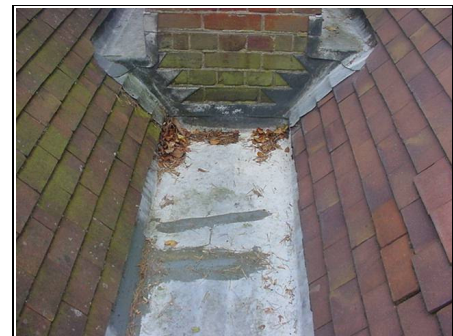
Valley gutter

Whilst this area can be accessed via a ladder (as we did as part of the survey) it is slightly tricky and there may well come a time when health and safety requirements mean that builders won't be able to/want to (for insurance reasons) access the roof without scaffolding.

ACTION REQUIRED: We therefore recommend you buy your own tower

scaffold for easier access to higher areas. It can then literally be wheeled around to clear the gutters and the valley gutters. We are sure trades people will much prefer safer access. You will have to carry out very regular maintenance with regard to clearing leaves and other debris from the trees or else you will get water into this property. We would also advise that if the hopper heads, gutters and valley gutters aren't cleaned regularly then dampness will get into the property.

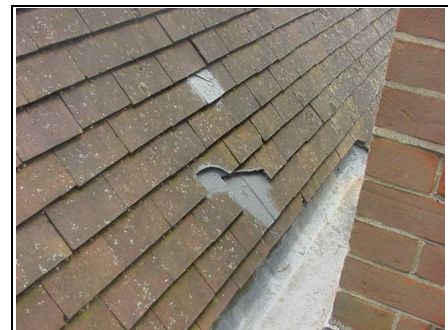
The property has a pitched clay tiled covered roof and a flat lead roof. Both have suffered from poor quality repairs rather than being repaired properly. We often find this where roofers think that as the repair is out of sight they can almost do what they like.

Poor repairs to roof tiles

ACTION REQUIRED: Have a roofer experienced in lead work spend one to three days on the roof to repair all the temporary repairs particularly to properly finish the lead work. You can see in the photo slates have not been replaced instead they have been painted over with a waterproof agent. We would much rather see slates in place. We would also recommend you get a good collection of slates.

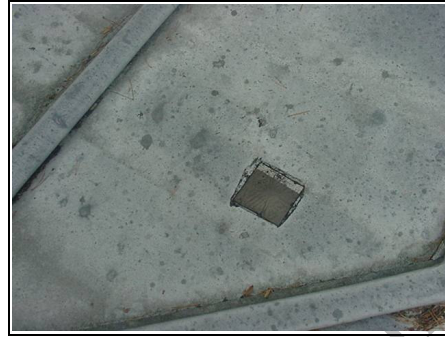
Poor repair to lead

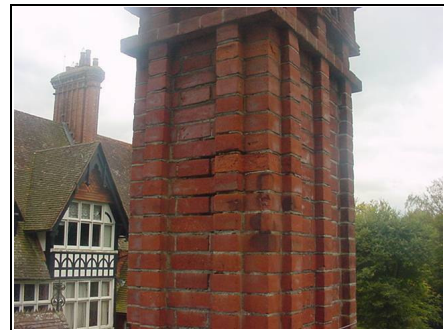
We would draw your attention to the main chimneys which will benefit from re-pointing where the mortar has been worn away. If they are not re-pointed then dampness will get into the property.

Weathering to chimney

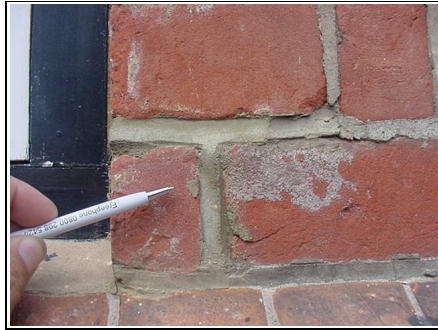
Poor repairs carried out to cement mortar

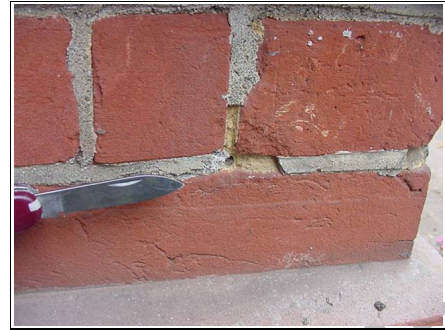
As discussed the original soft red bricks would have been pointed with a soft lime mortar. This has been replaced with a harder cement mortar which effectively stops it from breathing (if you recall we described how you require a gortex type structure rather than a raincoat or cagoule type structure). Fortunately the cement mortar does fall out fairly quickly and then you can re-point with the lime mortar.

Cement mortar coming away to reveal original lime beneath

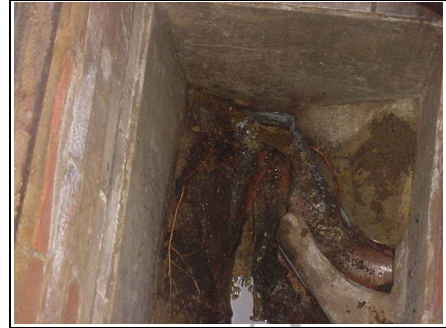
As discussed we found some roots in the foul water drain system and from discussions with the owner they also advised that there have been roots in the rain water drainage. This is a problem we feel will keep reoccurring and you need to ensure that the manholes are checked every three to six months to ensure there aren't any roots growing into them as this will very quickly block the drains up.

We've heard about problems with roots in the past, you still have them!

ACTION REQUIRED: This is a problem we feel will keep reoccurring. We would recommend a close camera TV report to establish the condition of the drains to check the conditions of the drains.

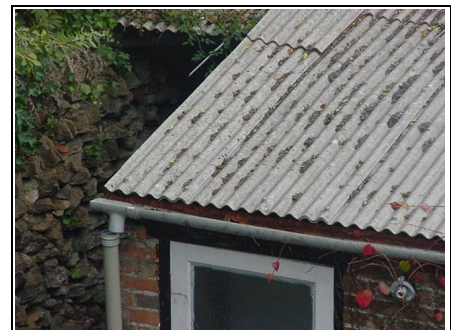
We noted that the garage had an asbestos roof. Generally asbestos is considered a hazardous material. You have to be a licensed contractor to remove the asbestos. The perception of problems with asbestos puts many people off buying these properties.

Asbestos roof on garage

ACTION REQUIRED: We would recommend the asbestos is removed as quickly as possible.

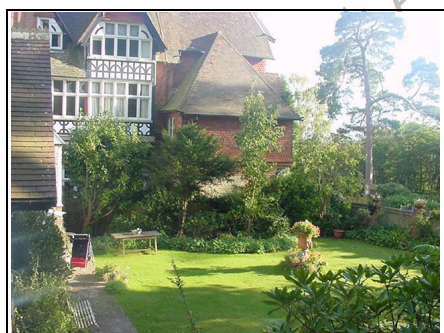
We suspect there is a lot of history between the owner of this property and the adjoining neighbours, particularly in relation to the extension and blocked up windows which have been blocked up in a different colour brick. You should be aware that the adjoining owners could be waiting for a change of occupant to put a window in. We also noticed the high level chimney to next door which has not been maintained for some time. We recommend you mention this to them.

Window blocked by garden next door

ACTION REQUIRED: We would recommend a cup of tea meeting with the neighbours before you commit to legally purchase the property to ensure you are not buying into any problems and ask your legal advisor to check that there isn't a long running dispute between these two properties.

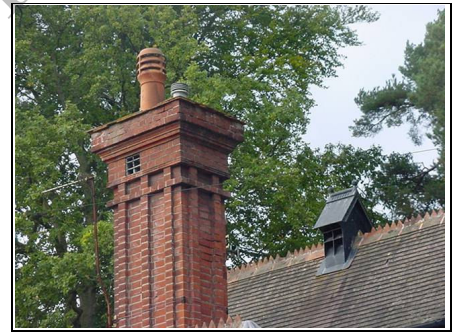
Chimney one

This chimney is brick finished with a lead flashing and one chimney pot. From what we could see from ground level it looked in slightly below average condition considering its age, type and style. Unfortunately we were unable to see the flaunching, we therefore cannot comment upon them.

ACTION REQUIRED: Please see our comments in the Executive Summary about re-pointing it.

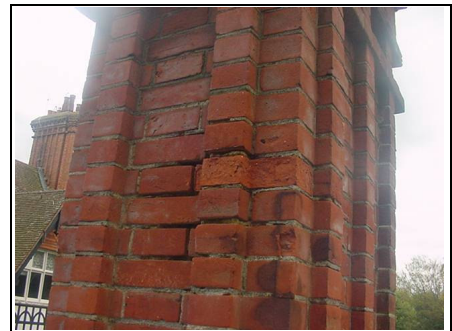
Close up of chimney that needs re-pointing

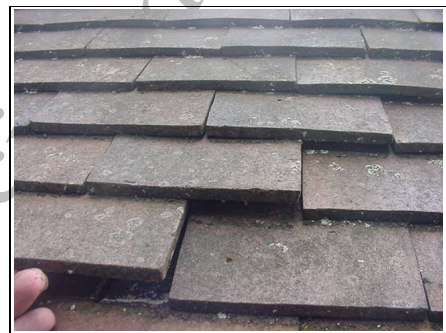
Roof Tiles

The roof is pitched and clad with a small nibbed clay tile and, from ground level, this looks in average/slightly below average condition considering the roofs age type and style. With this age of roof there will usually be a few missing or displaced tiles, this is nothing unusual.

ACTION REQUIRED: There are specific repairs that need to be carried out to the tiles as you can see in the executive summary. Also you need to carry out periodic inspections maintenance of the property particularly to the valley gutter.

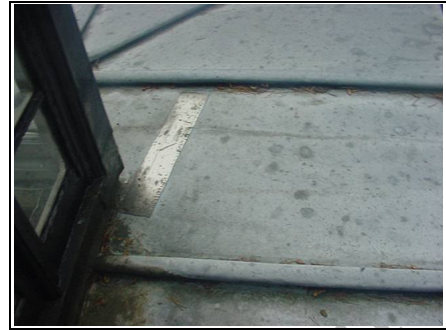
The property has an excellent flat lead roof on it. Lead for us is the Rolls Royce material for flat roofs. However this has suffered over time with some what we would term as sticking plaster repairs using the produce known as Flashband which is effectively we feel a temporary repair.

Lead roof with temporary sticking plaster Flashband repair

ACTION REQUIRED: please see our comments in the Executive Summary regarding having proper lead roof repairs.

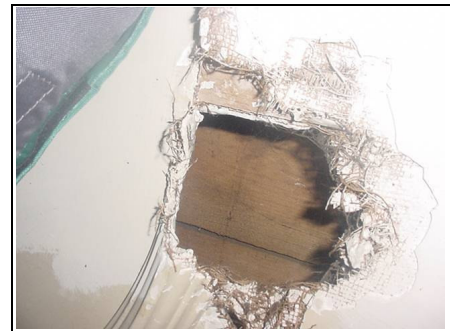
The concern with this area is that dampness is getting in via the valley gutter which we have recommended elsewhere in this report needs to be opened up and the ends of the rafters checked.

Small hole in lining with close boarding behind it

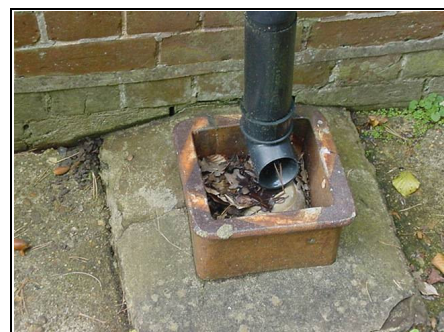
Leaves and debris

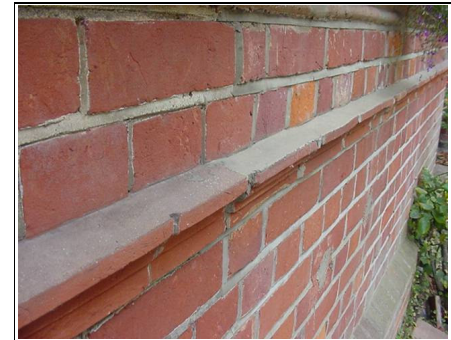
Repair to rubbed brick

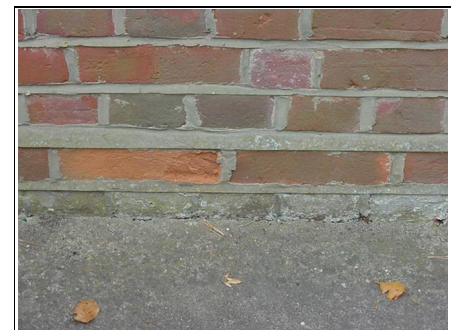
Cement causing spalling to the brickwork makes it more vulnerable to dampness

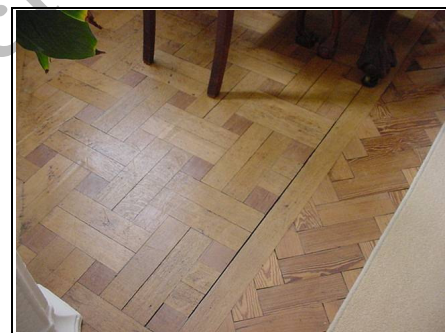
Flooring blocks covering the floor were opening up slightly

Please see our comments in the Executive Summary about looking at part of the floor. It may be the case that it is all solid we cannot be certain until you try to open up a section of it.

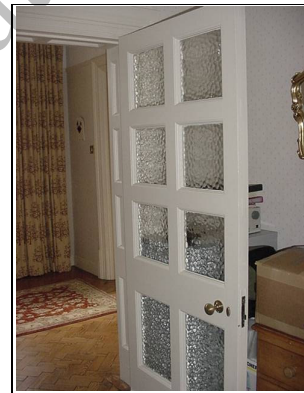
Glazed door

The glazed door may be a problem with young children as it is not toughened glass (we couldn't see the British Standard kite mark on it for safety glass). You may want to replace or guard the bottom panels.

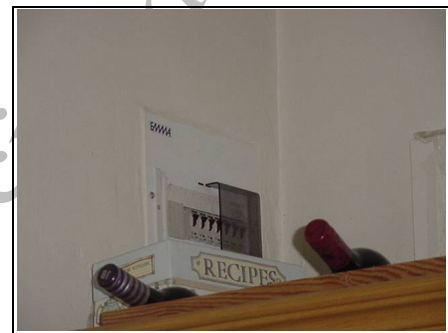
The fuse board looked dated. In an older property a defective fuse board can be particularly dangerous.

Dated fuseboard

ACTION REQUIRED: As the property is changing occupancy the Institute of Electrical Engineers (IEE) recommend an NICEIC registered and approved electrical contractor carry out an inspection, test and report.

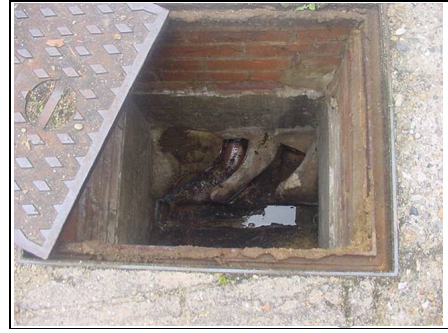
Drain at front with tree roots in it

ACTION REQUIRED: Remove the tree roots. Please see our comments in the Executive Summary.
