RESIDENTIAL BUILDING SURVEY

Wrexham LL14

This is a new building which is a two storey detached property with integral single garage. There are gardens to the front and rear, the front garden is predominantly given over to parking. At the time of our inspection the property was approximately four weeks from being completed. There was an established building to the left hand side and a new building on the right hand side which is currently coming out of the ground (at foundation level) with an adjacent church (all directions given as you face the front of the property).

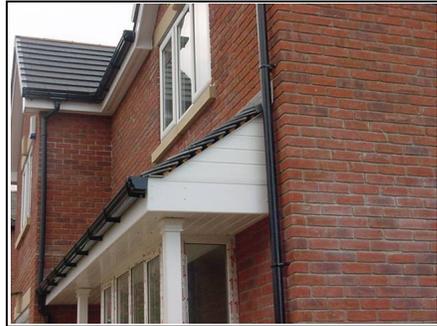
Missing verge cap to front right hand of bay window roof

The verge caps need to be added and to the front gable they need to be re-secured.

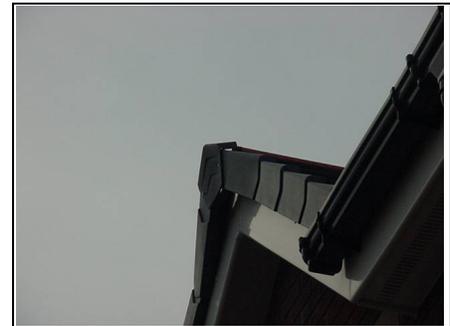
Verge cap coming off to front gable

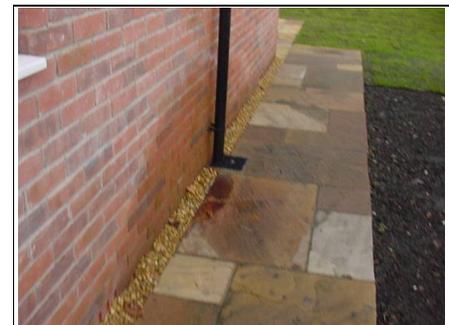
Gutters and downpipes not working

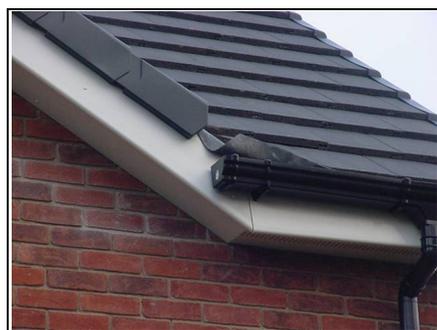
Gutters and downpipes on front left hand side – we think valley gutter may overflow and will ultimately require a hopper head

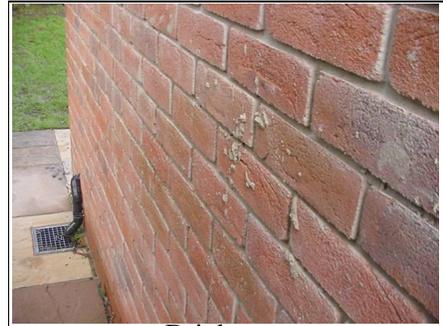
Brick snots

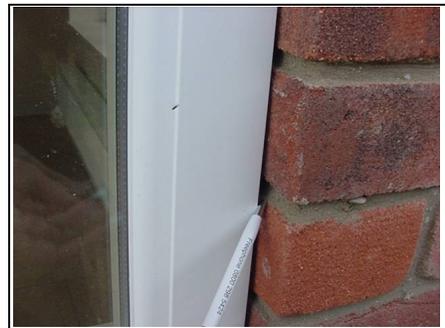
There has been no mastic finish around the windows. The mastic is to stop dampness coming through the sides of windows.

No mastic around the windows

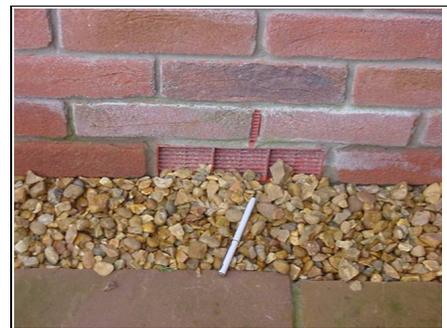
Air vent partially covered

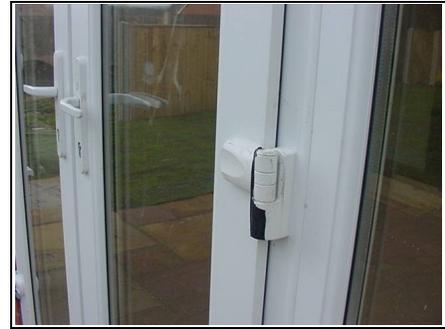
There are hinges visible on the rear door which is a security risk. This type of door is not acceptable to most insurance companies.

Hinges visible on rear door

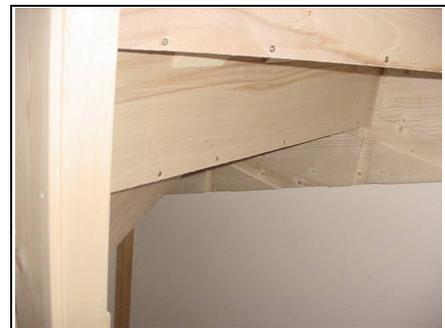
It was noted that the staircase was not lined which is a standard requirement and in the worst case scenario ensures that fire doesn't spread from the ground floor to the first floor quickly and gives you extra time to escape.

Staircase not lined

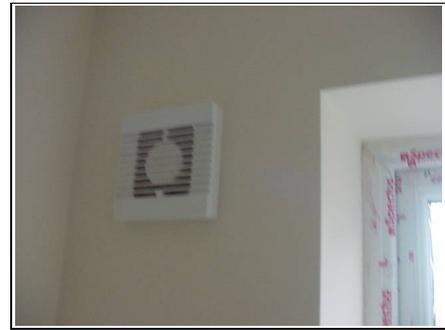
Extract fan

Whilst we appreciate they meet Building Regulation requirements these are a minimum requirement, we would recommend increasing the extract fan size. Within modern properties it is very important that any moisture creating areas such as bathrooms, showers and kitchens remove the moisture as quickly as possible to stop mould from occurring.

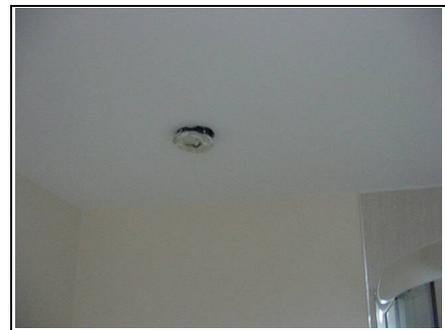
Lights are not finished.

Lights unfinished

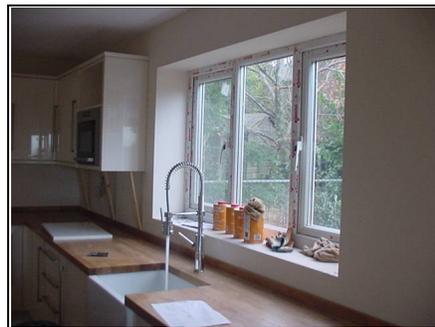
The window sill is missing in the kitchen.

Window sill missing in kitchen

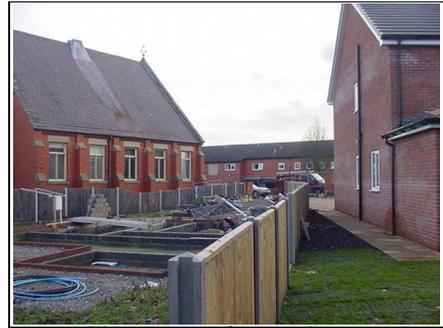
We believe it is very difficult to appreciate just how close the adjoining property will be and the affect this will have on daylight. If you recall we took you to the rear left hand side of the property where there are adjacent trees to try and give you a feel for this.

Closeness of next door

ACTION REQUIRED: Ask the builder/architects to produce a plan of the two buildings side by side (we have had a copy of the drawings but they do not include these). If these are forwarded onto us we would be happy to create 3D models of the buildings free of charge to give you a better understanding of the daylight and space issues.

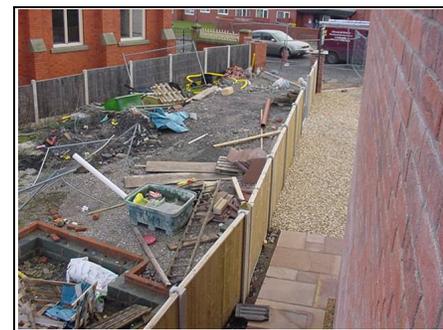
Closeness of adjoining property taken from bedroom window

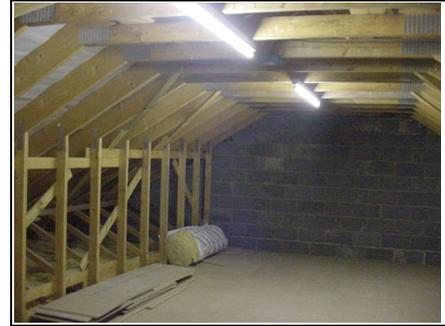
Large roof space

We would recommend that you negotiate with the builder with regard to having a window put in the right hand gable and rights of light and have this included within the price as this will ultimately mean that you can add a room to the roof space although you will need to carry out quite a lot of work to do this such as strengthening/replacing the ceiling joists, insulation, etc. but there is a large area of space in the roof.

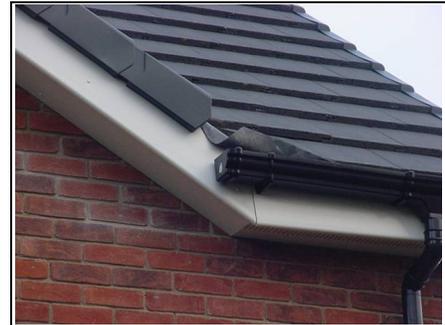
We feel that there may be a discharge of water on the front right hand corner of the building. We don't feel this lead detailing is sufficient, only time will tell.

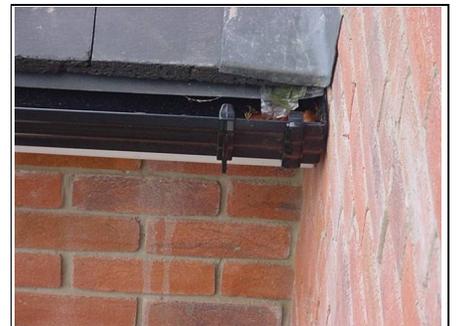
Both roofs are pitched and clad in a concrete tile as previously described. Where they meet the main building we are concerned that the flashing may not have been bedded properly and deterioration of this bedding joint may occur. This is a problem that we see too often on modern properties.

Base of conservatory roof – we would have preferred a bit more lead

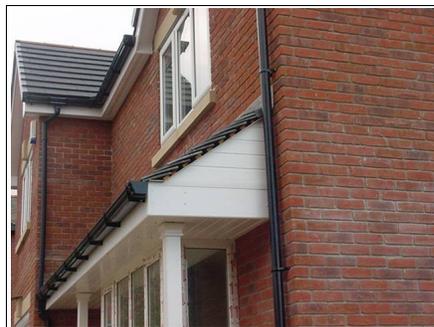
Missing verge cap to front right hand of bay window roof

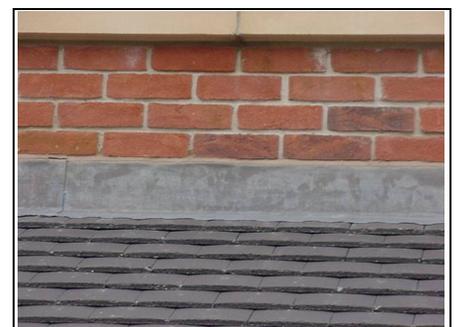
Close up of bay window flashings – we much prefer this to be bed in mastic, it looks to be from the slight difference in colour, however you need to have this confirmed by the builder

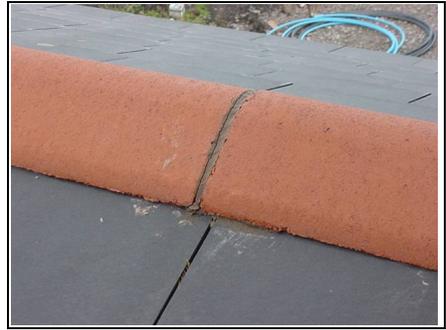
There is hairline cracking to the hip already which often occurs when it has not been bedded properly or a too hard a cement has been used.

Hairline cracking to hip

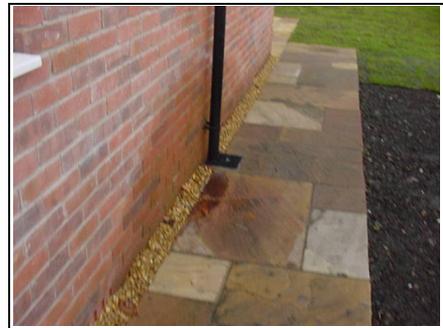
Leaking gutter

ACTION REQUIRED: You need assurance from the builder that they will come back and amend any areas where the gutter is not working properly. We find that only by living in the property can you fully understand whether gutters and downpipes are working! Even with new gutters and downpipes we would always recommend that they are cleared out periodically, the joints are checked and the alignment checked to ensure that the gutters fall towards the downpipes.

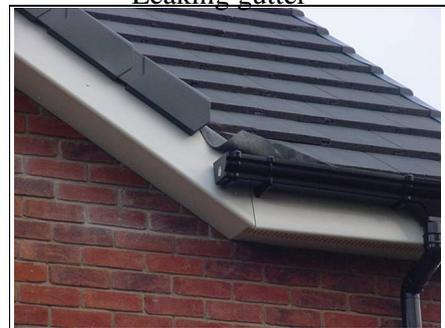
Gutters and downpipes on front left hand side – we think valley gutter may overflow and will ultimately require a hopper head

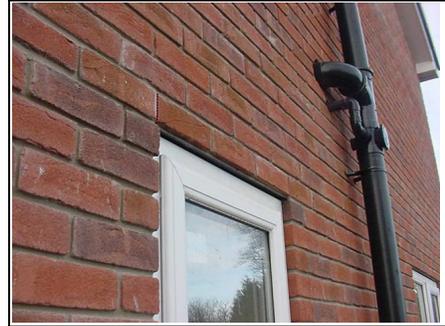
We could see a plastic soil and vent pipe. It still needed work where it had been cut through the brickwork, general sealing, etc. Generally the waste pipes and soil stack appear to be satisfactory where a surface inspection is possible, although for a major part they run in ducts and cannot be inspected.

Soil and vent pipe

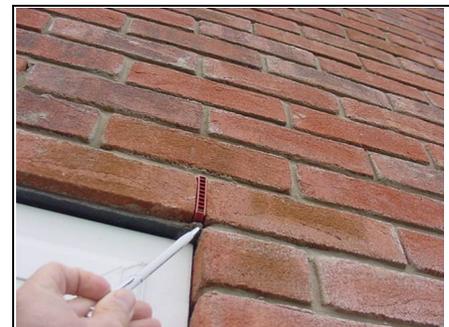
We generally found the brickwork and pointing in average to below average condition. Whilst the areas that were pointed were in good condition there are areas where ad hoc repointing is needed which is not normal on a modern property. There are areas where the cement 'snots' needed cleaning off the brickwork.

Repointing necessary

ACTION REQUIRED: Repoint in a suitable mortar.

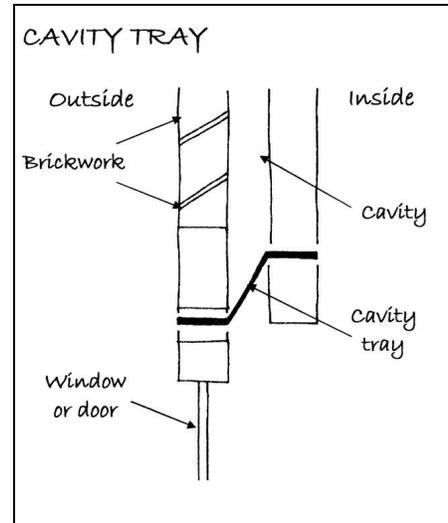
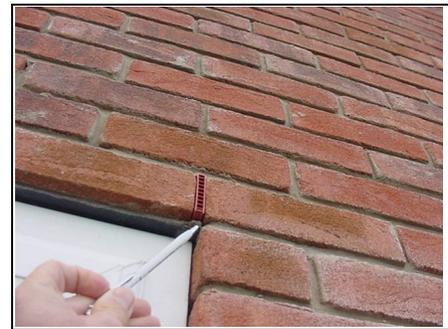
Cavity tray

We noted trickle vents to the brickwork which indicates that cavity trays have been utilised within the property. We have seen problems with these which is perhaps a modern day issue. There should be cavity trays adjacent to the front roof area and also the conservatory area. We very rarely find them where we have opened up the structure.

ACTION REQUIRED: Your solicitor needs to specifically ask the builder whether he has put cavity trays in this area.

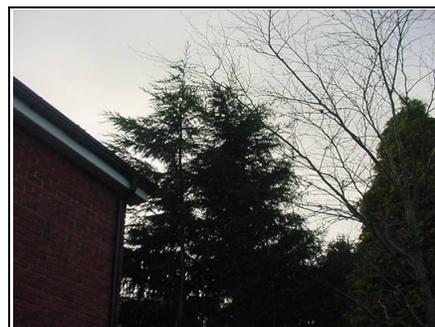
Next doors trees are very close to the building and need maintenance, we recommend you speak to your neighbour about the trees to ensure they are happy to maintain them. Please see our comments about having a cup of tea meeting with next door as their environment has changed considerably with the building of this house.

Next doors trees

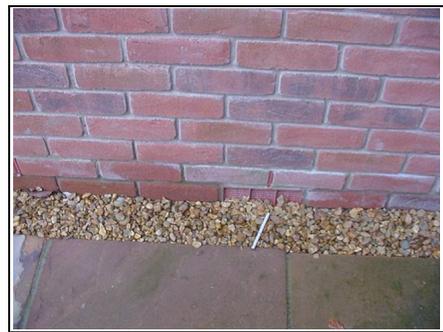
All modern properties should incorporate a damp proof course (DPC) and good building practice dictates that a differential of 150mm (6 inches) should be maintained between the damp proof course and ground levels. In this case the damp proof course would have been built in as work proceeds. You should check that it has Local Authority approval. We did note that the airbricks have been covered which indicates to us that the ground level may have been made higher by the landscaping to finish off the property which may in turn affect the damp proof course.

High level of shingle against the damp proof course

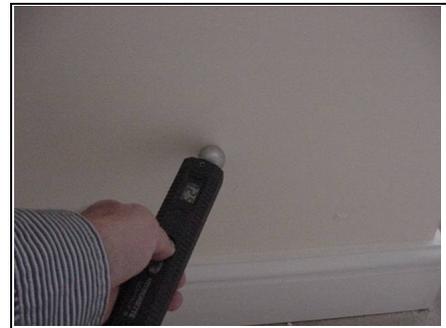
Trying to check dampness and getting readings between 15 and 30 which indicates plasterboard finish

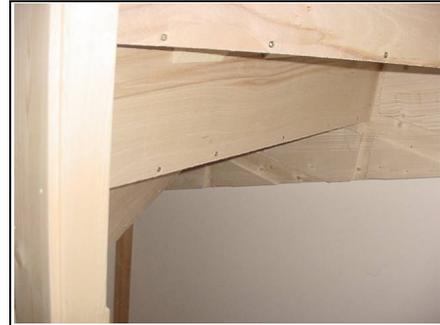
It was noted that the staircase was not lined which is a standard requirement and in the worst case scenario ensures that fire doesn't spread from the ground floor to the first floor quickly and gives you extra time to escape.

Staircase not lined

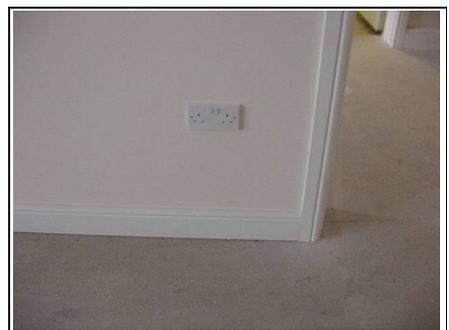
High electric points

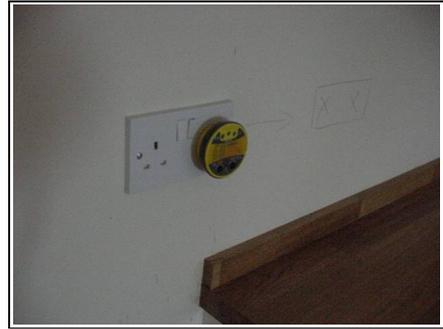
We usually carry out an earth test in the kitchen area to the socket point that is normally used for the kettle but in this instance the electricity was not on so therefore we could not test.

No electricity on at time of inspection

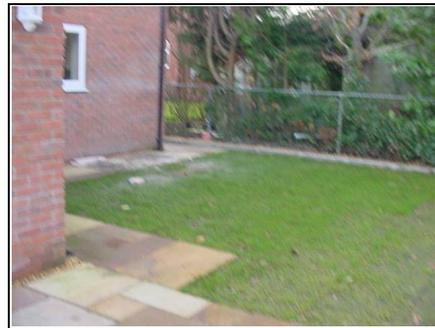
Relatively low boundary fence to right hand side – we suggest higher posts and a trellis
