SPECIFIC DEFECTS REPORT - CRACKING

Cambridge
Cambridgeshire

We have been instructed by Mr E to prepare an independent report to survey and inspect XXX Cambridge, Cambridgeshire CB21 relating to cracking.

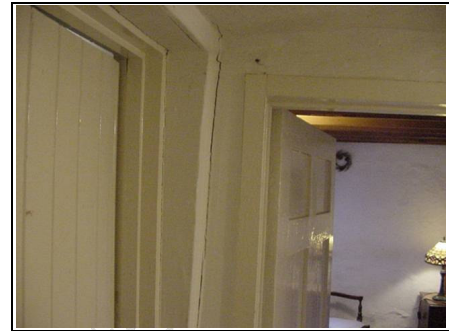
Many older properties have historic movement, sometimes being as old as the original initial settlement. We can see in this instance that there has been movement over the years, which the occupiers of the property have effectively adjusted the structure and lived with, for example, the positioning of the door frames in the wall structure.

Vertical door frame sits into non-vertical wall

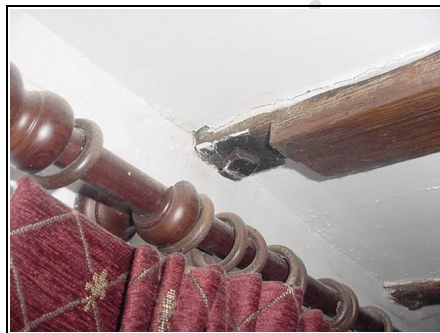
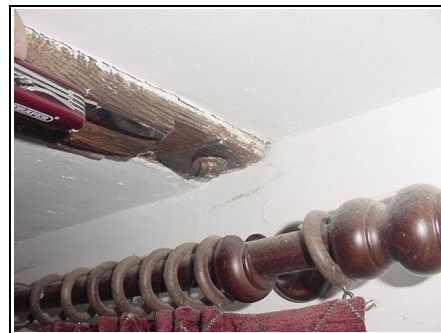
We can also see some older style repairs to the structure from the post war era to the rear of the lounge where restraints/ties have been added to the floor joists, and also to the first floor right hand side bedroom restraints/ties have been added to the roof structure.

Metal ties / restraints visible to floor joists

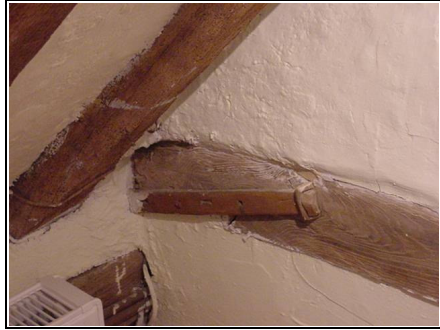
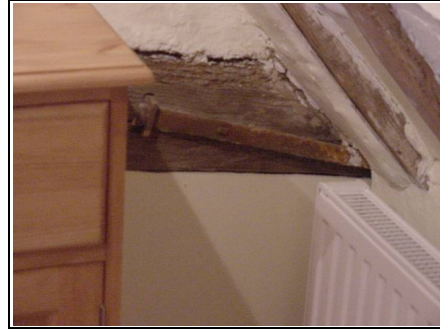
Old ties in right hand bedroom

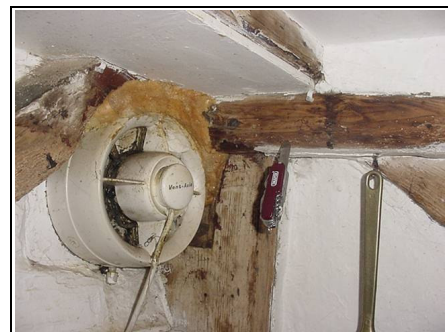
Possible active woodworm in kitchen

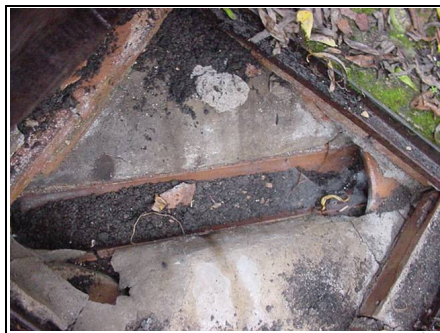
Drain one to rear right hand side

As you will no doubt recall, we lifted the manhole to the rear of the property and found some blockages.

ACTION REQUIRED: You need to have your drains unblocked. Ideally a closed circuit TV camera report carried out to establish the condition and to see if they are leaking. This is likely to cost a few hundred pounds. We would recommend that you give lots of cups of tea to the people carrying out the work and watch the video that they produce whilst they are actually so they can explain it if at all possible.

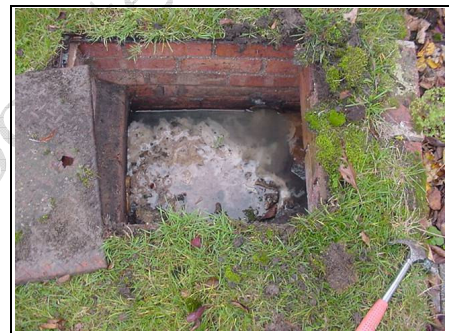
Blocked drain

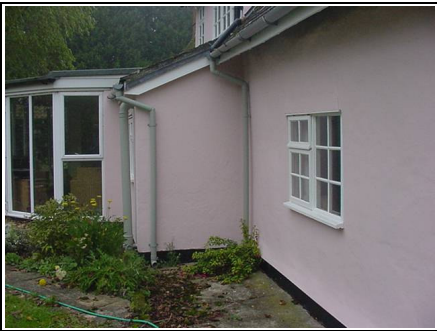
As with many older properties, the rainwater is discharging directly onto the ground. However, in this case, due to the large concrete slabs, rather than the rainwater dissipating into the ground open area it is then being directed back towards the building or via the various cracks that we could see in the slabs. We have talked more about these slabs later on within this report.

Where does the rainwater go, other than helping the plants to go?

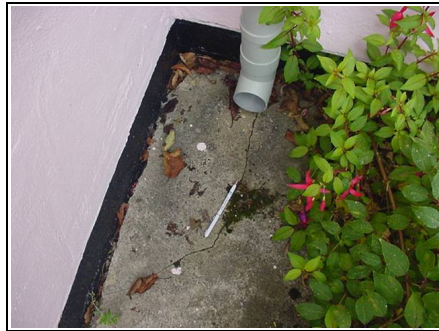
Cracking to ground near bathroom

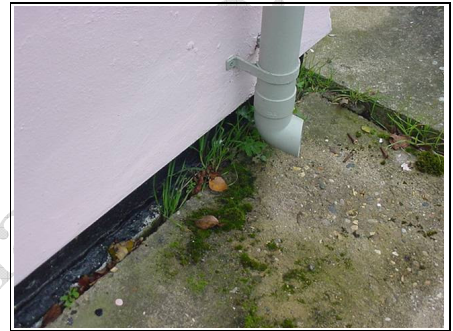
Water logging to rear left hand side allowing grass to grow

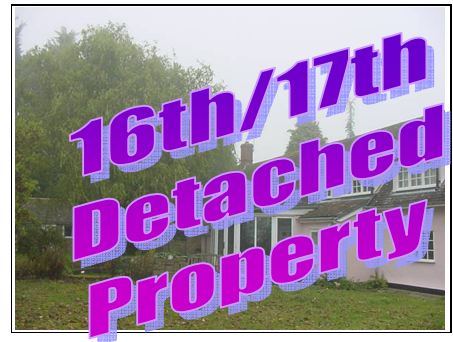
Willow tree to rear

Where you have a timber frame building, such as this, that has little foundation this can affect it considerably, causing cracks to open up or re-open, or sometimes seemingly appear from nowhere.

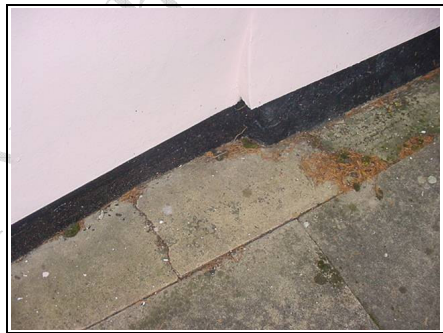
Concrete surrounding building

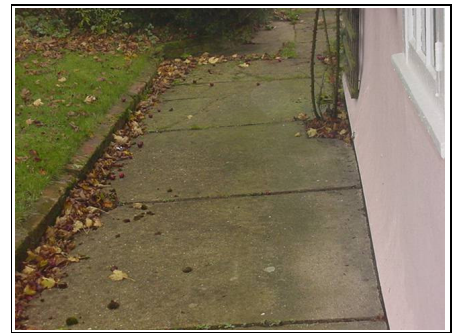
Concrete slabs around prop that indicate that major work has been carried out to foundations

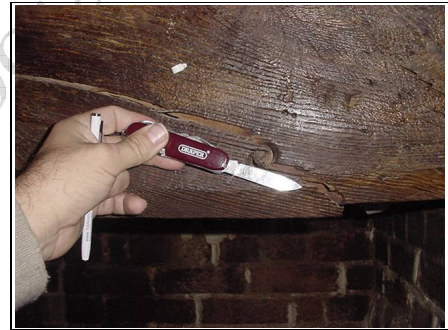
Cracking to chimney breast beam

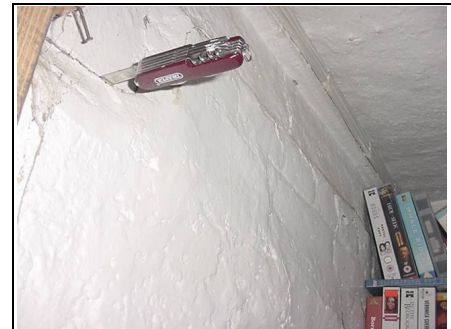
Cracking to right hand side of breast of beam in adjacent cupboard

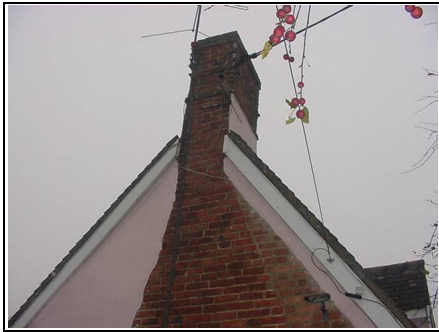
Left hand chimney – where there's movement

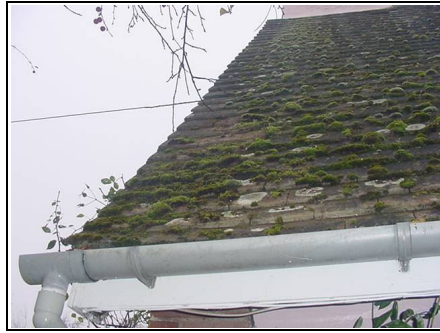
Moss sitting on roof indicates that property is not getting sufficient sunlight

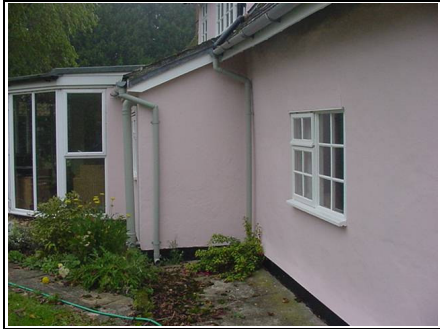
Downpipes discharging to rear left hand side

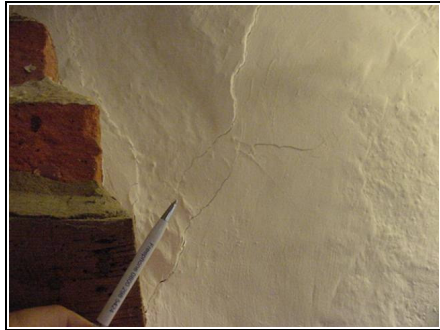
Cracks to right hand chimney

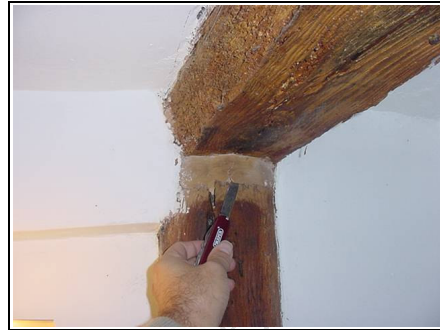
Spine beam and floor joist – filler in timber supports indicates previous repairs

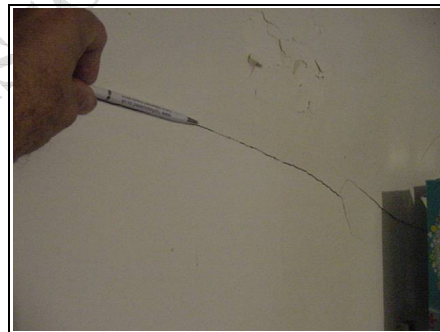
Cracking in utilities room

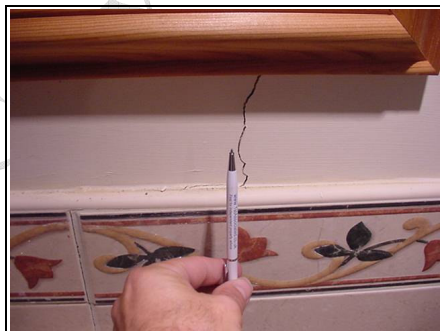
Cracking to bathroom

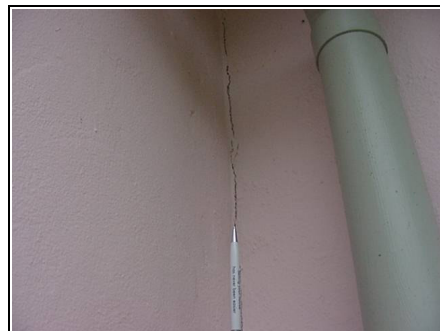
Cracking to bathroom
