SPECIFIC DEFECTS REPORT

Relating to Dampness

London N6

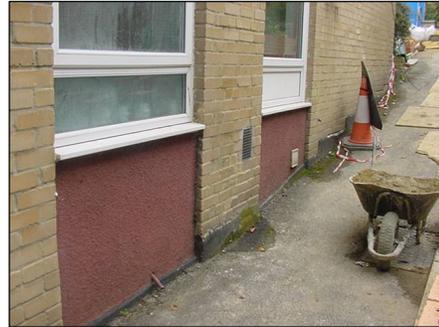
Dampness and moss sitting against the property

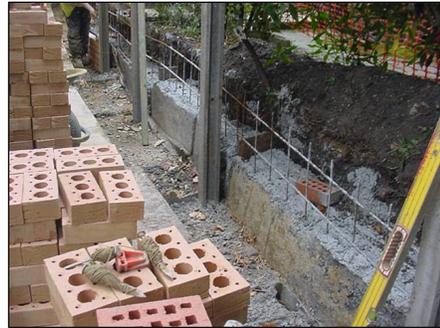
We would comment that a new factor that is introduced that may be effecting how ground water moves around your property which in turn will be effecting the ability of the walls and floor (remembering it is a concrete floor which acts like a sponge) to adjust and adapt to the moisture is the building of the party boundary wall with the far deeper foundation that it would have originally had which would have changed the path that the water takes.

Wall possibly redirecting the water

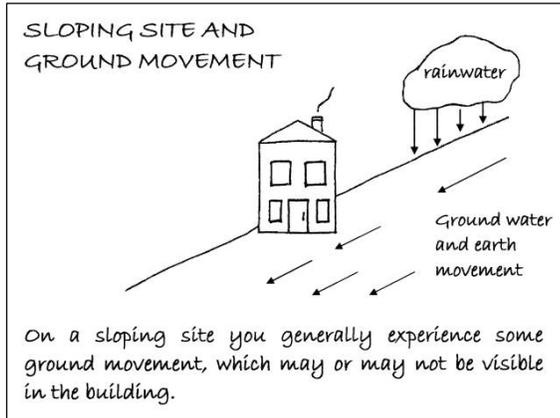
Sloping site

The building sits on a sloping site, water needs to get from the top to the bottom and the building is in between.

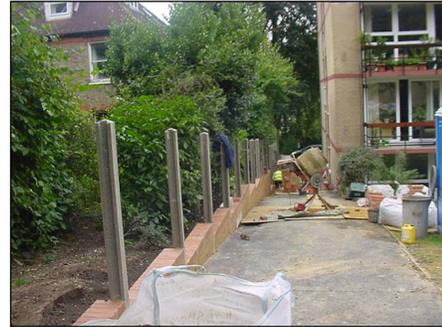
Retaining wall

No weep holes present.

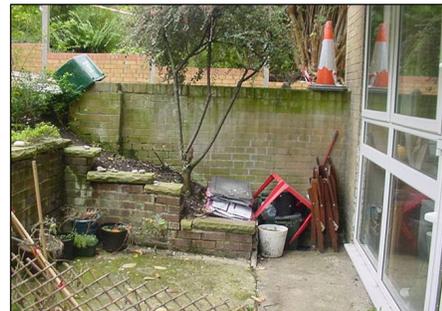
Retaining wall with no weep holes therefore water is being diverted

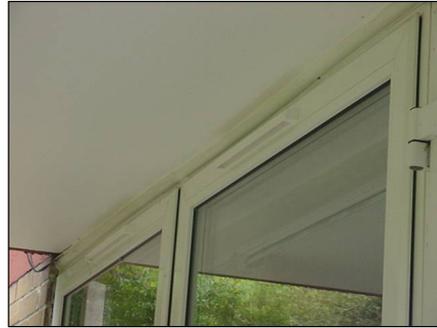
Trickle vents

We recommend fully openable windows the present windows are not good quality (apologies we forgot to check this). Can the kitchen and bathroom windows open fully?

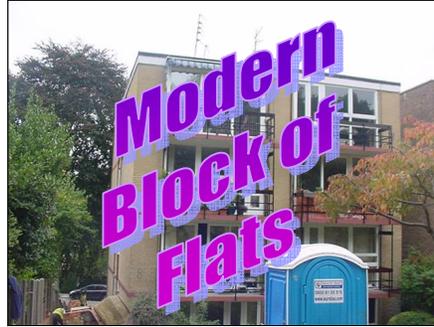
Rear elevation

Construction as the front elevation but with larger surface areas/percentage of glazed windows. The rear elevation is below ground level and as such will suffer from ground water travelling from the top of the site to the bottom.
