SPECIFIC DEFECTS REPORT

Relating to cracking
London Borough of Enfield

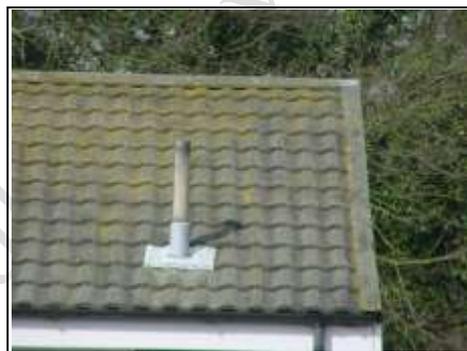
Originally these properties would have had an asbestos roof. This looks to have been replaced although it should be noted that we have not been in the roof space and a full asbestos report should be carried out.

Roof

We would recommend an asbestos report is carried out on the property as a whole to establish if there is any asbestos and its condition.

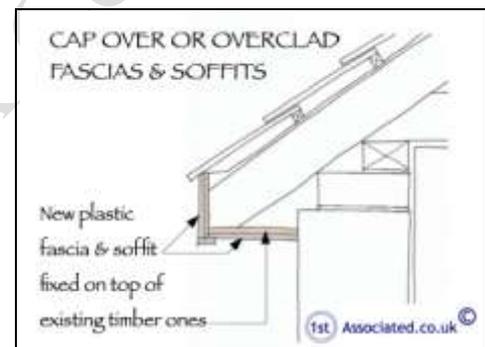
The fascias and soffits are plastic which could be overcladding asbestos.

Overclad fascias and soffits

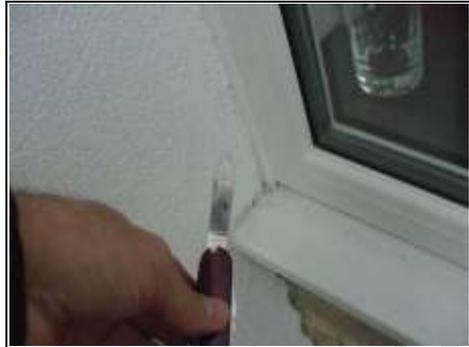
The porch is out of true with the main building as shown by the difference in the cover bead where the porch meets the main building.

Cover bead at bottom of porch

ACTION REQUIRED: We request further information with regards to the work carried out here.

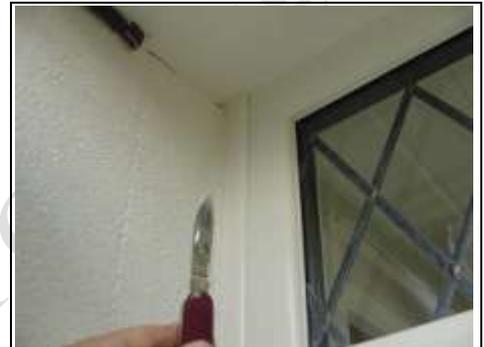
Cover bead at top of porch

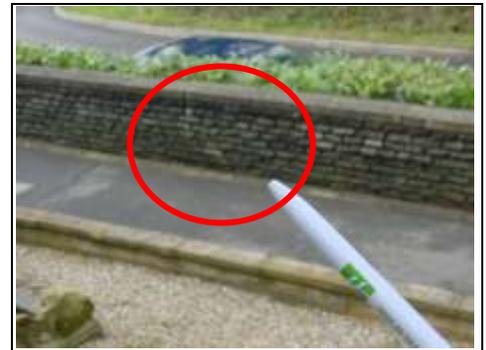
Crack to front garden wall

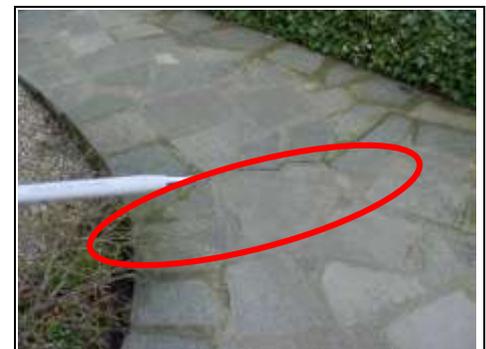
Crack to path

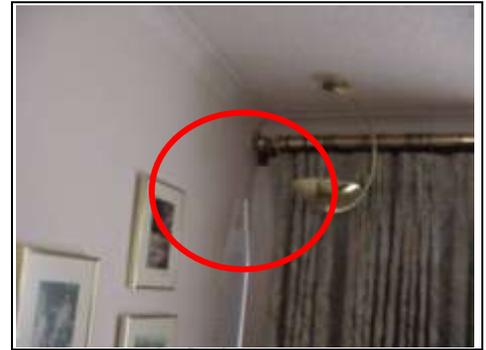
Distortion to entrance door between lounge and dining room

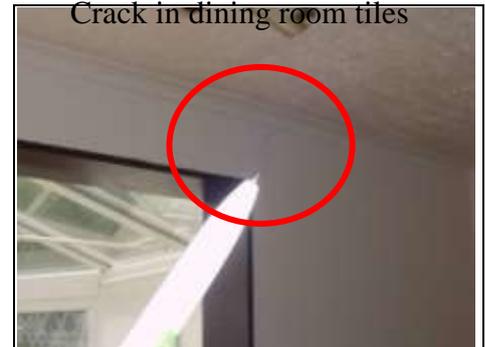
Crack in dining room tiles

Crack to dining room/ access to conservatory

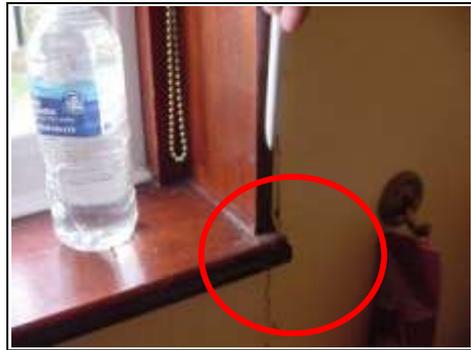
Cracking around both sides of the window (it was not possible to access the wardrobe area on the right hand external wall

Crack to left hand side of window

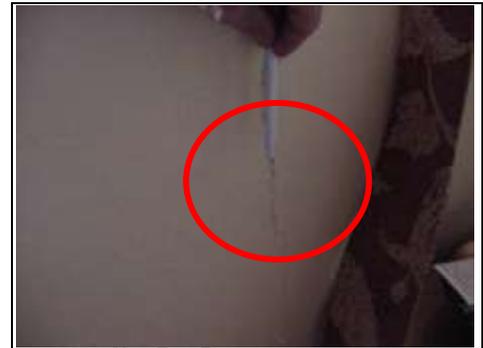
Close up of crack, approx half a metre to a metre in length

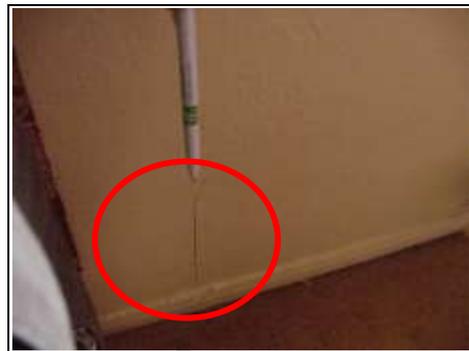
Crack on right hand side to base of wall near window

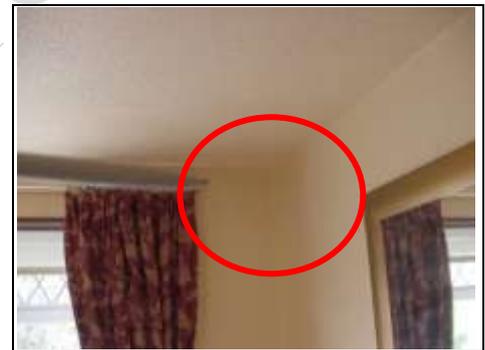
Wall to ceiling crack

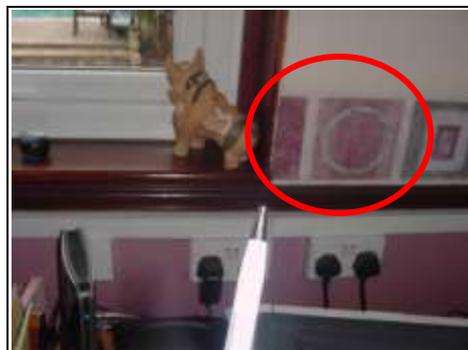
Cracking around air vent/window at high and low level

Crack next to window

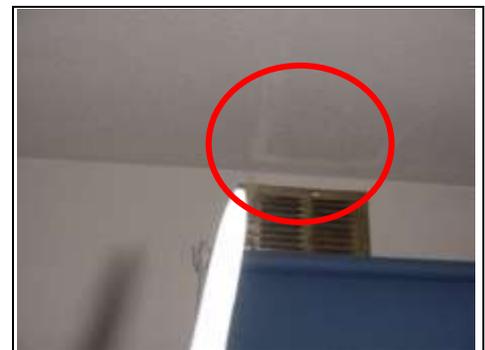
Crack around air vent

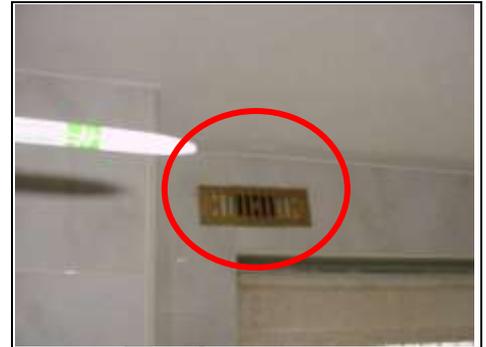
Cracking at wall to ceiling junction which has been repaired

Repaired crack

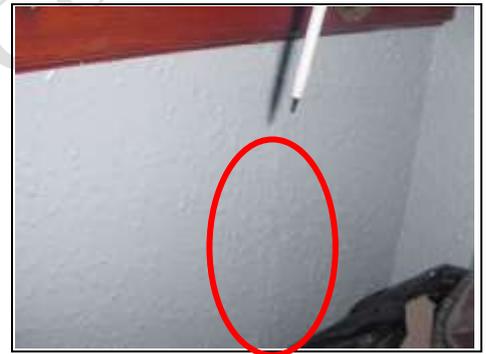
Crack at top of stairs

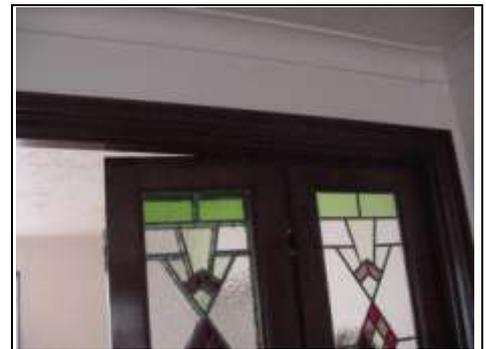
Throughout the property doors and windows are particularly difficult to open and shut, for example in the front right bedroom, the cupboard door has to be kicked closed and the bedroom window on the right hand side cannot be opened and the left hand side window is showing a gap and light visible.

Doors unable to shut between lounge and dining room
