SPECIFIC DEFECTS REPORT

Relating to identified Dampness

XXXX London. E17 XXX

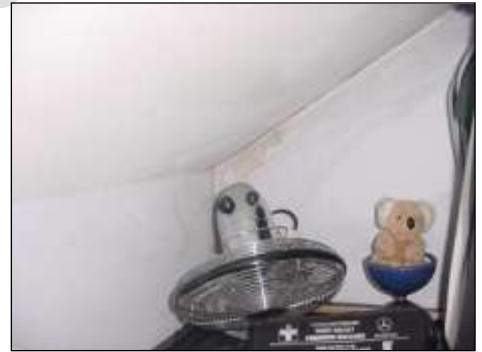
1. We believe that rainwater is getting in through the parapet wall, this is in a variety of ways:-
 - i. Dampness from your neighbours side where there does not appear to be a flashing which certainly is not visible and in addition to this there looks to be a green layer of moss which indicates that there is dampness which we believe is the main cause of dampness coming through into the bedroom, possibly also affecting the other areas.

Dampness within top bedroom front left hand corner

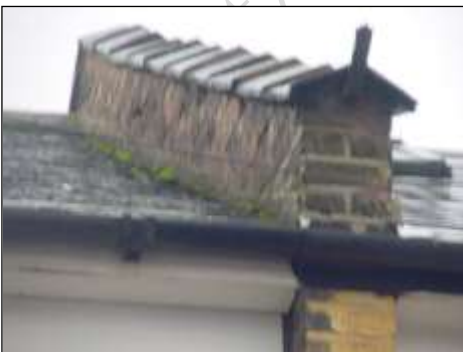
Close up Parapet wall from your neighbours' side

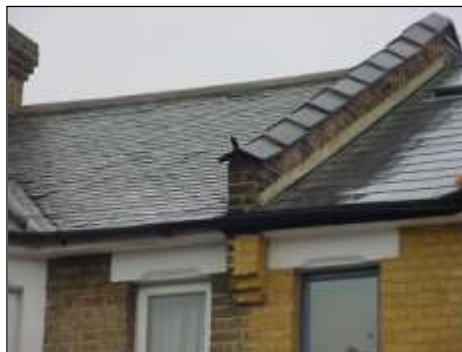
Parapet wall left hand side

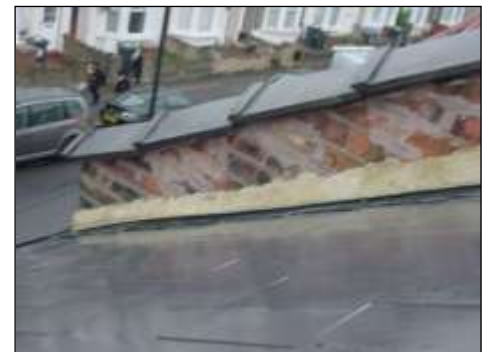
Parapet wall close up your side

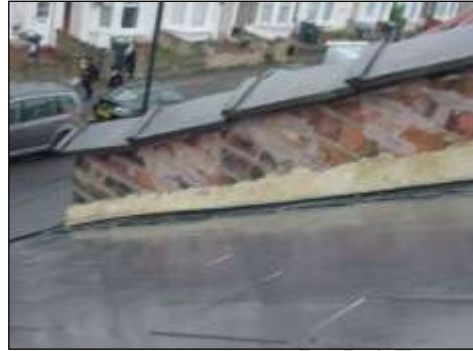
- ii. Residual water left in the parapet prior to the coping stones being rebedded.

Rebedded coping stones

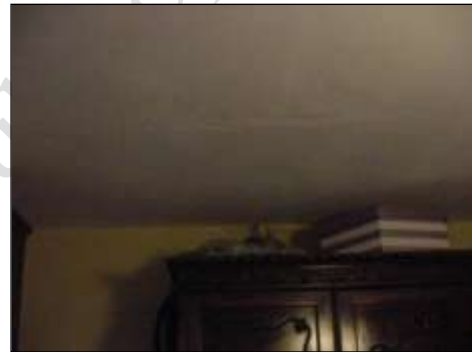
- i. The parapet wall issues that we have already mentioned.
- ii. The shower waste pipes which we have carried out a dyed (Ribena water test) we are sure you will advise us if any red or pink colour comes through on the ceiling.

Dampness within main bedroom left hand wall

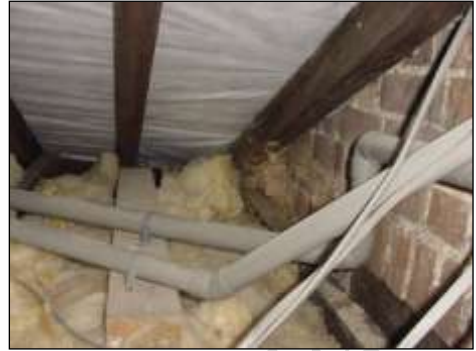
Close up of common rafters checking rear detail

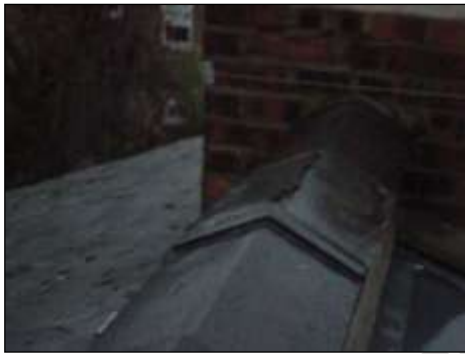
Damaged coping stone that has been put back

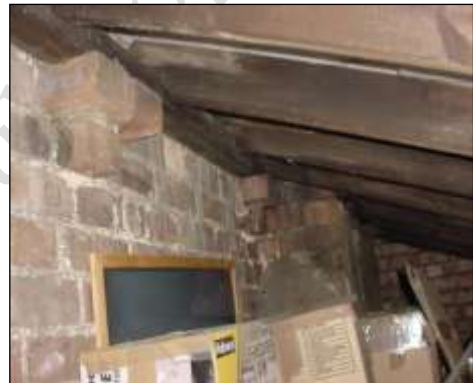
- i. This relates to the parapet wall, in this case it is likely to be the rear parapet wall.

This is where the parapet wall starts to the left hand side of this photo

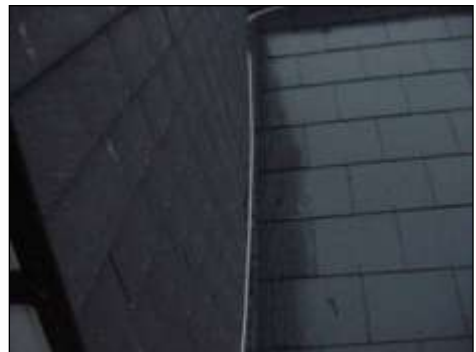
- iii. As in the previous section it could be the junction between the main building is defective

Defective junction

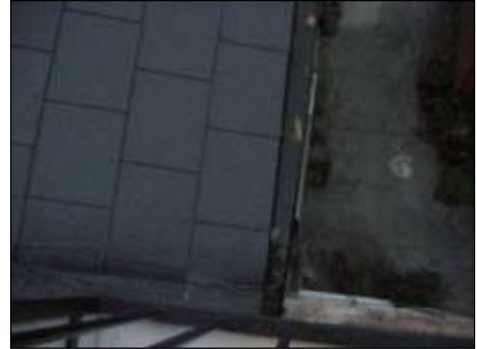
Gutter full of water at rear discharging against property, this is the best view we had of the junction between the main building and the rear building unfortunately all we could see was a gutter full of water!

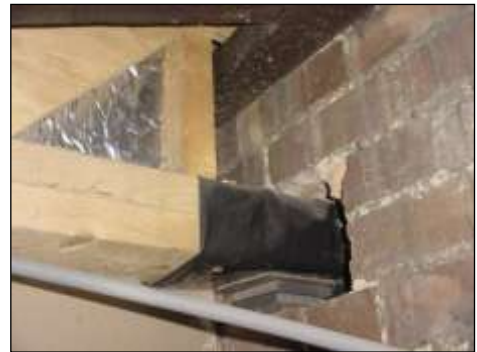
Example of poor workmanship, the packing underneath the joist within the roof

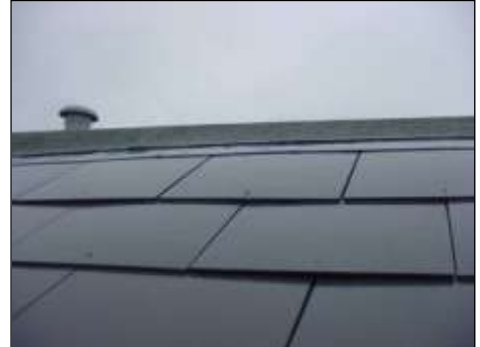
i. roofs - we noted that the original roof has been replaced with a manmade slate

Manmade roof slates

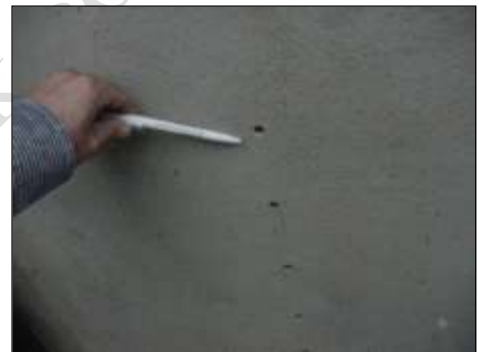
ii. walls – we noted the walls have been finished in a modern cement render which may not be appropriate for this age of property in addition to this we noticed the detailing was poor around the windows and also the damp proof course (DPC) has been inserted

Wall showing holes where DPC has been inserted

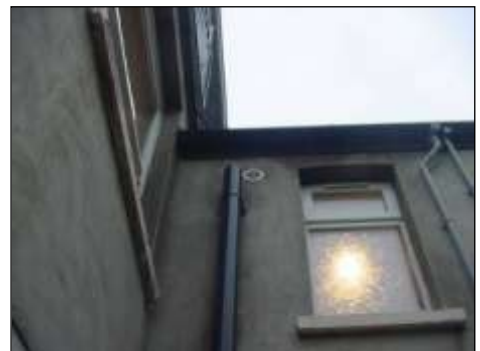
iii. windows – the windows have been replaced with modern plastic windows, whilst these have trickle vents they do have a reduced airflow around the property compared with a traditional sliding sash window which is what these would originally have had.

Plastic replacement window

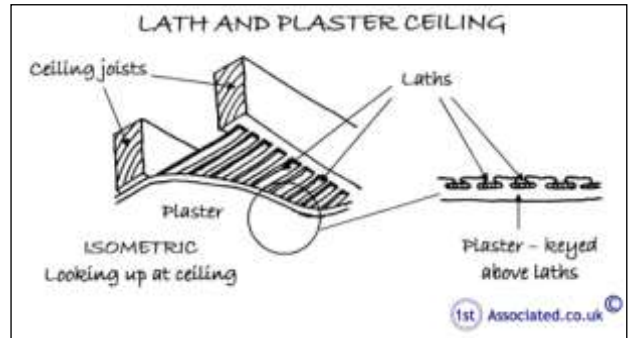
Lath and plaster

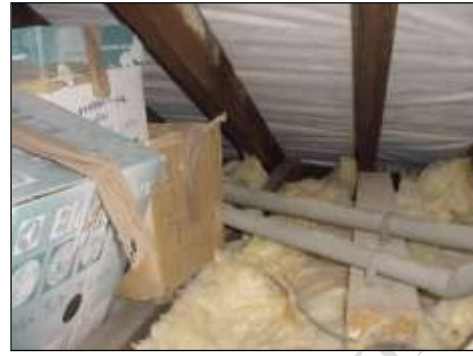
4. From our visual inspection within the roof we noted that there was wall plates sitting on top of and into the parapet wall with signs of dampness, we noted poorly supported new timbers and we noted what looked to be a breathable felt that has been used on the underside which we feel is good practice. Our view was limited by stored items in the roof and our view was carried out via torchlight.

Inside the roof
