# **SPECIFIC DEFECTS REPORT**

**Relating to dampness and noise transfer within  
the ground floor flat  
XXXX Plaistow, London E13 XXX**

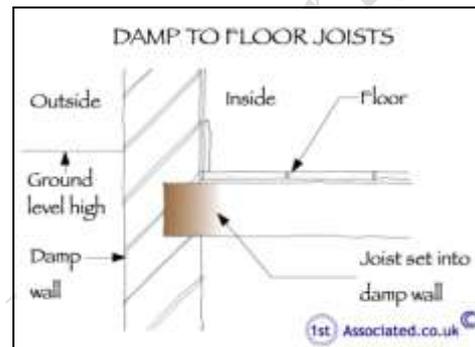
There is rising damp in the property which is common in many properties of this age however this can be reduced by ensuring there is airflow underneath the floor via the airbricks. This property has a suspended timber floor (which you can see in the first sketch) so you need to ensure there is an airflow from the front to the rear of the property (as you can see in the second sketch).

Damp to floor joists

Given the condition the property is now in you will need to replace timbers particularly embedded timbers that have rotted over the years the repair and replacement of the timbers should only be carried out once an air flow has been established from the front to the rear of the property.

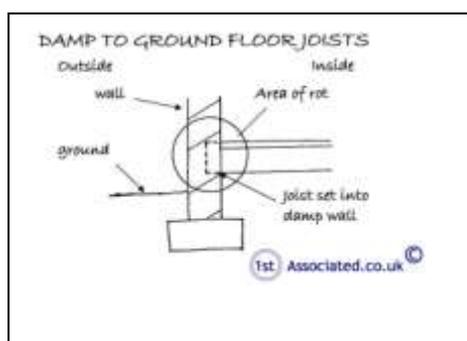
We believe problems relate due to a lack of ventilation under the floor of the property and lack of air movement in the property in general which has resulted in dampness getting into the floor timbers (this is not just within the hallway but it is throughout the entirety of the ground floor of the property).

Damp to ground floor joists

**TION REQUIRED:** You will need to clear and open up the air vents to the outside of the property and ensure there is no air flow underneath the whole of the floor of the property. Once this has been carried out you will then need to replace the deteriorated timbers and we would also recommend that the plaster is removed and replastered as it will be contaminated with hygroscopic salts (salts that attract moisture) and ideally it should be replastered in a lime based plaster (we are aware that many builders will not want to do this because it is hard) but lime based plasters will dissipate any dampness in the structure.

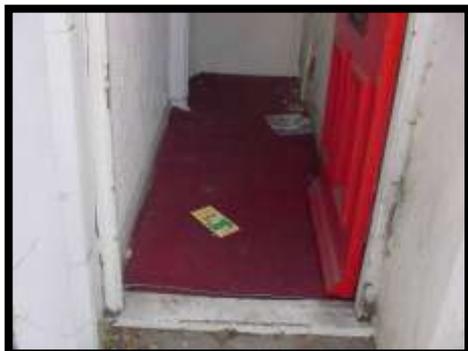
Unfortunately repairs have been made in modern gypsum plaster which has compounded the problem as modern gypsum plaster cannot cope very well with dampness.

Shared entrance Hallway

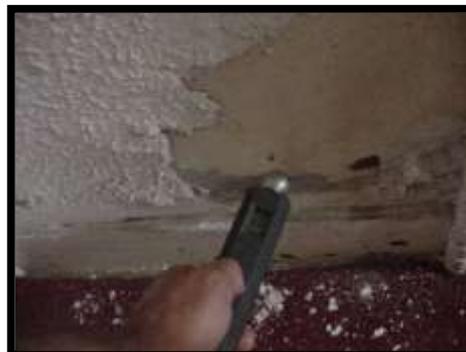
Electric resistance damp meter readings have been taken typically we would expect readings in the region of 30-40 we have found readings in the region of double to triple that.

High damp meter readings in the hallway

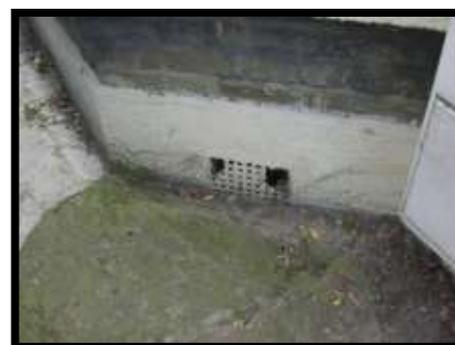
Air brick

Open up the airbricks and put larger airbricks in to at least double the size of the existing bricks (making sure the holes in the airbricks are big).

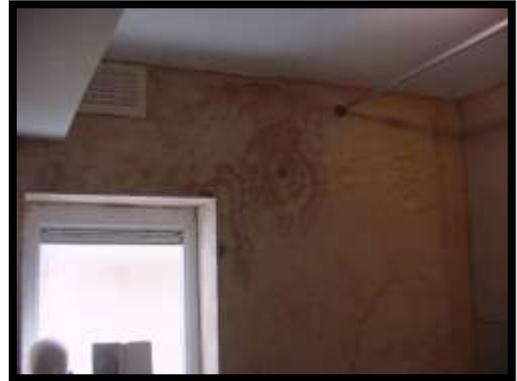
Dampness was noted within the bathroom. This looks to be caused from lack of ventilation, which is affecting the modern gypsum plaster. As we have not met you we are unable to discuss or confirm the frequency of use.

Gypsum plaster to the bathroom

**ACTION REQUIRED:** We would recommend the installation of a humidity controlled mechanical extract fan of 150mm diameter.

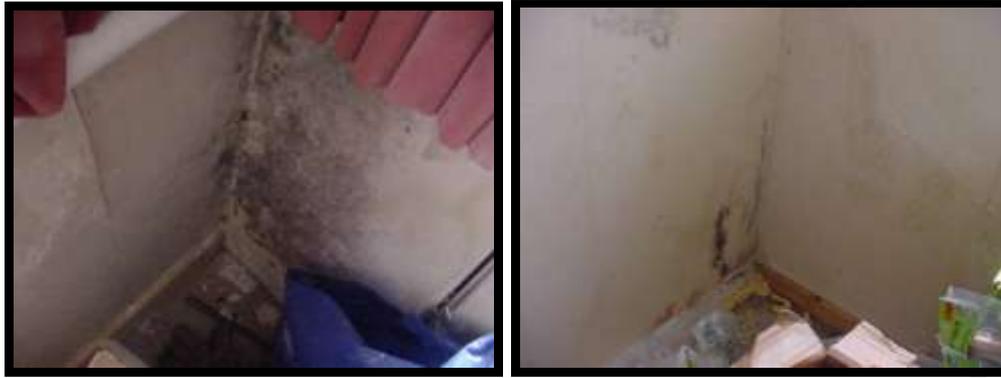
The mould we can see to the bedroom walls is typical of what we see with condensation. The condensation we believe is being drawn from high humidity areas such as the kitchen and bathroom to the relatively cold areas such as the bedroom in this property.

**Mould to the corners of the bedroom**

We would relate this back to our comments on the bathroom. We feel that if a mechanical extract fan is added in the bathroom and kitchen this should reduce the dampness in these areas but you do need to put some background heating on as old properties have cold areas (known as cold bridging) which does draw condensation.
