Tailor made report

SPECIFIC DEFECTS REPORT

Peacehaven, East Sussex. BN10 XXX

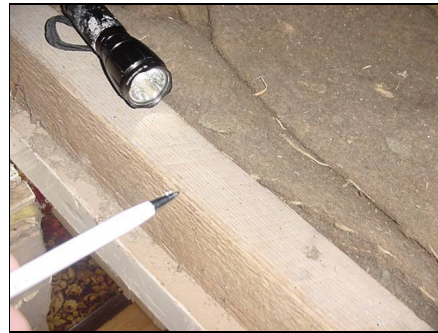
Woodworm in the roof

Within the roof we found woodworm flight holes but we could not see associated frass even when we tap (the wood) this normally indicates that the woodworm is active particularly at this time of year which tends to be breeding season.

ACTION REQUIRED: The only way to be 100% certain is to have the items in the roof, such as the insulation, removed and have the whole roof inspected and the area chemically treated. Remember that many of the chemical treatment companies will only make a profit if they find woodworm, so you do need to ask them to show you any active woodworm they say they have found.

We recommend that the whole roof is cleared, chemically sprayed by a company with an insurance backed guarantee and have the same treatment carried out to the floor. We feel the costs are likely to be in the region of £4000-£6000; quotations required.

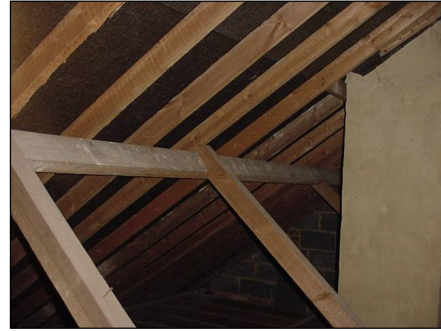
We did not note any woodworm which we would consider structurally significant, however we feel unless evidence to the contrary is available then a 'belt and braces' approach has to be taken.

The nearest diagonal timber, (which is known as a prop), is supporting the purlin, (which is the horizontal timber) which in turn supports the common rafters (which form the pitch of the roof).

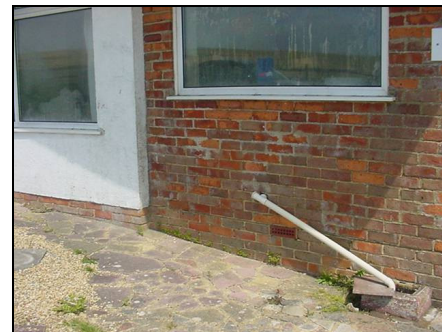
Our concern would be at the front of the property where the ground level raises and also to the rear of the property where the concrete is present for the green house/conservatory.

Airbrick also showing slope of the ground

ACTION REQUIRED: We would recommend that a French drain is added to the front of the property where there is a sloping site. As you are aware because you carried out investigations with us, from what we saw there is minimal dampness to the floor but we did however think that it smelt slightly damp.

ANTICIPATED COST: To add a French drain and a running vent to the rear of the property adjacent to the green house/conservatory you should budget in the region of £1500-£2500; quotations required.

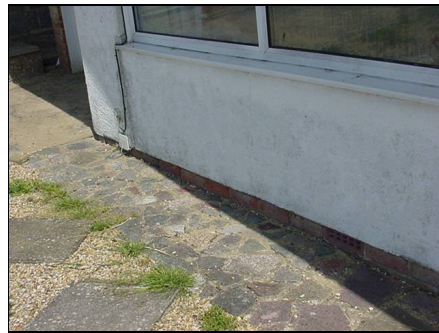
Area needs a French drain front left hand corner

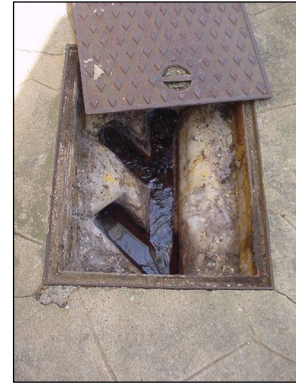
In both cases the water was free flowing from what we could see and they were not showing excessive signs of excess wear and tear considering the properties age, type and style.

Drain lifted close to entrance door

ACTION REQUIRED: Use the drainage to see how it copes, it is likely it will have had relatively low usage in recent years.

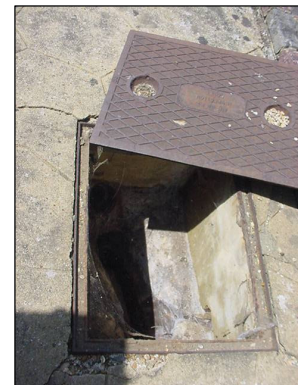
Drain lifted front corner

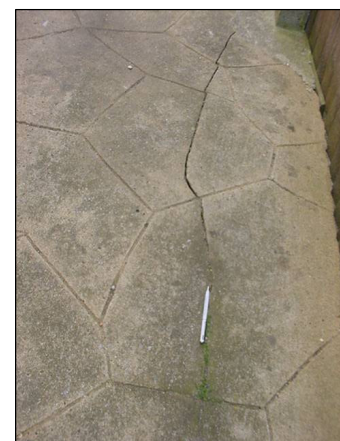
There is some cracking along the edge of the pavement where the drains run underneath. In theory this could relate to minor ground movement caused by leaks to the drains, they will be leaking to some extent as do most older drains. In this case in the main it is probably due to lack of support as the path steps down.

Cracking adjacent to drains

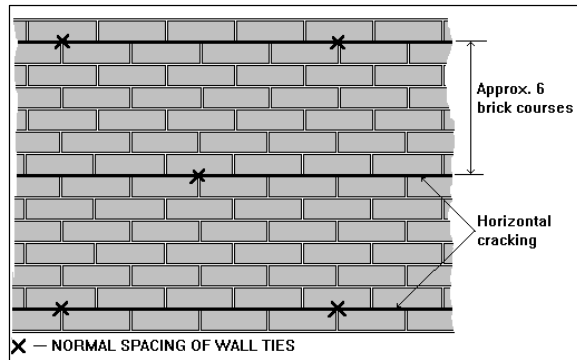
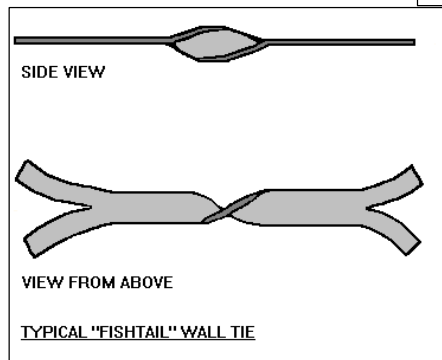
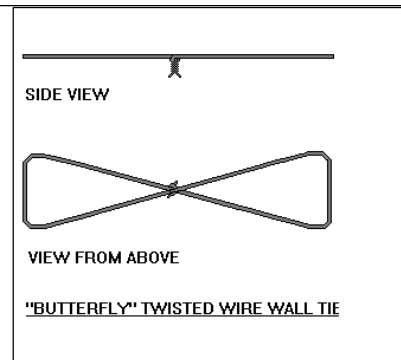
Two examples of wall ties

You will never truly know the condition of the wall ties and the bricks until you open up the structure although we can see that the brickwork is heavily spalling and that the mortar joint has weathered.

We would recommend the existing brickwork is re-pointed in a like for like mortar. Where the bricks are spalling we would recommend these are removed and reversed, where at all possible. We would not add new bricks unless there was no other option as they never match and you get a spotty dog look to the property. The walls ties need to be checked at the same time.

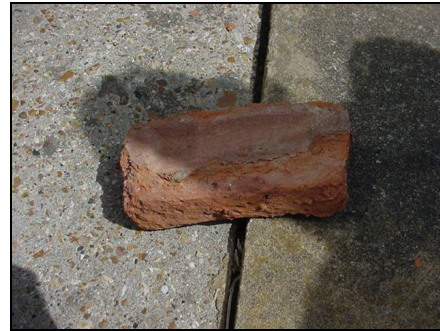
Spalling occurs to brick or stone when water penetrates the surface and via freezing and thawing starts to cause deterioration to the surface. This in turn allows further water penetration and the surface breaks up further. This ultimately can lead to water damage or structural damage to the area.

This brick shows spalling to front and rear

ANTICIPATED COST: We would expect costs to be in the region of £2500-£4000; quotations required.

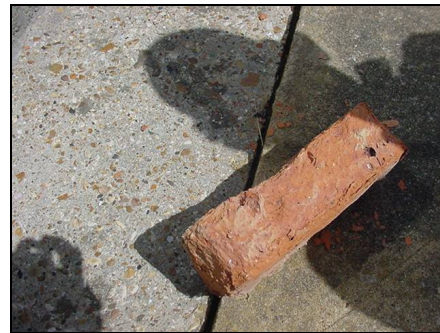
Deterioration to rear of brickwork

Spalling brickwork and weathered pointing.

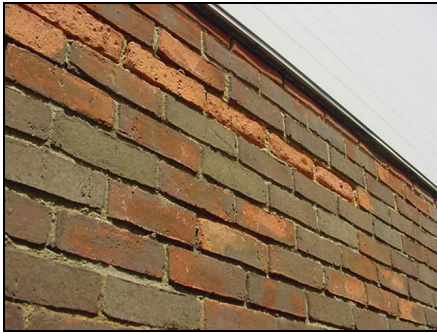
Brickwork right hand side

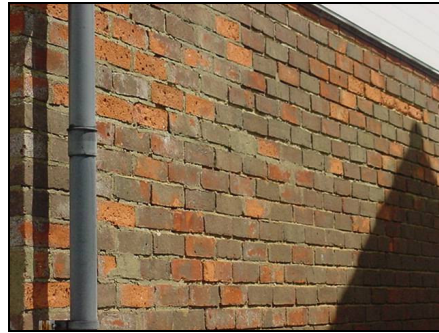
Poorly repointed brickwork

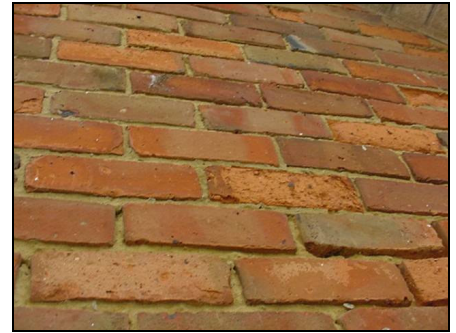
Close up of brickwork

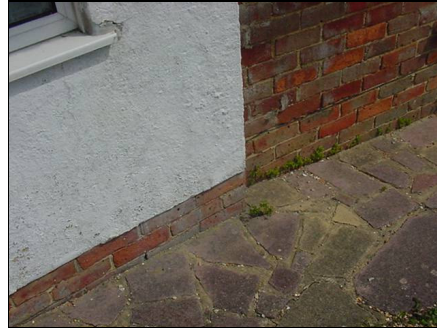
Render

Rain cladding is a general term given to surfaces that are added to walls to protect them. In this case you have painted render to the front of the property and also the plastic shiplap boarding to the gable ends of the property.

You may wish to look at repairing these or replacing these areas. A style that we see very commonly today is a timber cladding.

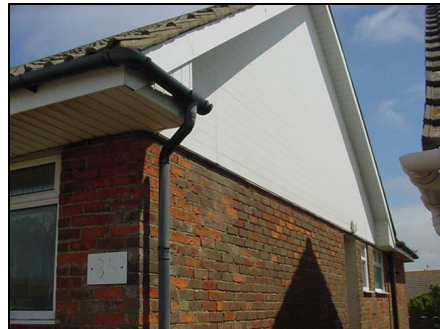
Gable end shiplap boarding

The benefits of new rain cladding will mean that you will be able to add new insulation behind them on the outside of the property which as the walls are cavity walls but not insulated (as far as we could see) this will benefit the energy efficiency of the property.

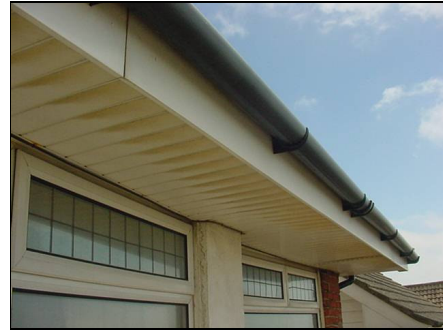
The fascias and soffits to the property have a plastic cladding. We believe this may be over cladding which is where the plastic cladding is put directly over the timber. The timber is normally rotting or in poor condition and should be removed and replaced with solid plastic fascias and soffits. Often stick on over cladding is used.

Fascia board in need of attention

In the region of £3000-£4000 and we would also recommend vents are added to ensure the roof is properly vented; quotations required.

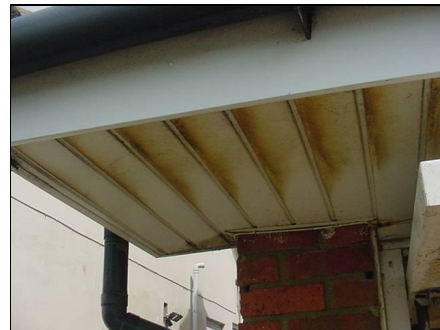
Close up of cladding

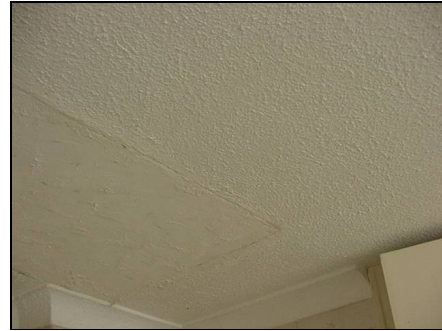
We noted that the ceiling in the kitchen has a textured paint (commonly known as Artex) that contains asbestos. We also noted that the flue from the boiler system looks to be asbestos.

Possible asbestos to ceiling paint commonly known as Artex

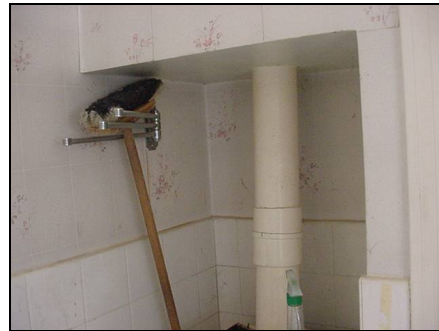
Vent coming from the boiler system

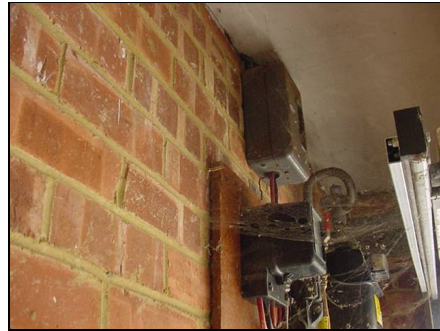
The electrics are dated and we would recommend that the whole system has a test to Institute of Electrical Engineers (IEE) standards by a competent electrician (NICEIC registered) or equivalent and it is likely that they will recommend a new fuse board.

Dated electrics

We could not find a fuse board in the traditional sense just the actual meter which is located in the garage this surprised us it may be that everything is on one fuse or we have missed the fuse board.

ACTION REQUIRED: We would recommend a new fuse board and re-wiring of the property.

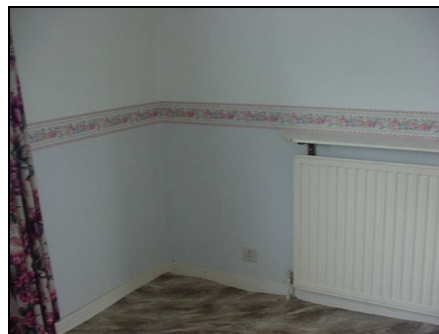
You have single panelled radiators, it is more common to have double panelled convection radiators located underneath windows. The reason for having radiators located underneath the windows is as warm air rises from them it hits the cooler air to the windows and circulates around the room. The reason radiators are not located underneath windows is because the plumber is often trying to save time and money as well as

Internal single panelled radiator

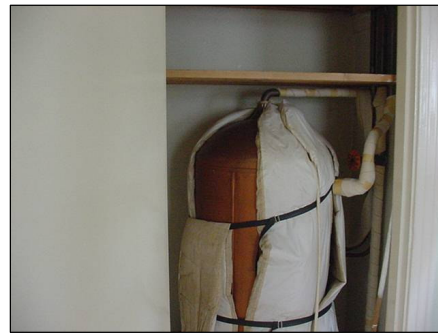
You have an old hot water cylinder we would recommend it is replaced with a modern factory insulated unit our experience has been that these are very efficient.

Old hot water cylinder

ACTION REQUIRED:
Replace.

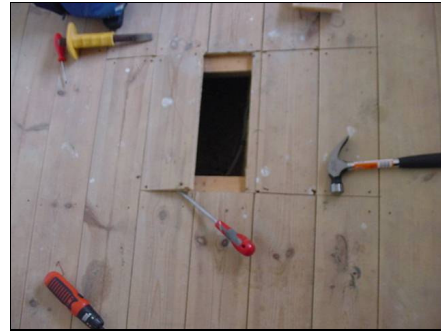
Lifting up floor in the left hand side bedroom

In each case the opening was approximately 200mm x 400mm and was examined via torchlight. In each case we could see no signs of structurally significant woodworm. In most cases we could not see or smell signs of dampness with the exception of the front reception room where we decided to make a second trial hole to the front left hand corner and we noted no signs of wet rot or associated fruiting body.

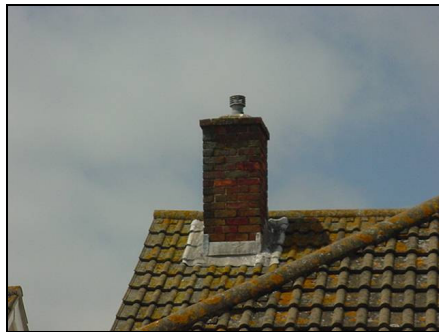
There is spalling to the chimney brickwork.

Chimney One right hand side chimney
one viewed from the rear

ACTION REQUIRED: We recommend re-pointing and checking of the flashing to the chimneys.

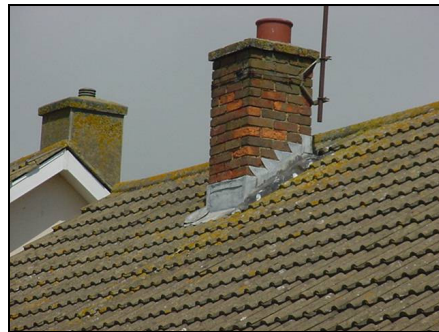
Chimney Two front left hand side

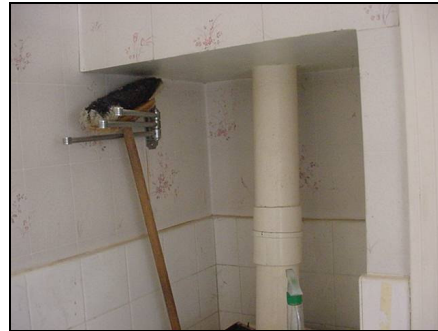
It looks likely that you have an asbestos flue.

Remove, not just because of the danger but we find that it affects the value of the property if there is an asbestos content anywhere in a property today.

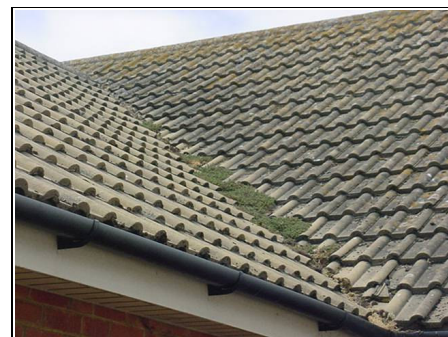
Valley gutter needs cleaning.

ACTION REQUIRED: Some clearing of the valley gutters required.

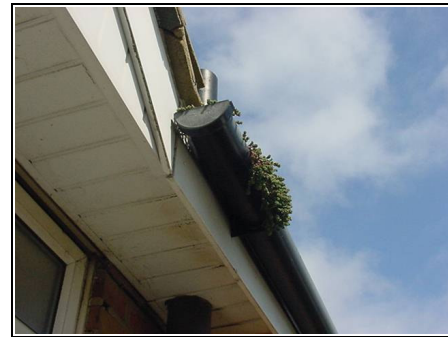
You have older style plastic gutters and downpipes which are leaking in some areas and needs a general clean.

Gutters blocked

ACTION REQUIRED: We would always recommend that the gutters and downpipes are cleaned out, the joints are checked and the alignment checked to ensure that the gutters fall towards the downpipes.

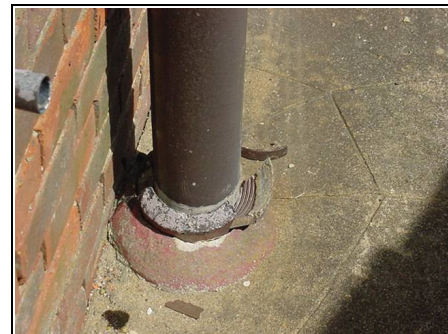
There is damage to the base of the soil and vent pipe, this may leak although it did not leak during the time of our inspection when the water was run.

Soil and vent pipe

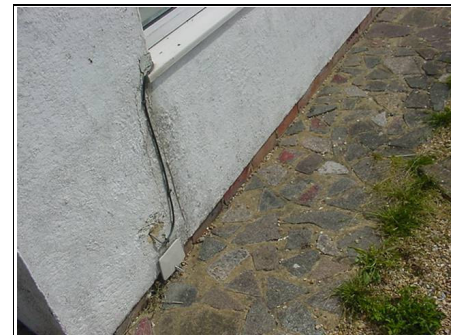
Render

There is a painted render which is worn and weathered.

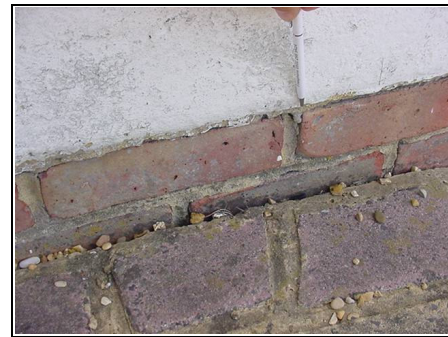
Damp proof course

All modern properties should incorporate a damp proof course (DPC) and good building practice dictates that a differential of 150mm (6 inches) should be maintained between the damp proof course and ground levels. In this case, as the property sits on a sloping site some of the damp proof course is positioned too low.

Please see our comments regarding adding a French drain in the Executive Summary.

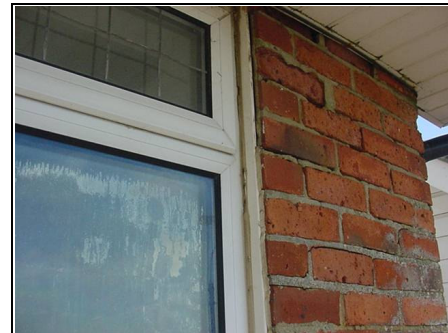
1.3) Windows and doors – these are double glazed and have misted over in many cases indicating that they have failed. You can either replace the glass units in the window or replace the whole window.

Misting of window

Please see our comments regarding replacing windows. We would budget for replacing these, you may wish to have a window that is a feature of the property, windows can vary considerably in price.
