SPECIFIC DEFECTS REPORT

**Relating to the replacement of the
kitchen and associated building work**

**xxxxxxxxxx,
Elstow, xxxxx,
Bedfordshire,
MK42 xxx**

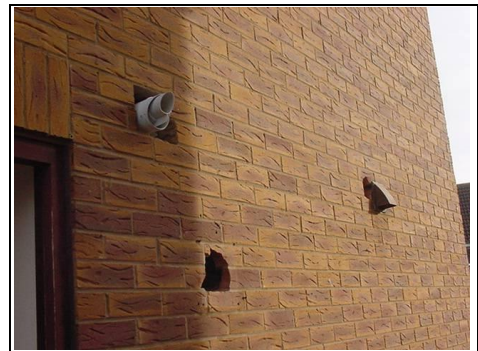
There are openings to the right hand gable wall that have not been made good or have not been fitted around the flue. We would also comment that we would expect the flue from the gas boiler to come out further away from the wall. This should be confirmed and checked by a heating engineer while carrying out a Gas Safe test and inspection. Please see our later comments.

External wall

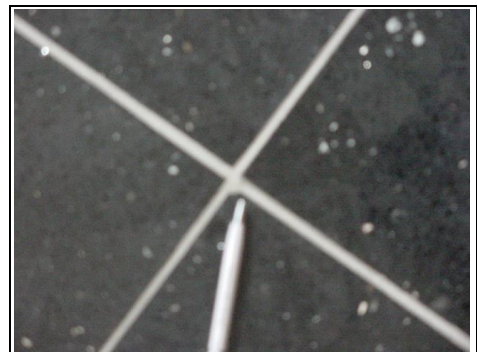
The floor tiles are uneven and some are damaged.

Tile needs replacing

ACTION REQUIRED: Make good as necessary. It is always very difficult to make good a laid tiled floor and great care has to be taken if not more damage can be caused and of course you do

need to be able to match the existing tiles.

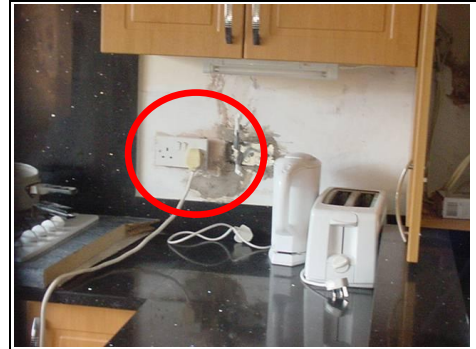
From our discussions with you and as we understand it there is no Gas Safe certificate or Institute of Electrical Engineers (IEE) certificate carried out by an NICEIC approved electrical contractor. The gas boiler was working and the electrics were unfinished and taped at the time of our inspection.

Unfinished electrics

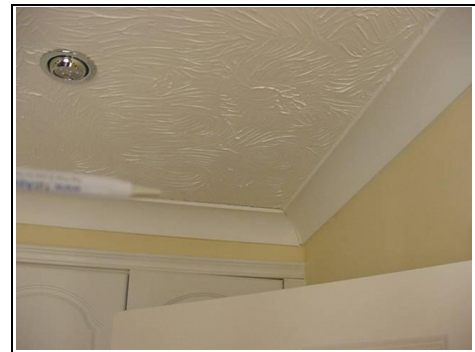
You advised that the bedroom floor has more deflection than previously. We were unable to confirm if the ceiling has been constructed to Building Regulations or not as the floor is covered with laminate flooring which limits our view.

Movement between the ceiling and the architrave

ACTION REQUIRED: The builder needs to provide evidence of the work carried out and the materials used and structural calculations.

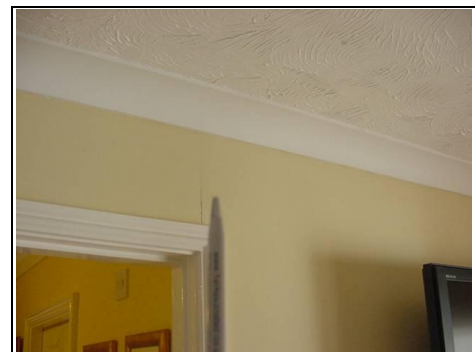
Crack in the wall

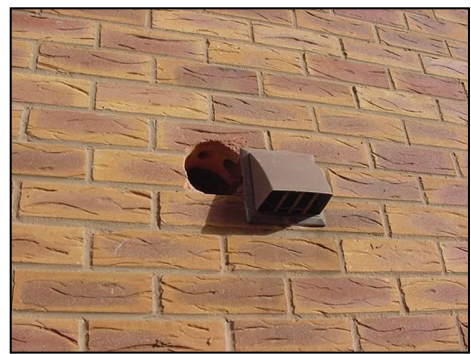
Circular hole not made good

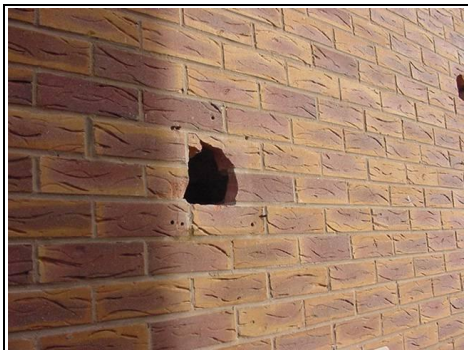
Hole in brickwork not made good we assume from a vent

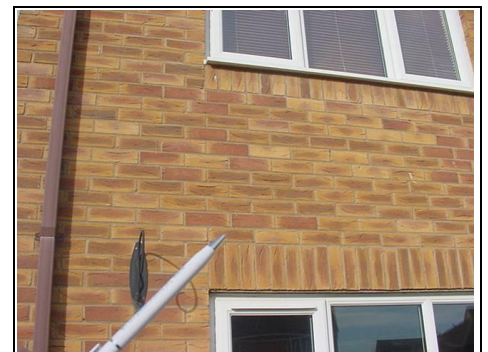
Hairline crack above kitchen window

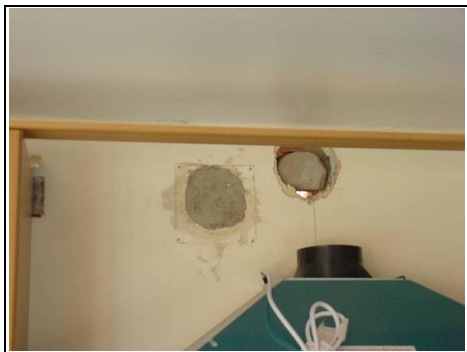
Unfinished wall repairs -internal

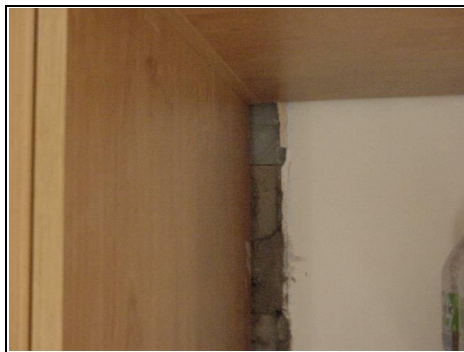
Unfinished plastering

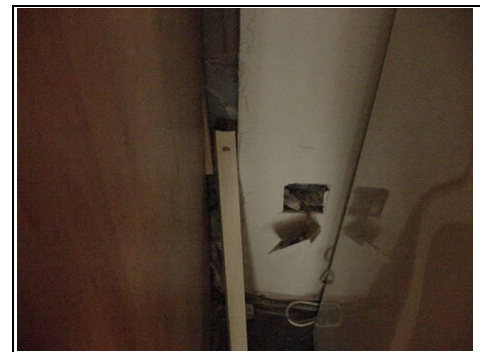
Unfinished wall.
Unfinished electrics

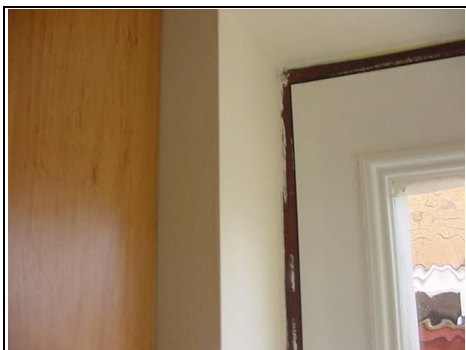
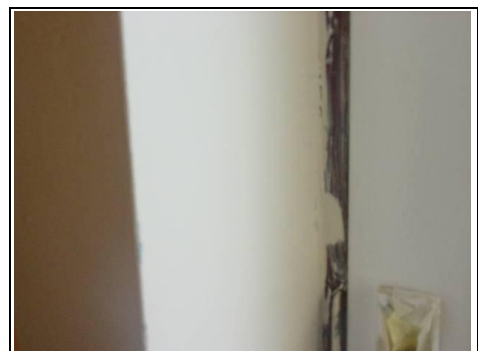
Unfinished painting

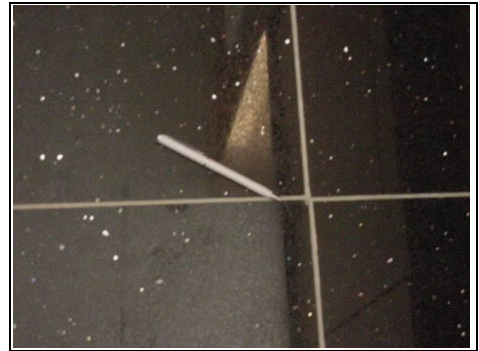
Grouting does not line up in some areas

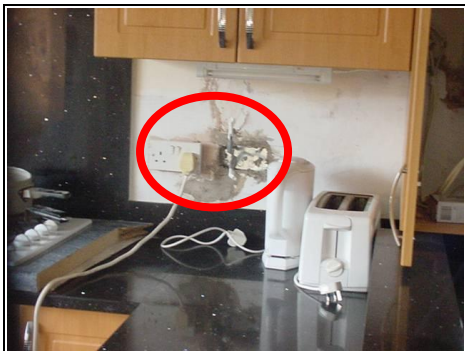
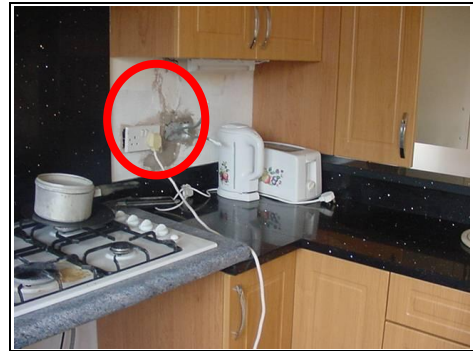
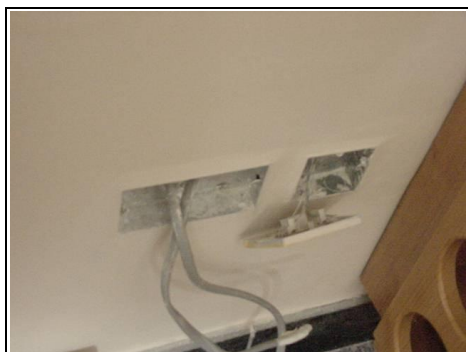
Unfinished electrics

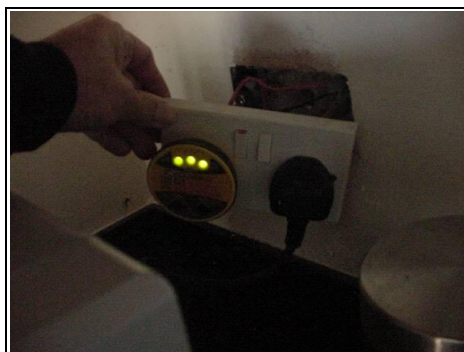
Earth test on loose socket

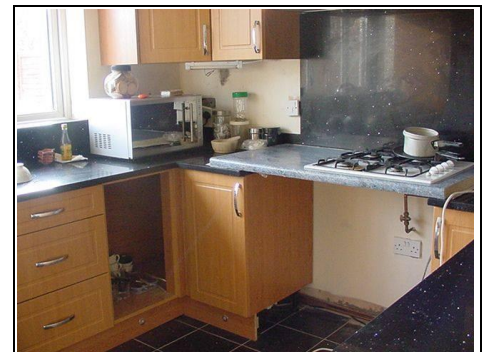
Unfinished gas work
Hob is balanced on worktop

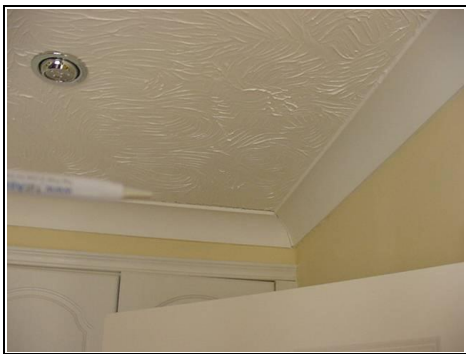
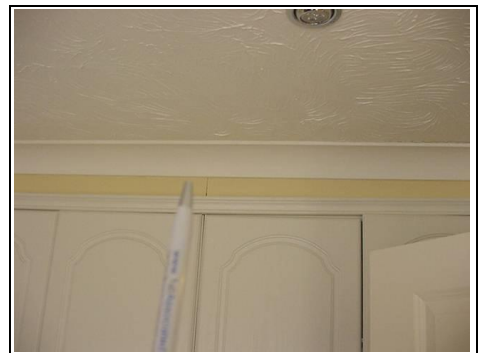
Movement in the ceiling

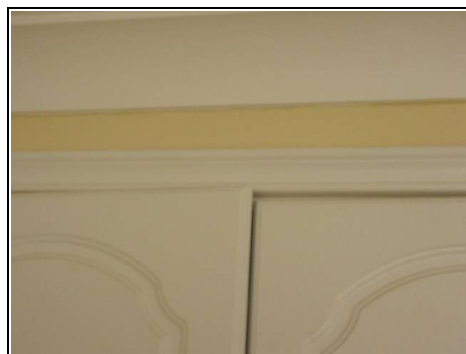
Doors do not align anymore
