# **SPECIFIC DEFECTS REPORT**

## **Harrow HA3 Relating to Problems with Suspended Timber Floor near Bay Window**

FOR  
**Mr S**

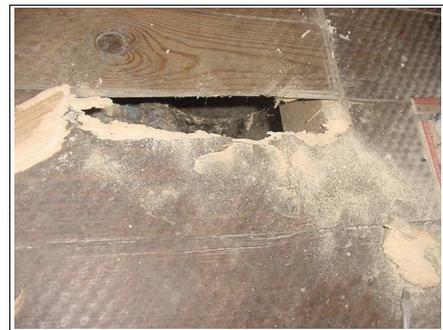
As you are aware we have taken up the floorboards and found woodworm. We believe this to be "active", based upon the amount of "frass" (the chewed up wood), that we can see.

Opening up a small section of the floor

**ACTION REQUIRED:** We would recommend that you strip back the defective timber floor boards and dispose of them promptly (ensuring that you don't leave them somewhere where the woodworm could transfer, although upon reading on this subject it appears that they do not transfer from timber to timber that readily).

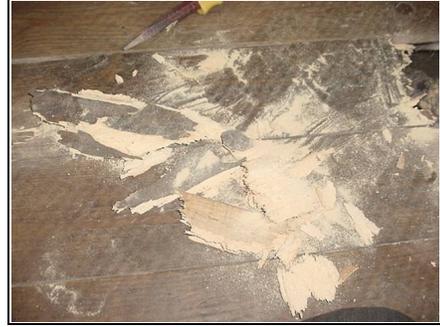
Looking at a sample of the Timber removed showing "Frass" (chewed up wood)

The amount of "frass" is far more than we have seen for a long time and whilst we are aware that woodworm is more active during the spring and summer months, we were surprised about the amount of frass, particularly as from our discussions, you don't use that lounge area that often so there is likely to be little heat in there. Having said that you certainly have woodworm causing damage to the timbers and we feel that if you work through our action plan, you should be able to remove this problem at minimal cost. Please be aware that woodworm companies are there to sell their chemical sprays and will always be pushing for you to have more done than is necessary. If you can't see the woodworm holes and the frass then it is unlikely that there is active woodworm. Most older properties have had some form of woodworm. If you wish us to comment further, we would be more than happy if you email photographs to us or speak to us and we may be able to come back and view any other suspected area of woodworm infestation.

Once you have removed the damaged floorboards we recommend that you check the airbricks are open to give an adequate air flow.

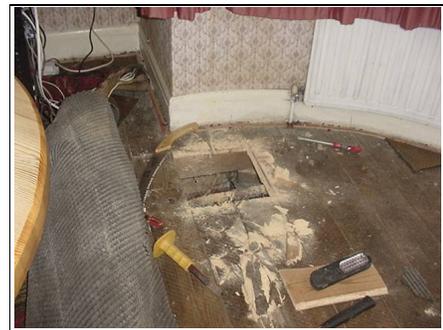
Opening up two floorboards to the bay window area

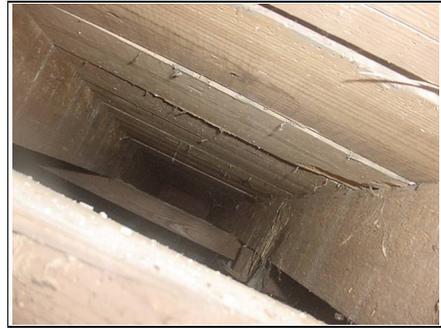
Underneath the floorboards you can see the woodworm holes within the first few timbers

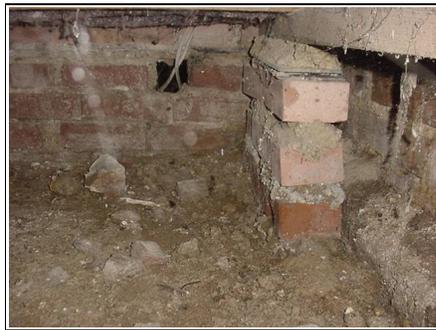
Venting going underneath the suspended timber floor

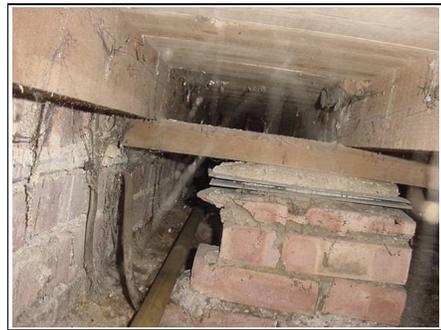
We were pleased to see that the sleeper walls have slate damp proof courses

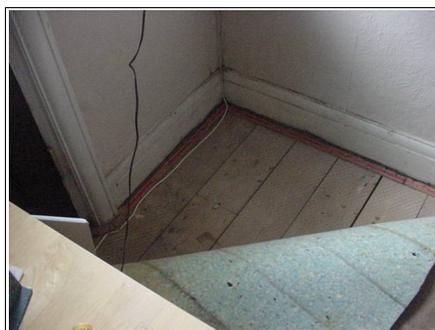
We lifted back the carpet in the hallway to see that a new section of floor had already been put in

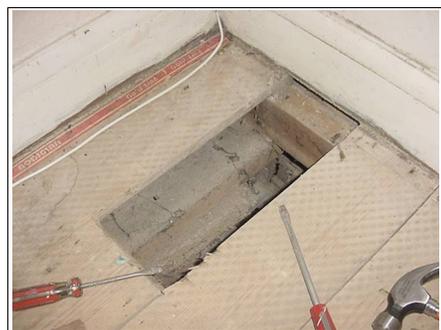
We opened up a section of the floor in the hallway just to be certain that there were no problems in this area

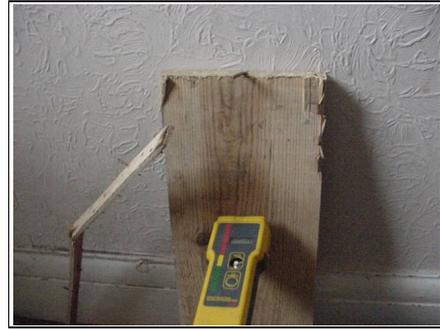
Upon a visual inspection of the timber that was taken out we could see no woodworm although we could see some dampness

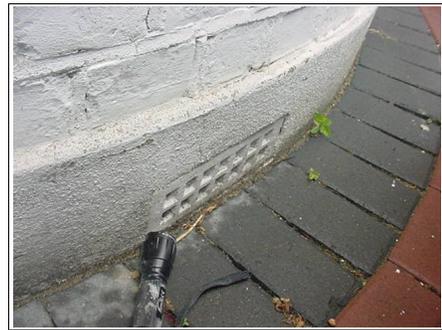
At present your airbricks are blocked in some areas and other areas such as the front airbrick, we believe it is acting as a gutter due to the addition of the brick paves.

Front airbrick acting as a gutter

**ACTION REQUIRED:** We recommend that a row of brick paving is removed to the front of the property and a French Drain is added.

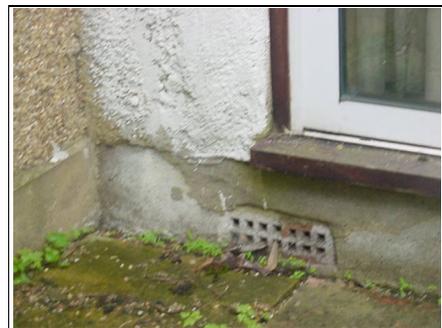
With regard to the rear airbrick that is to the kitchen area, it will be interesting to see if this airbrick has actually been put in place properly as we have seen some false airbricks over the years, so we would suggest that some timber is taken up internally in the kitchen to check to see if there is a clear airbrick opening in this area.

Rear airbrick, again possibly acting as a gutter

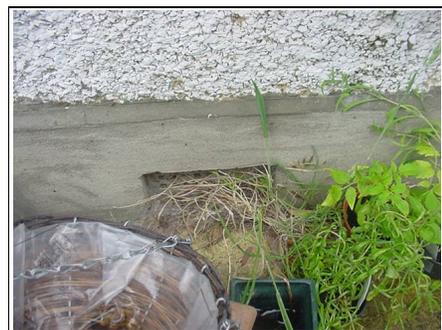
Independent Chartered Surveyor Blocked airbrick, again to the rear

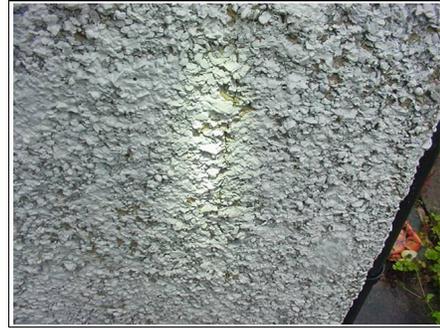
Redecorate the render once the cracks have been sealed

We would recommend sealing any cracks in the render (re-rendering if necessary) and redecorating the entirety of the render in an appropriate paint.

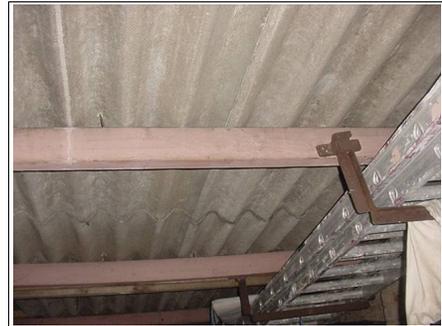
You have an asbestos roof to the garage which you advised us that this has already been sealed on the top. We have not seen this but you should check that it is adequate. We recommend that you line internally and put a sticker on advising that asbestos is behind.

It can be seen that the Garage roof is asbestos

Equally if you send a test sample away, you would then know the type of the asbestos and also obtain a formal recommendation how to remove it (our insurance requires us to advise that we are not trained asbestos surveyors).

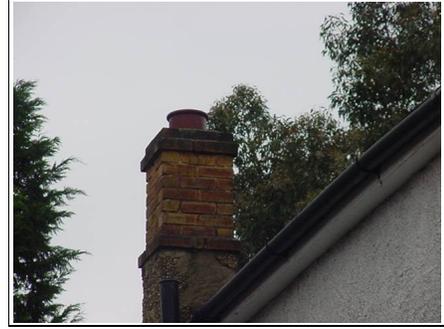
Chimney (left hand side)

The chimneys are deteriorating and ideally need to be checked however this is quite a difficult job, needing long ladders and/or scaffolding. You may wish to leave this for the future purchasers to carry out

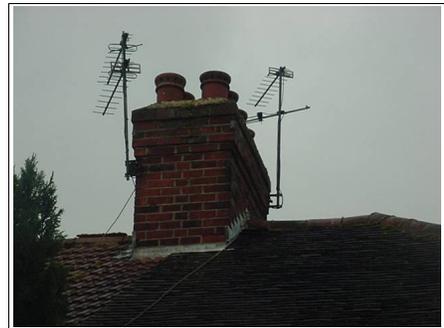
Is there a problem with the Flaunching?
