SPECIFIC DEFECTS REPORT

Hertfordshire

Mr & Mrs X

INDEPENDENT CHARTERED SURVEYORS

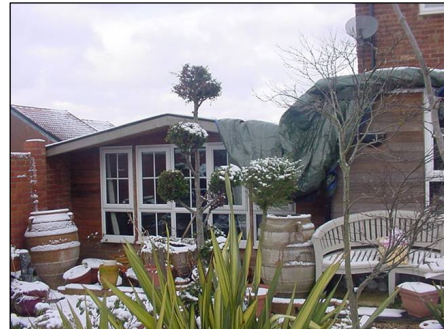
Side extension

Substantial Lean to timber structure which forms home theatre/cinema room and access corridor this is a timber frame structure encased with the brick boundary wall and unlikely to have foundations or to meet Building Regulations or Planning Requirements.

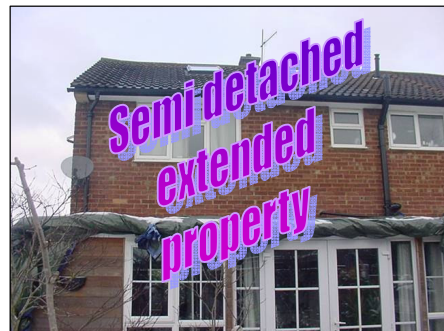
Dining room area

Substantial Rear Extension including two large openings to original house rear walls (approximately 1.2m wide and 2m wide respectively)

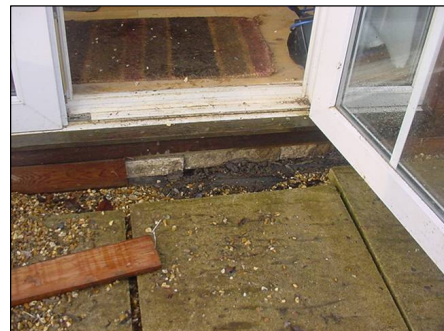
Light weight construction unlikely to have foundations

Lightweight extension appears to be on paving slabs

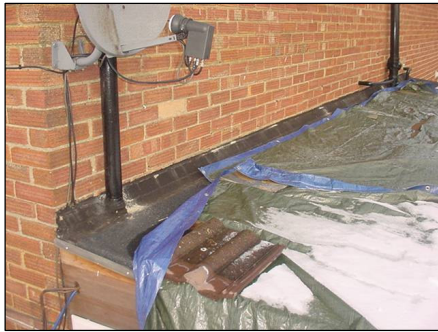
Felt roof system has defective flashing and defective detailing around the roof lights.

Tarpaulin limiting view but necessary to stop water coming in

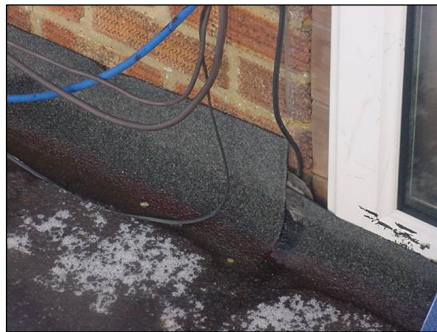
Flashing detail right hand extension showing not been slid

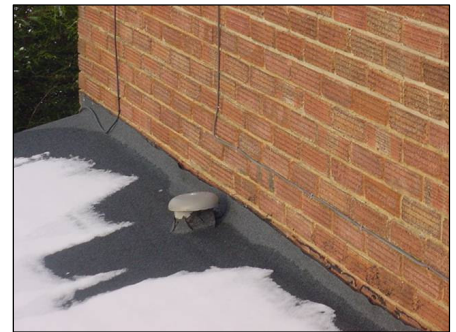
Poor flashing

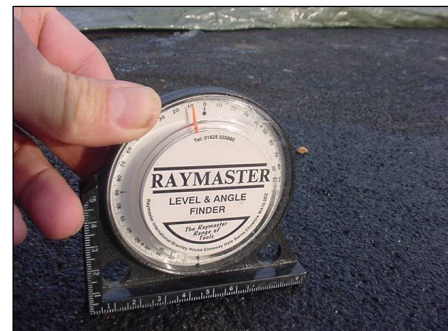
The roof lights used are at too shallow pitch according to the Velux window literature as we read there should be a minimum of 15 degrees also the detailing around the gulleys is very poor.

Angle of roof 8-10 degrees

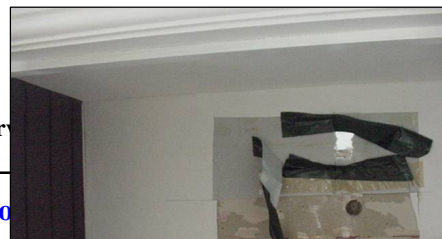
Where rear extension meets side extension there is a valley gutter which sits against the window and is leaking into the main property.

Dampness coming in beneath where rear roof meets right hand side roof

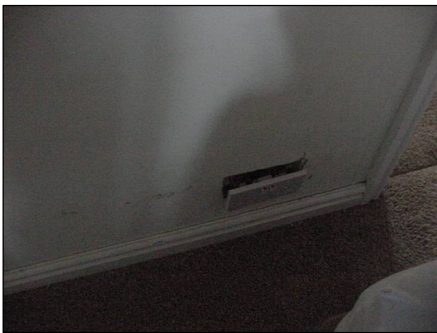
We are advised that the original owner was an electrician and therefore should have been aware that the electrical work being carried out in the family bathroom and the cloakroom should not have had exposed socket points as these should have been sealed off. Our cause for concern is if these areas can be seen what quality of work is hidden.

Socket point off wall rear walk through bedroom

We recommend a full electrical report is carried out to Institute of Electrical Engineers standards by an NICEIC approved electrician or equivalent with a copy forwarded on to us.

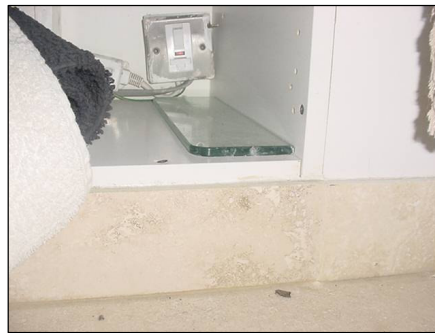
Metal switch within bathroom

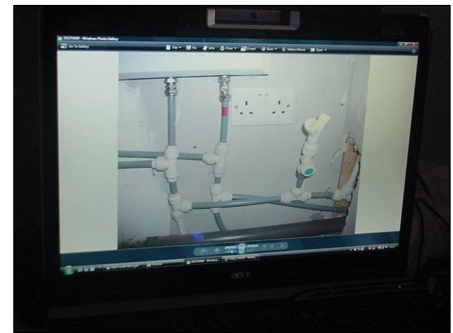
Socket point within cloakroom

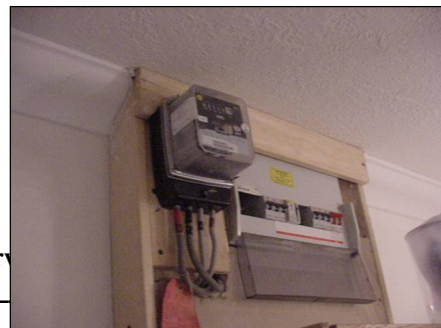
There are numerous examples of the electrics not being to Institute of Electrical standards such as socket points within the bathroom, bare wire visible within the extension areas not to mention areas where sockets are not fitted

Fuseboard in kitchen with missing
circuit breakers

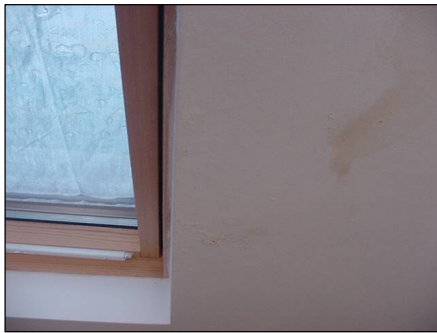
Water coming through ceiling of
extension

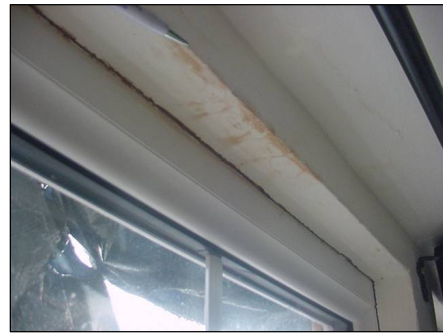
Water coming through window
detail

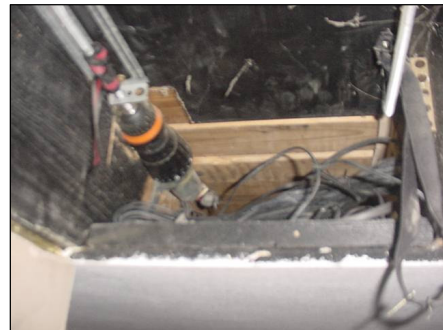
Drill in ground floor ceiling

Access to lounge ceiling with drill
