SPECIFIC DEFECTS REPORT

**Relating to:
The electrical incident**

Hertfordshire

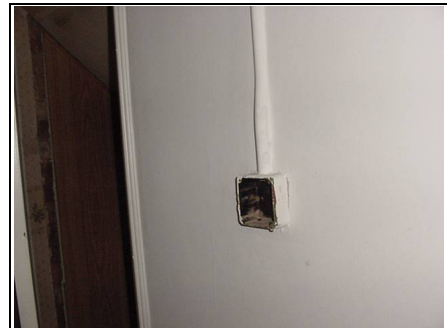
The power point that caused the alleged shock is located in the kitchen and is original with metal casement. The external light switch looks to have been part of the original construction or very dated. This is where the alleged shock took place. We are advised that there was no-one else at the house at the time the incident took place.

As we understand it from the Electrician, when he arrived at the property and moved the switch point he noted it was secured with wood screws which had cut into the light electric cable and had earthed itself through The Tenant and caused the shock.

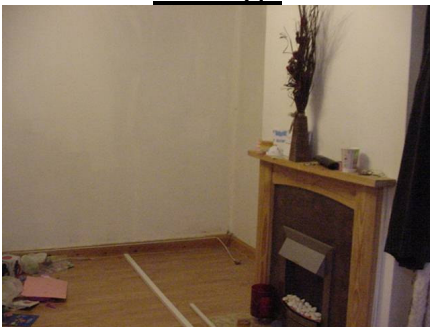
<u>GROUND FLOOR</u>		
<p style="text-align: center;"><u>Lounge</u></p>

DESCRIPTION	CONDITION	ACTION REQUIRED
Electrics not to Institute of Electrical Engineers Standards, as reported by The Electrician	<p>Extension cable passing through the air vent to the external lights.</p>

<p>Cable going through air vent to outside lights</p> <p>Socket points found without circuit protection conductors (CPC's).</p>

<p>Old socket point with broken back</p> <p>Extension cable without socket box not fixed to the wall and which had a broken back.</p>

<p>Old live light switch replaced with plastic switch</p>	Amend to Institute of Electrical Engineers Standards

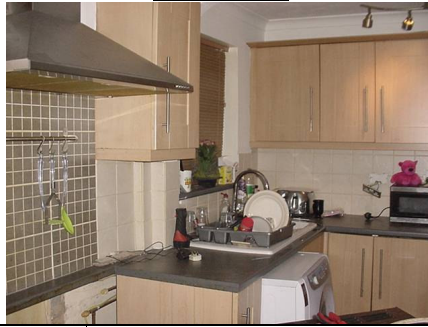
Kitchen

DESCRIPTION	CONDITION	ACTION REQUIRED
Electrics not to Institute of Electrical Engineers Standards, as reported by The Electrician	<p>Original outside metal box that has had wood screws through the switch plate which are cut through into the wires. This is where the shock was given to the occupier.</p>

<p>Metal conduit and casing in kitchen</p>

<p>New fuseboard as it doesn't meet IEE requirement to have dual RCB's</p>

<p>Light switch in kitchen</p>

<p>Showing burning around the screw fixing point.</p>	Amend to Institute of Electrical Engineers Standards

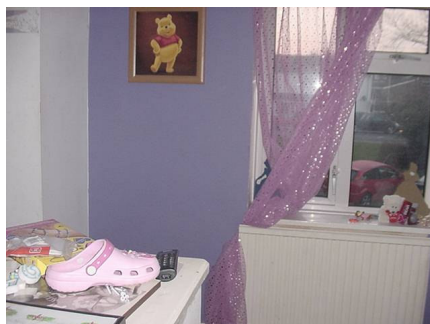
Front Right Hand Side Box Bedroom

DESCRIPTION	CONDITION	ACTION REQUIRED
Electrics not to Institute of Electrical Engineers Standards, as reported by The Electrician	<p>Extension cable passing through wall into bedroom on left hand side.</p>

<p>Extension leads</p>

<p>Where extension cable went under wall</p>	Amend to Institute of Electrical Engineers Standards

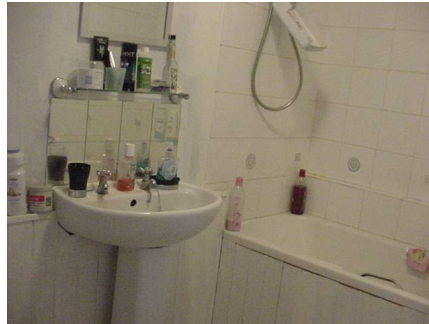
Bathroom

DESCRIPTION	CONDITION	ACTION REQUIRED
Electrics not to Institute of Electrical Engineers Standards, as reported by The Electrician	<p>Shower unit burnt out, believed to be due to oscillating loose wires</p>

<p>Burnt out shower</p>	Amend to Institute of Electrical Engineers Standards
