# **SPECIFIC DEFECTS REPORT**

**Relating to the roof and associated problems**

**In Kent**

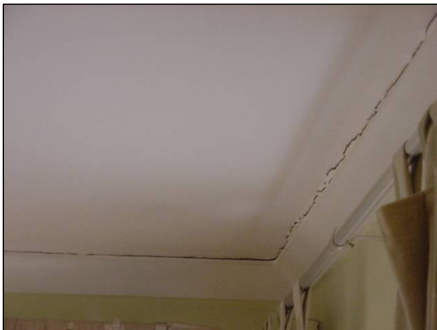
Cracking to the ceiling

Within the rear extension there is cracking at the ceilings and wall junctions.

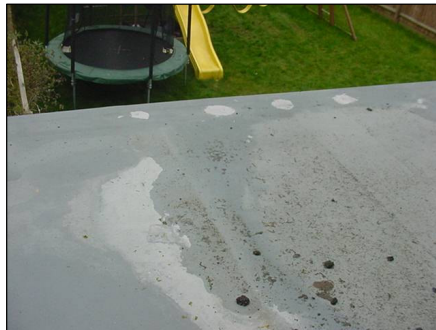
Ponding on the roof

5.2 There is insufficient fall on the roof leading to ponding

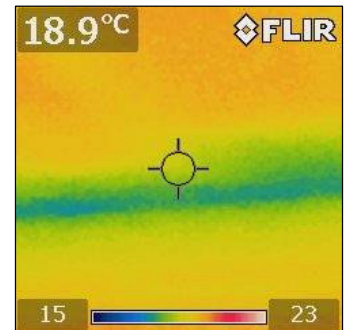
Thermal Image Photo  
Blue represents crack  
indicating it is more than  
just a surface crack.

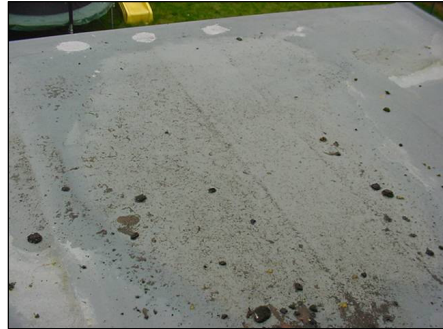
5.1 Based on what we can see the deflection in the roof, in our opinion, is too great and the thickness of plywood is possibly not thick enough for the span of joists.

6.1 Our recommendation is whilst we think that there is an element of settlement we feel that the installation of the flat roof is not satisfactory and will not have a long term life. The weight of the water caused by the ponding on the roof will cause further deflection.

We could see ponding on the main roof and also upon standing on the roof we could feel a deflection in it over and above what we would normally expect and we could see higher areas where the joists are which run from the front to the rear of the property.

We would also comment that the deflection within the roof decking is over and above what we would normally expect. We would like to see receipts to confirm the type of boarding used and the thickness (the specification advises plywood WBP (Water and Boil Proofed) of 19mm)

Ponding on roof

5.4 We would recommend the roof is opened up and the dampness content of the decking checked.

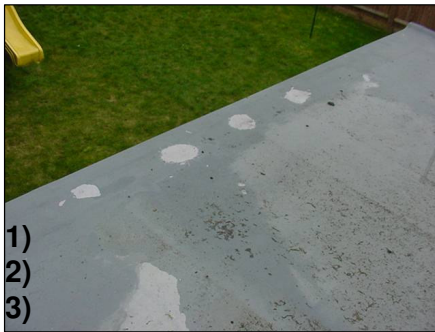
Nail fixings where decking board is nailed down

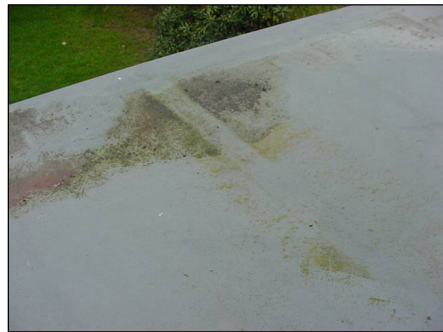
Roof rests onto timber joists that run from the front to the rear of the property

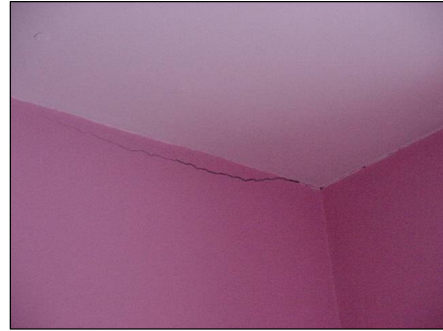
We believe, in this instance, that interstitial condensation is taking place within the roof at XXXX, there is presently a family with three children (one just aged 6, one aged 3).

Crack to WC wall

**ACTION REQUIRED:** We would recommend venting of the roof space.

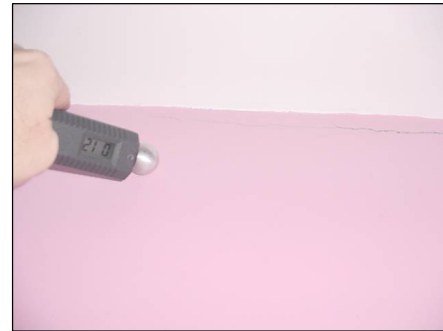
Taking damp meter reading on cracked WC wall - 21

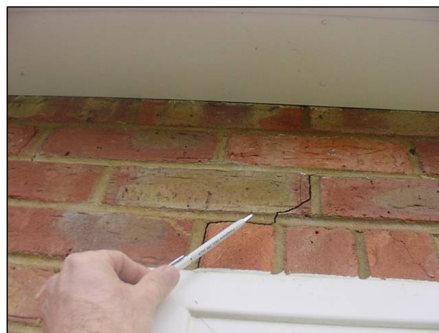
Cracking on neighbours side

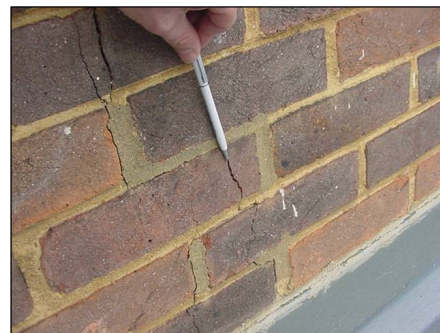
Cracking in rear wall (old main wall of property)

Rear wall – the cracks ranging from 5-10mm (gauged by eye sight)

Monitoring may be an option. See different monitoring devices within the Appendices.

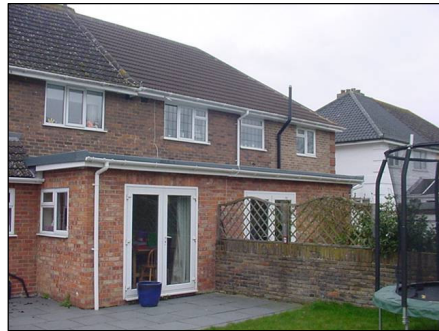
We have no way of knowing the size of the lintels in the windows and door however we note there has been cracking above the opening formed to give access to the extension. We also note there is cracking above the French doors to XXXX

French doors at rear of properties
