SPECIFIC DEFECTS REPORT

Relating to Dampness

xxxxxxxxxx,
Luton,
Bedfordshire,
LU3 xxx

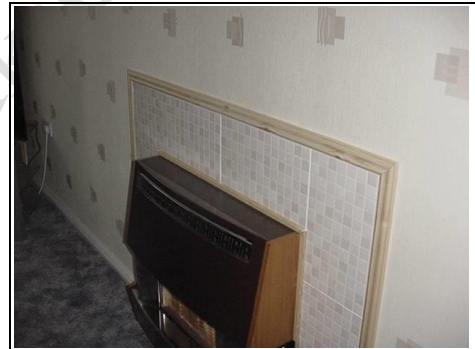
Although you advised there has been a Gas Safe test on the boiler in the roof there is also a gas fire in the through lounge that we would recommend is tested.

Have the gas fire checked

ACTION REQUIRED: We would recommend a Gas safe test is carried out on the fire in the front room to ensure it is venting properly and a carbon monoxide monitor is secured to the wall and in working order.

ANTICIPATED COST: In the region of £100 to £200; please obtain quotations.

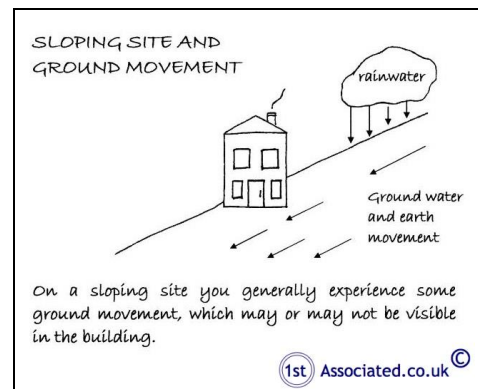
The property sits on a sloping site where we believe rainwater and surface water travels down to the property and sits against/ is absorbed by the concrete foundations and is drawn in to the house. Of course with the recent spell of wet weather the area will have had more rainwater/ ground water than usual.

Sloping site

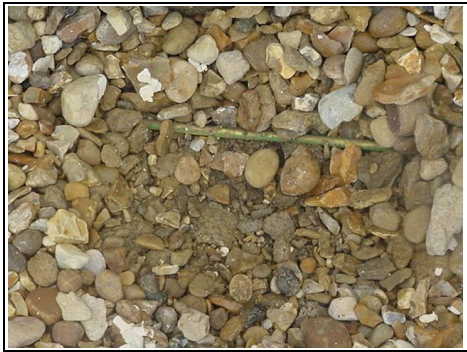
When we first viewed the rear of the property we were pleased to see there was a French Drain; however, our basic investigations revealed this to be a mock/false French Drain which is only approximately 100mm (four inches) deep. A real French Drain involves pea shingle, a perforated pipe underneath that feeds into the drainage system which takes away any rainwater.

False French drain.

Be careful when digging as earth cable is buried here

ACTION REQUIRED: Add a real French Drain around the property. There are wires/cable currently buried in the area so care should be taken when work is carried out.

ANTICIPATED COST: £750 to £2,000 to add a French drain to the rear and left hand side of the property (all directions given as you face the property); please obtain quotations.

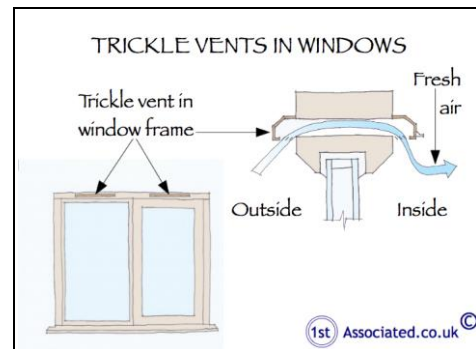
The double glazed plastic windows that are in the property do not have a trickle vent so the air flow and air movement in the property is minimised.

Trickle vents

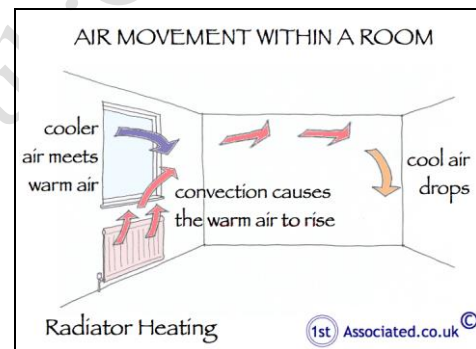
Also we noted in your lounge that there is no radiator under the front window which means that air is not circulating as well as it should be in the room.

Air movement

ACTION REQUIRED: Where possible move radiators under windows.

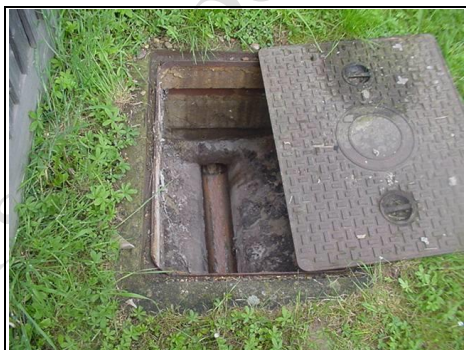
You explained how your neighbour had high pressure cleaned the drains. We do find in older drains that this can damage the joints.

Drains are ok

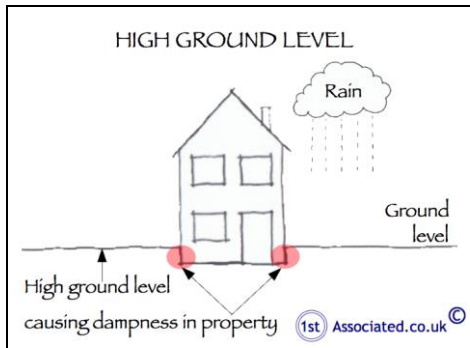
We also noted a high ground level to the left hand side of the property which could be encouraging dampness into the property and allowing it to stay in the walls rather than dissipate into the air. We would recommend, as mentioned, that you add a French Drain to the left hand side as well as the rear of the property.

High ground level can cause dampness

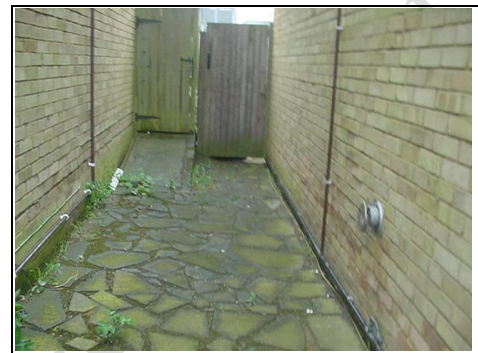
High ground level to left hand side

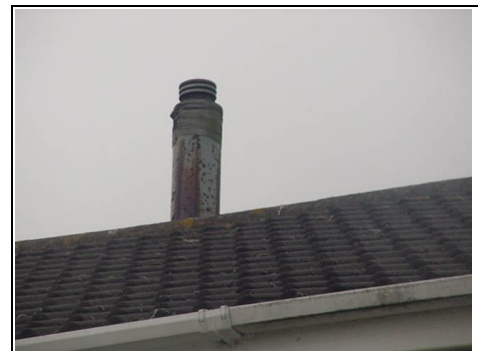
Concrete nibbed tiles on roof
Rusted flue visible

We noted a rusting flue pipe and it would be beneficial to remove it as we have come across rusted flues in the past where they have allowed water into the property and rust staining to

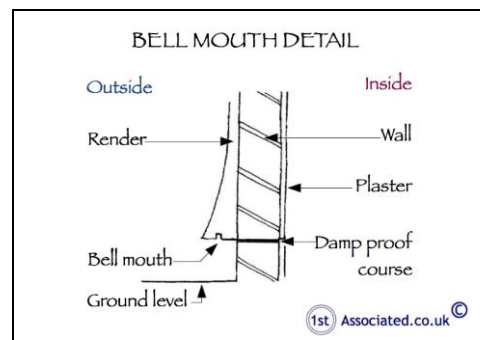
We like to see a bell mouth detail to the base of the render

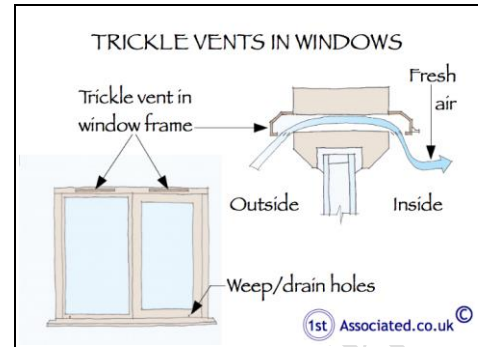
The windows are plastic double glazed and are the older style without trickle vents. Please see our earlier comments.

Trickle vents

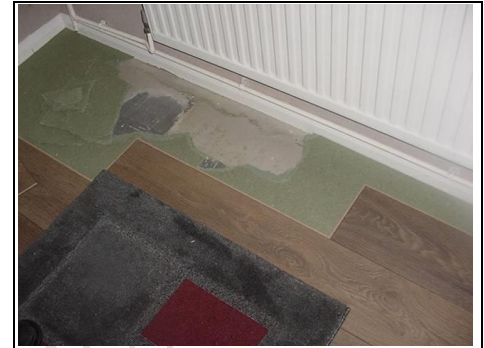
The floor that was exposed in the lounge showed a concrete screed base and as mentioned this can absorb water.

Floor has been lifted and is very damp

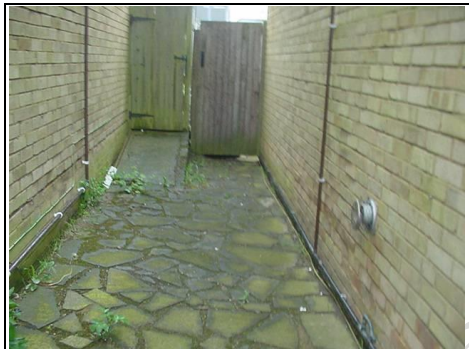
Left side high ground level
