# INDEPENDENT SURVEY REPORT

**Relating to insurance claim  
and reinstatement work  
carried out for  
Mr & Mrs X**

**XXXX  
Chadderton,  
Oldham,  
Lancashire.  
OL9 XXX**

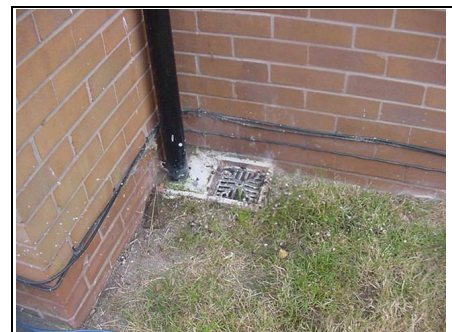
2.2) Tipping paint/grout down the drains.

Paint/grout tipped down the drain
