SPECIFIC DEFECTS REPORT

Relating to the condition of
all external windows and doors at:-

Poulton-le-Fylde Lancashire FY6 XXX

Specific Defects Report

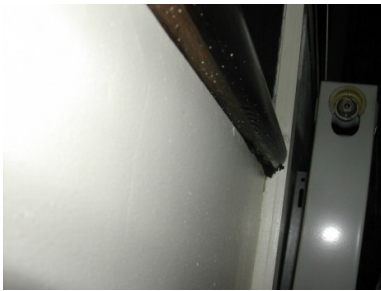
Window 3. Detail beneath cill.
9412

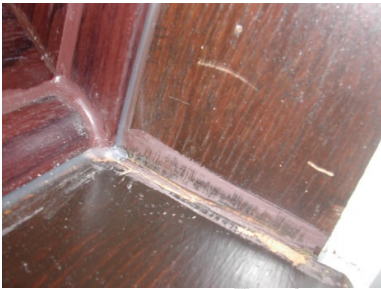
Window 3. Additional sealant applied.
9413	 	Window 3. 10p coin between casement and frame. Additional sealant.
9415

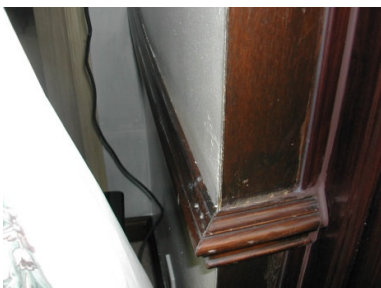
Window 3. Additional sealant and timber reveal detail.

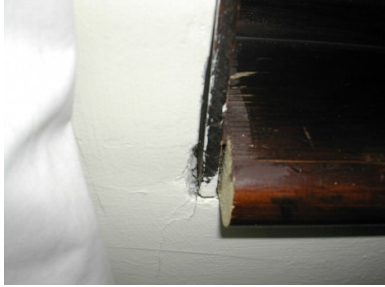
- 1.0) Window 1- Lounge. There is evidence of re-sealing with silicone. There are small gaps in the seal. The sealant finish is untidy. The rubber seal around the inner face of the casement appeared in-tact but the frame appeared to bow along its sides, the casement being top hinged. There is a vertical crack in the wall running from the left hand corner of the cill.

Window 1. Cill detail and crack beneath.
9458

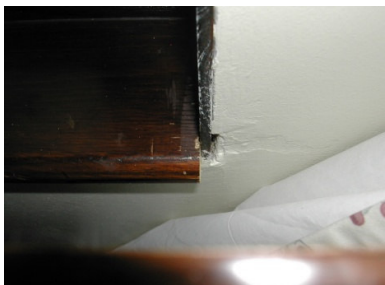
Window 1. Cill and timber reveal.
9459

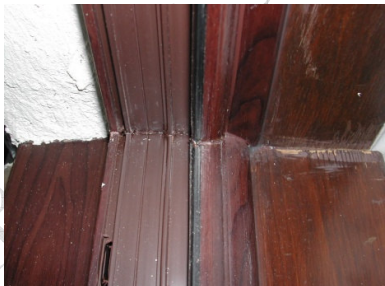
Window 1. Additional sealant.
9460

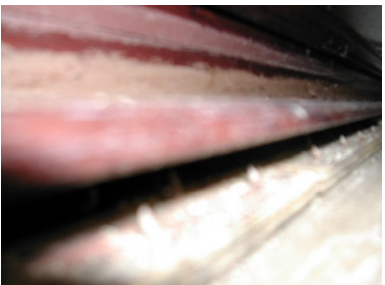
- 6.0) Window 6 – Being the front entrance door. There is evidence of extensive re-sealing around the frame and side casement joints. The door is visibly bowed at its top and along the sides. A different and thicker rubber seal has been applied to the door. There is evidence of water ingress at the threshold of the door.

Window 6. Front Door. Gap beneath threshold.

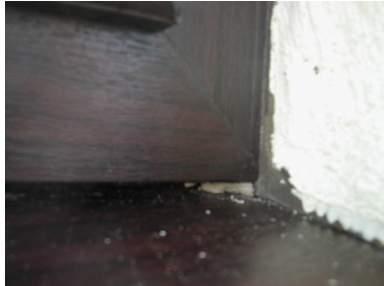
Window 2. Render detail.
9518

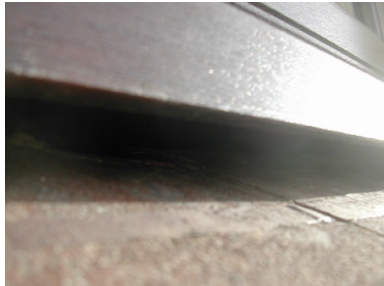
Window 2. Gap between cill and tile cill.
9519

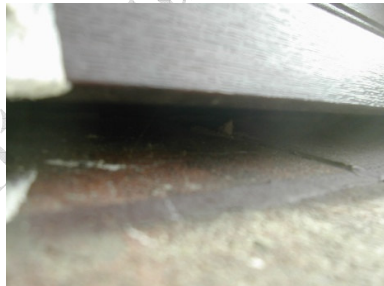
Window 2. Gap between cill and tile cill.
9520

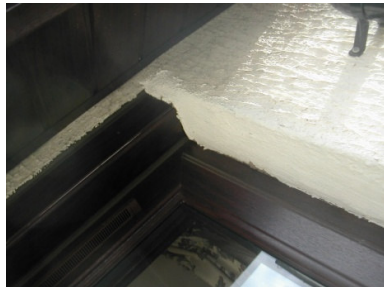
Window 2. Render detail.

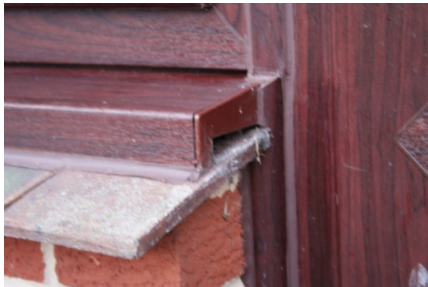
Window 5. Incomplete end profile.
1164

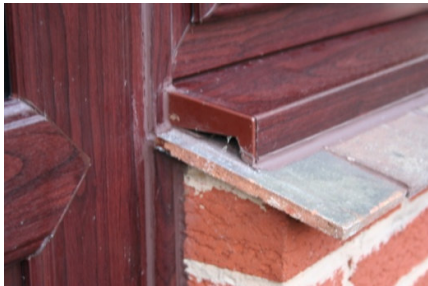
Window 5. Incomplete end profile.
1165

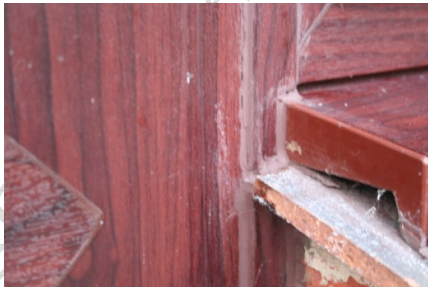
Window 5. Incomplete profile and additional sealant.
1167

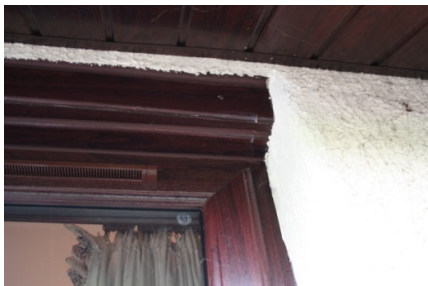
Window 5. Render detail.
