# **SPECIFIC DEFECTS REPORT**

**Independent Report in relation to  
Dampness, Cost of Work/Valuation and  
Right Hand Boundary Wall  
at**

**Redhill  
Surrey, RH1**

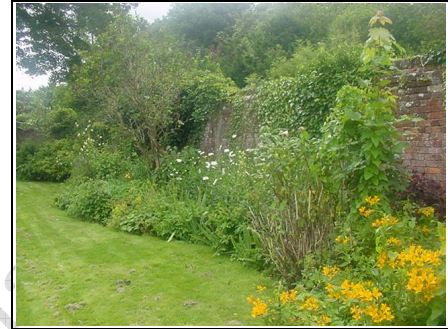
Right hand boundary wall

*The brick constructed boundary wall along the right flank of the garden is in poor condition. It is leaning quite badly and should be repaired or replaced. This could be expensive to repair. You now need to instruct a contractor to provide an estimate for the necessary repair work.*

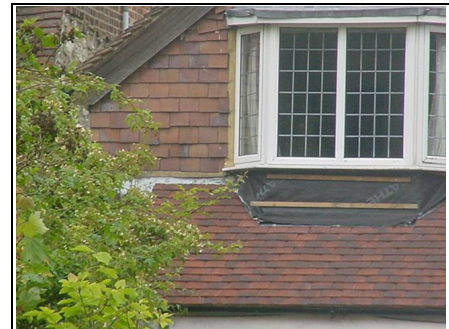
A large percentage of the major work has been completed with some areas of incomplete work, for example the oriel window to the rear (high level splayed bay window) needs work completing on it.

Work required to window

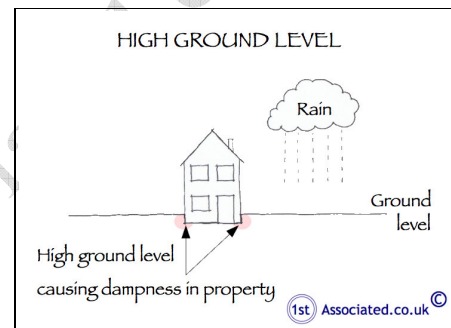
The property is damp inside and we believe this is from a combination of reasons which often is the case in older properties. We would draw your attention specifically to the ground levels around the property being too high and the property being on a slight slope. These we believe are the main two reasons for the dampness.

**ACTION REQUIRED:** Lowering of the ground level and the addition of a French drain, in both cases around the entirety of the property would help lower the dampness in the property. Lowering the ground level would reduce the bridging that gives dampness and a French drain would allow a way for the rainwater to drain away from the property.

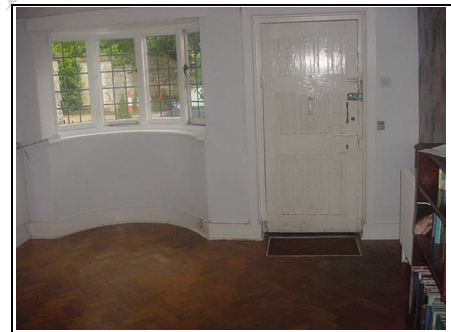
Skirting within main entrance reception room

*Dry rot is affecting the skirting within the main entrance reception room to the dining room wall.*

Dry rot is extremely problematic but equally extremely rare. Bearing in mind that we are looking predominantly at older properties every day in one way or another we come across dry rot perhaps once every five years. We didn't see any specific signs of it such as the fruiting body or the cobweb type root that is present. We would ask that the surveyor specifically states where the dry rot is as we haven't been able to find it.

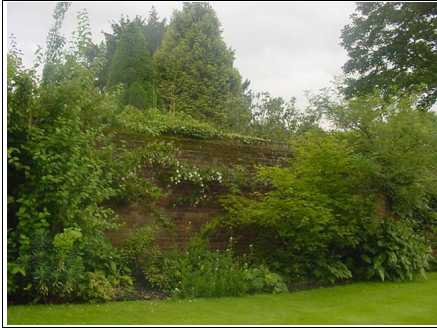
General view of boundary wall with vegetation

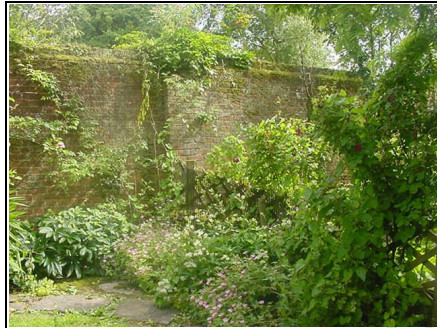
Vegetation to boundary wall

In theory it could be argued that vegetation on the wall and plants close to the wall are affecting the wall. The wall has stood for a considerable time and the vegetation is part of the charm of it and they have lived in harmony together for many years but the plants still do need maintenance.

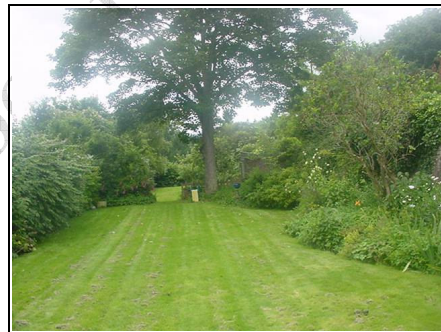
There are also elements such as the tree within the subject garden which in modern day thinking would be what insurance companies consider to be within influencing distance of the boundary wall and a wall simply would not be built so close to a tree or vice versa, however we do feel that the wall has stood the test of time and that a rebuilding process with the associated foundations would have a detrimental effect unless absolutely essential. We feel it would be a better way forward to maintain the wall and add buttresses.

Garden view with tree

**ACTION REQUIRED:** We believe that buttresses would be a better solution and help retain the character of the older wall. If the wall is listed it will need specific permission before alterations are carried out particularly demolition. In addition the wall requires general and regular maintenance, repointing and some plants cutting back.

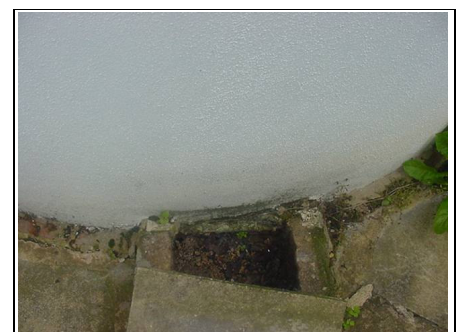
Airbrick hidden

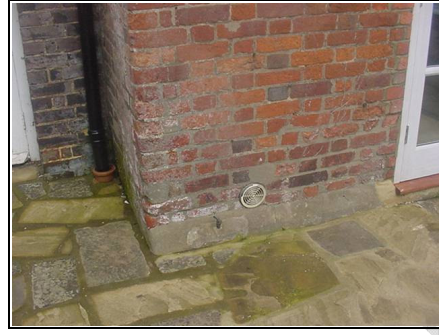
Rustic paving slabs – ground level needs lowering

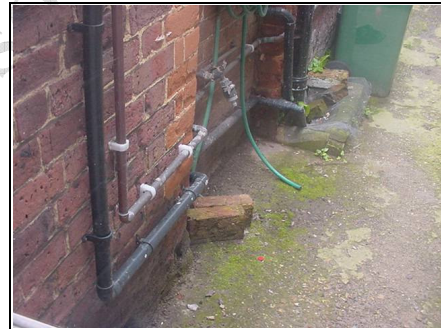
Soft red brick with moss sitting against it. Moss indicates not much sunlight gets in. Ground needs lowering

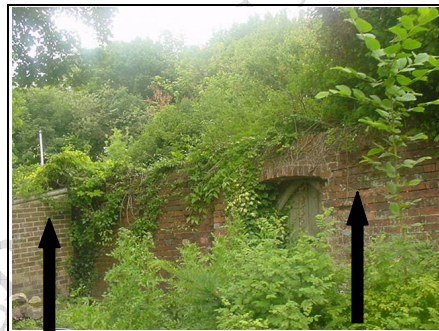
Shed to left hand side, repointing  
required to right hand side of gate

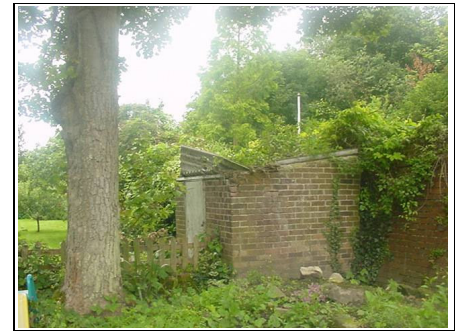
Shed with dilapidated roof

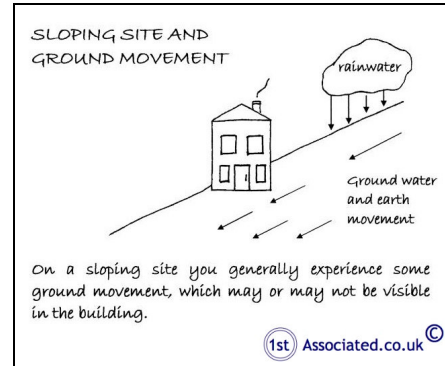
All of the property sits on a slight slope running from the front of the property to the rear.

**ACTION REQUIRED:** We would recommend that a French Drain is added around the entirety of the base of the property (speak to a Conservation Officer first) as water needs to be taken away from this property and ground levels are currently too high. This is, in its basic form, a shovel width by a shovel depth to reduce the ground level allowing the property to breathe and dissipate any dampness.

This will also have to be combined with a gradual repointing of the brickwork externally with lime mortar and internally the removal of any modern gypsum plasters and replacement with a lime based plaster to allow the wall to breathe.

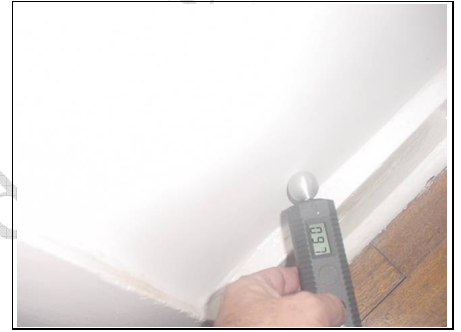
Damp meter reading of 97 in hallway

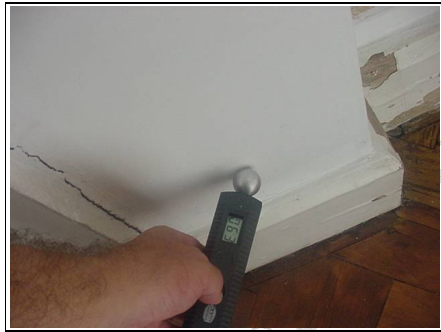
Damp reading of 63 to rear reception room

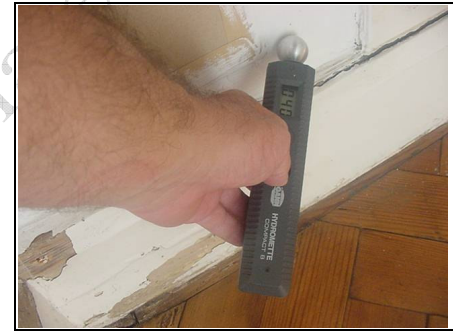
Damp reading of 40 to rear reception room

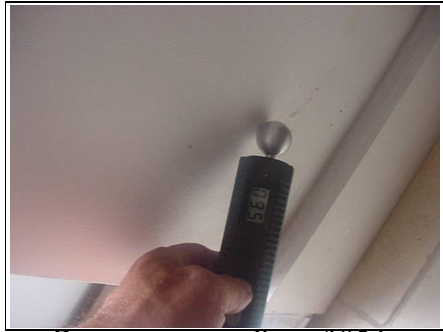
Damp meter reading of 95 in kitchen

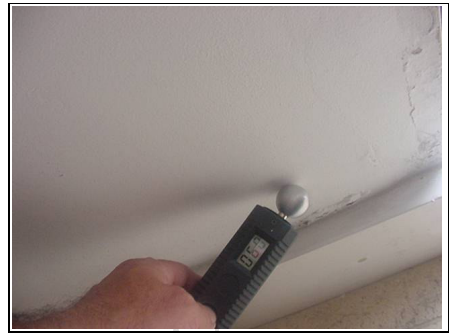
Damp meter reading of 90 in kitchen

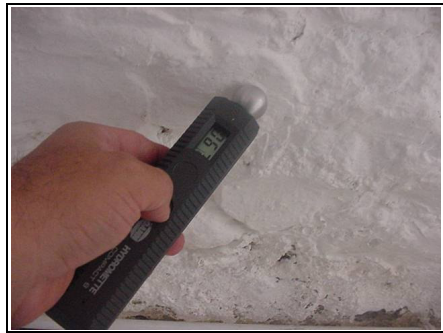
Damp meter reading of 93 to shower room

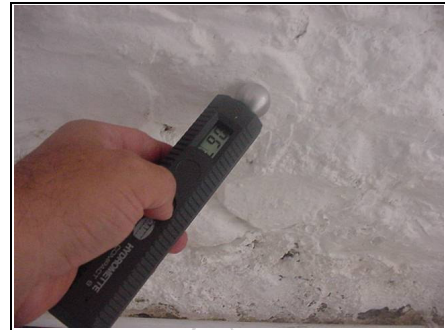
Damp meter reading of 67 to shower room
