SPECIFIC DEFECTS REPORT

Relating to main roof problems,
xxxxxxxxxxx,
Islington, N7 xxx

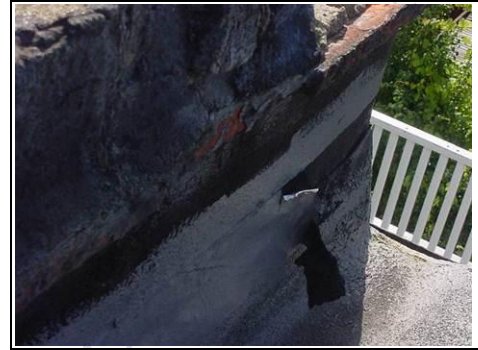
Flashband repairs to the rear of the left hand valley gutter have come away

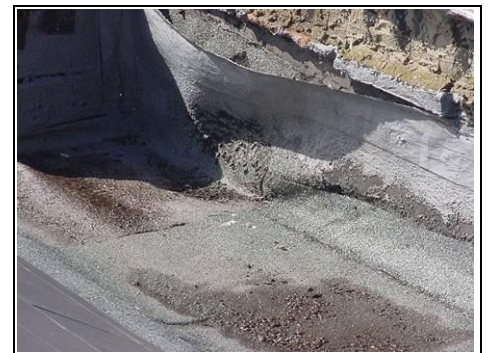
Felt flashing that is coming away. Lead should have been used.

We would recommend renewing all of the flashings, ensuring that they are lead and checking that they work. We would also recommend ideally lining the valley gutter with lead. However if you do wish to sell, in the short term, another coat of mineral felt (high performance felt with elastomeric) would help the situation as long as it is suitably lapped underneath the slates. Note some contractors will give an insurance backed guarantee on this type of work.

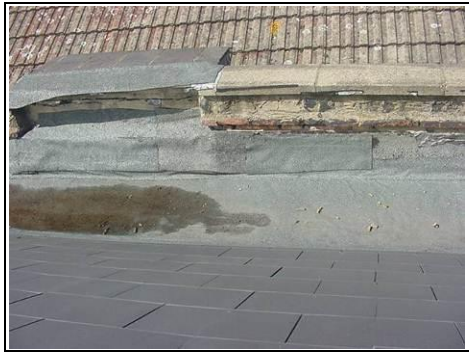
Lack of any decent flashing at all to the middle and front of the right hand valley gutter

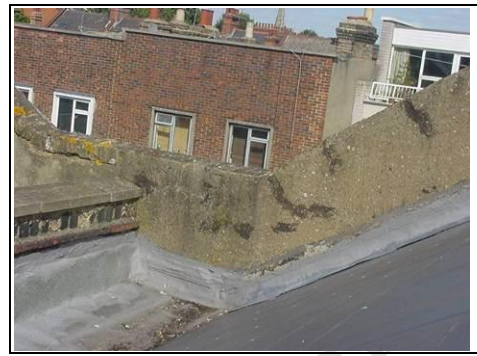
Flashing not fitted correctly to the front right hand side

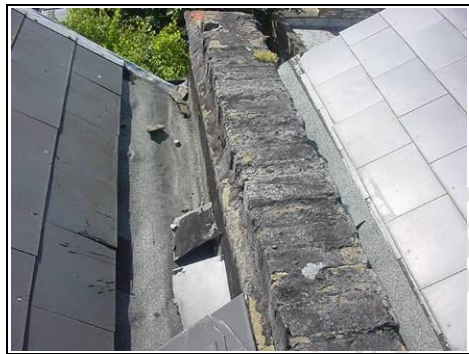
This could affect you as it is in poor condition with the felt becoming un-bonded

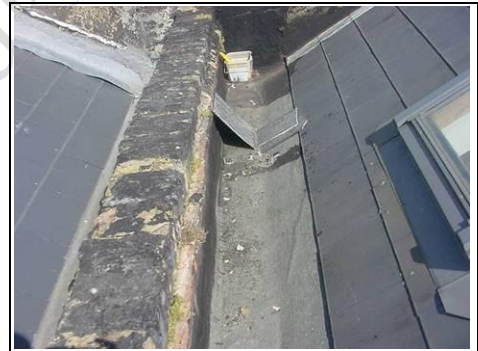
Bitumen paint used

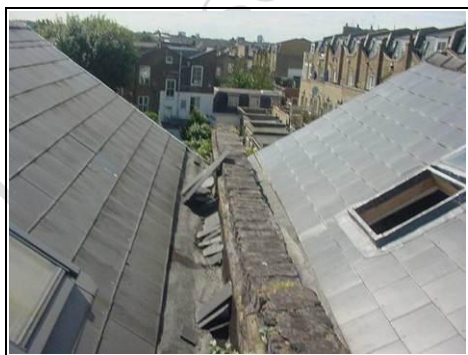
Many slates have been damaged

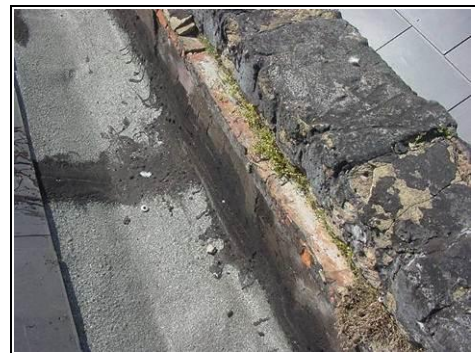
Bitumen repair. Also note the parapet wall is letting in water which is why the plants are growing from it

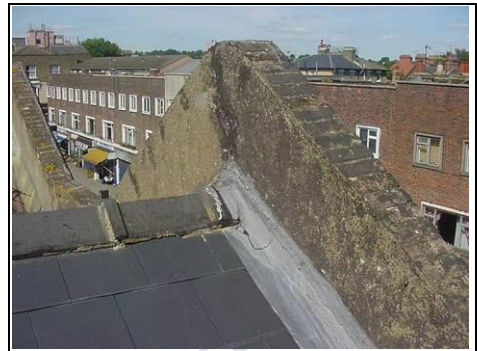
The felt does not lap underneath the slates correctly. We would expect this to lap by at least two slates which is typically half a metre. In this case it is barely 100mm.

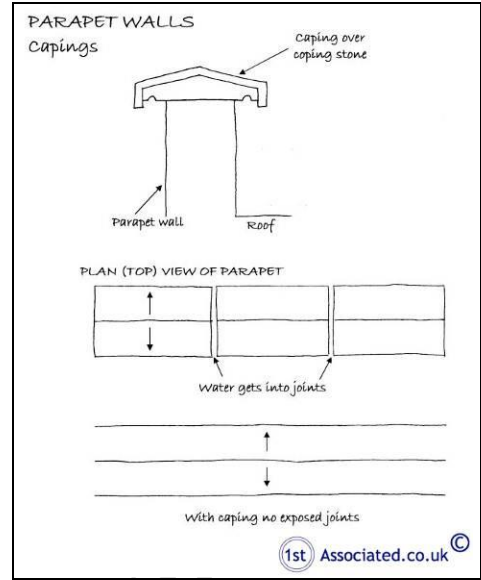
We feel for a long term water tight building then you need to look at capping the parapet walls or alternatively regularly tarring them as has been carried out in the past.

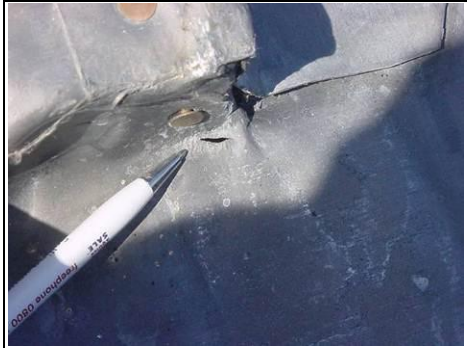
Split lead to the access area

ACTION REQUIRED: We would recommend replacement of the roof light with a purpose made double glazed unit.

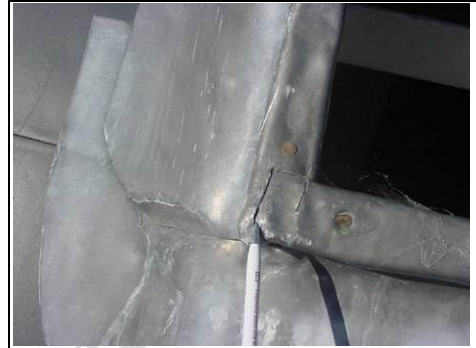
Damage to the lead

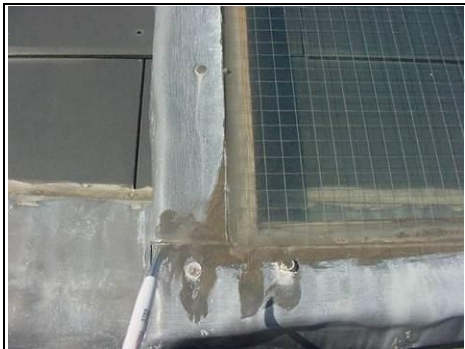
Mastic sealing to access area

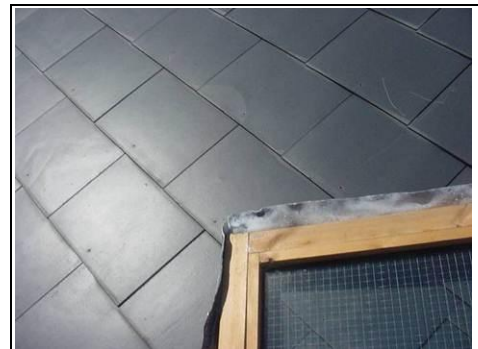
The access hatch is formed in lead and is purpose made as opposed to manufactured. We noted that there was no stop to hold and guide the roof light in place. It is literally held on by the lead.

There is a lack of a stop on it.
This means the weight rests on the lead

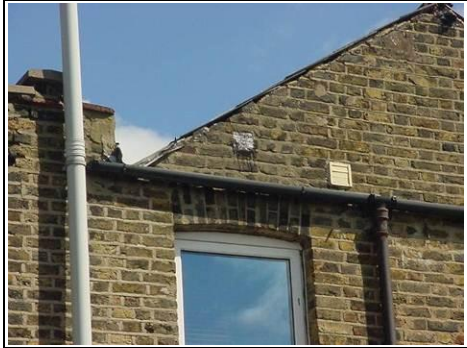
To the rear of the property is the gable end. We are concerned that wind driven rain may get underneath this. We would be happier for it to be filled in cement and also for it to have a lead detail.

Gable end showing that there should be mortar or an end cap to the roof

There are gaps in the verge between the tiles and the wall which will allow wind driven rain in. We recommend mortar filling these gaps or putting a lead detailing similar to the one on the adjoining left hand side property.

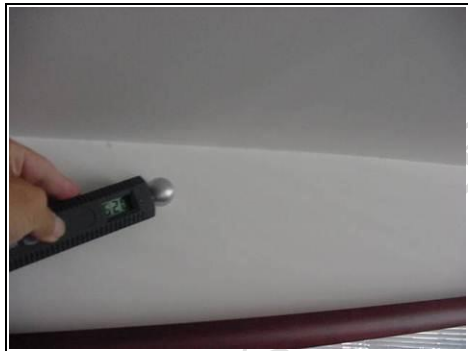
Reading of 29

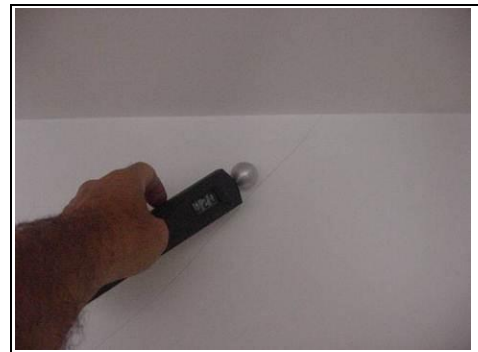
Hairline crack with reading of 28

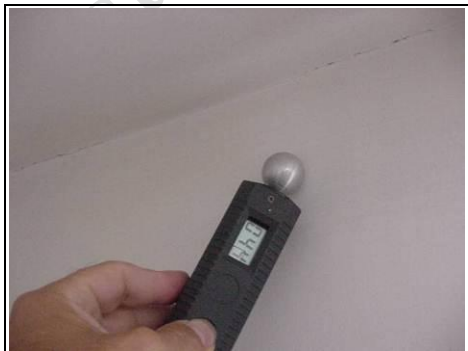
Reading of 44

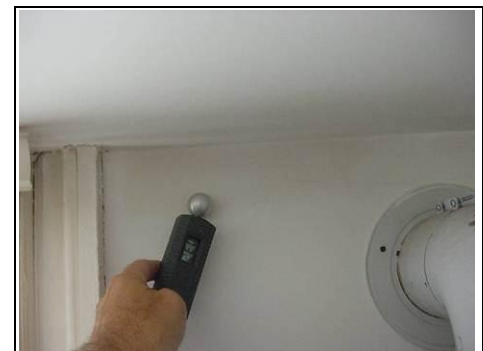
Reading of 32

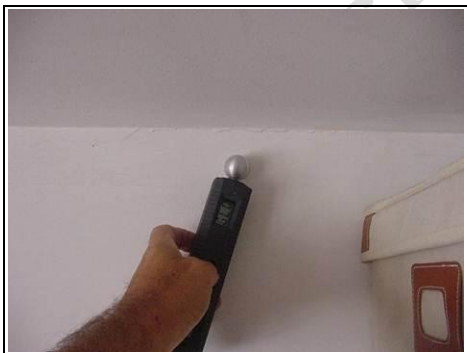
Reading of 79

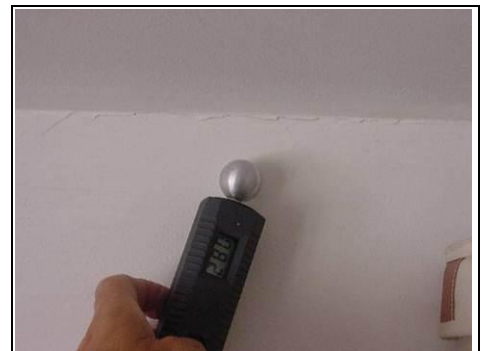
Reading of 82

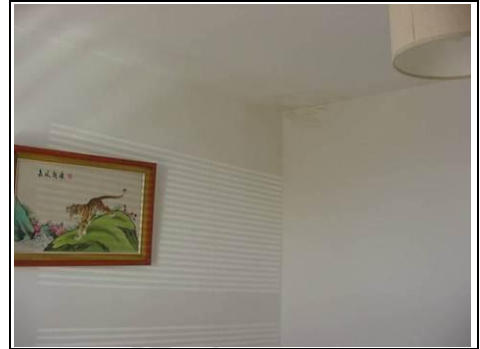
Dampness in the corner of the rear bedroom

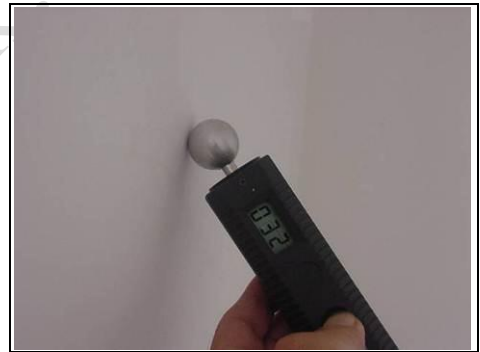
More typical reading of 32

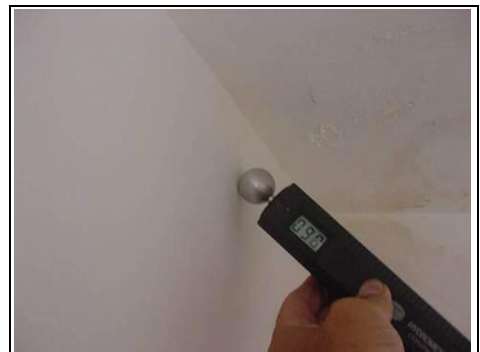
Meter reading of 98

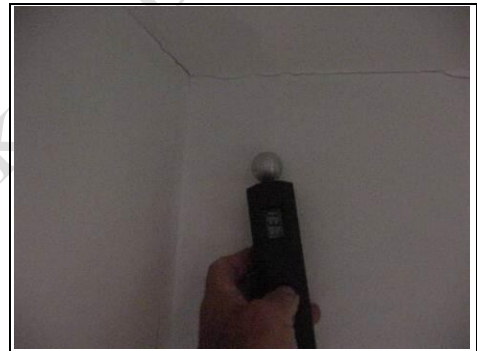
Reading of 33 on the Gann meter.
This is acceptable but the hairline
cracking does suggest something
has occurred

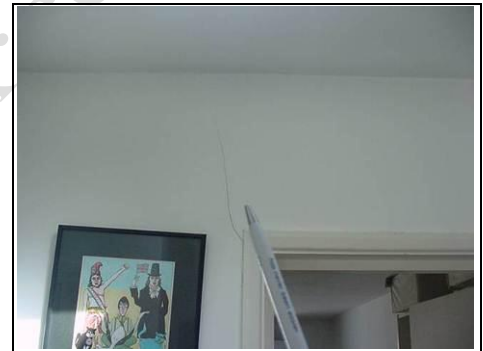
Crack above door

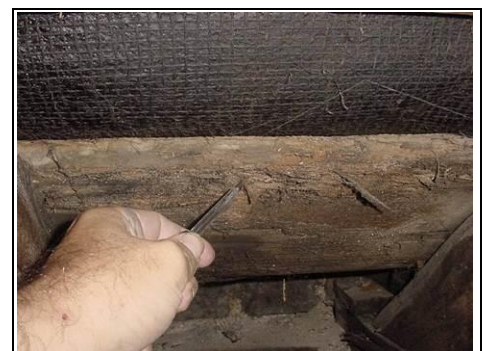
Dampness promotes woodworm. There looks to be old woodworm
