SPECIFIC DEFECTS REPORT
Relating to roof work and associated elements
London, SW12
(visual inspection)

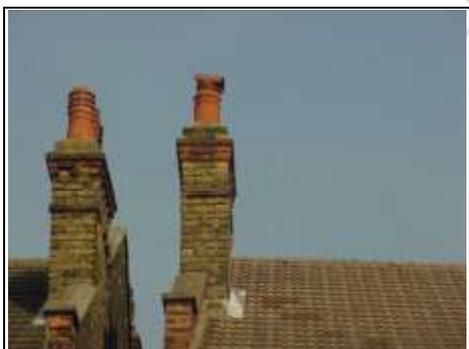
Repoint and repair the chimneys. The chimneys are weathered and are allowing dampness into the property. Dampness is visible within the top floor flat.

Lean to chimney

ACTION REQUIRED: Repoint the chimneys. There may possibly be some rebuilding work required.

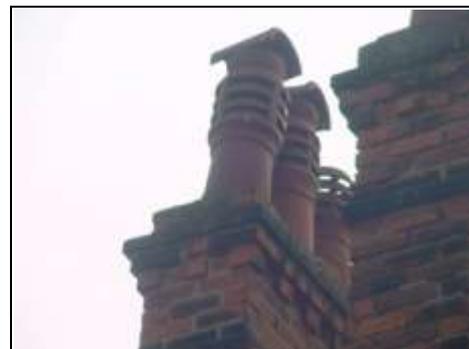
Close up of chimney showing weathered pointing

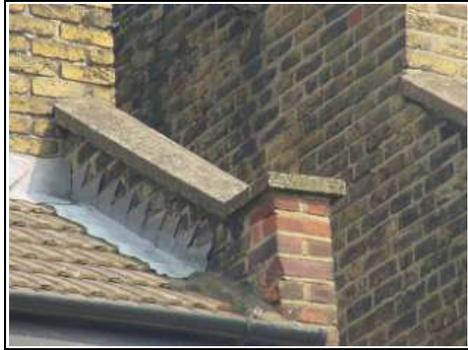
Repairs to the flashings, replacing the existing cement fillets with a lead flashing and checking the lead flashings to ensure watertight. Currently some water is getting into the top floor of the property.

Flashing badly repaired to the rear left hand corner

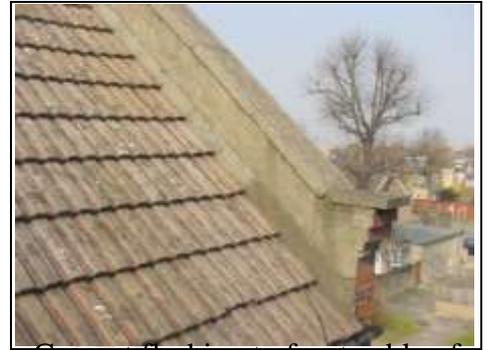
Cement flashing to front gable of the property

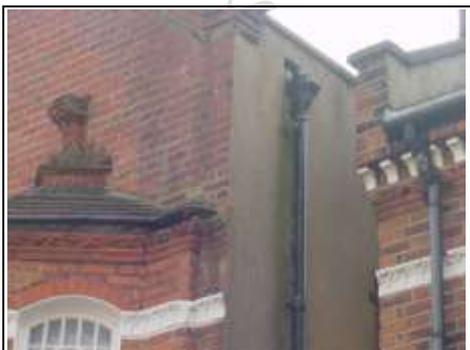
The property has a mixture of cast iron and plastic gutters and downpipes. We can see that these have corroded and are in need of repair/replacement.

Hopper head and cast iron downpipe

ACTION REQUIRED: Repair or replacement. If you do replace the gutters in cast iron be prepared to carry out regular maintenance/re-decoration which is difficult because of the height of this property, then this is the best alternative with the longest life. We would avoid plastic if at all possible, we do appreciate it has a cheaper capital cost. We would look at a modern metal guttering/downpipes as an alternative.

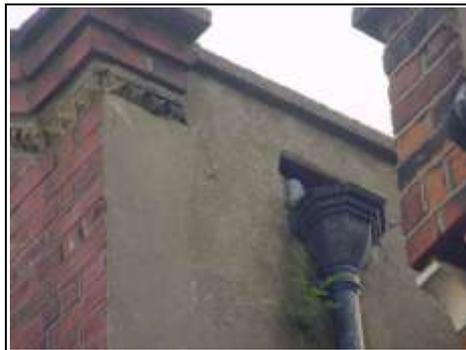
Close up of hopper head

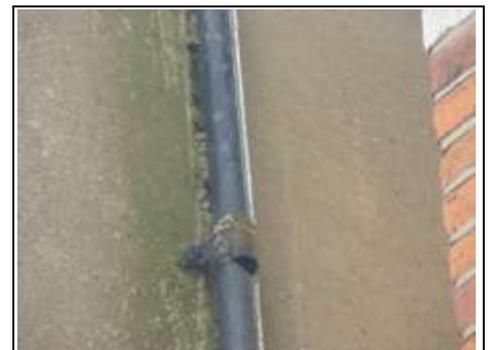
Close up of hole in cast iron pipe

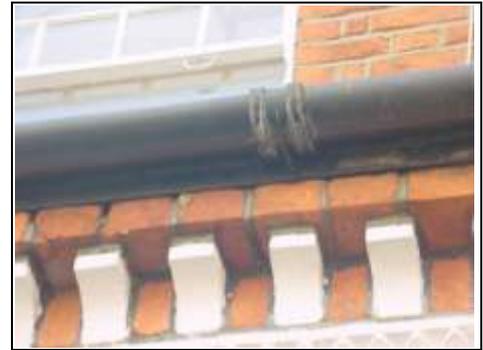
Leaking plastic gutters

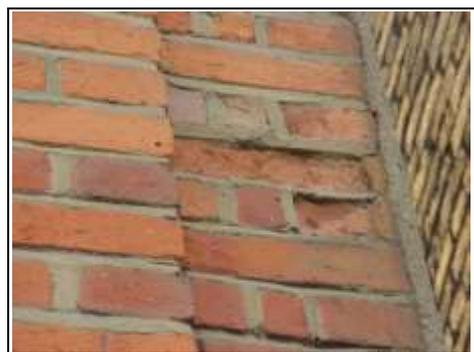
The brickwork would have originally been bedded in a lime mortar. The cement mortar has effectively smothered the building. We believe the scaffolding gives an ideal opportunity to check the brickwork and the pointing and we would recommend that as much cement mortar pointing as possible is removed and repointed in a lime mortar to allow the building to breathe and reduce future spalling of the brickwork.

Spalling starting to occur to brickwork

In our experience this type of work is best carried out with a soft brush to remove any loose cement and repoint.

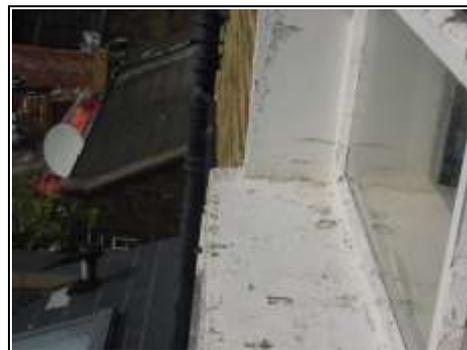
Windows in need of repair

ACTION REQUIRED: Repair/repaint windows.

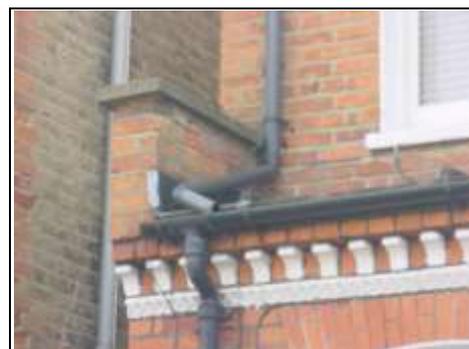
At the front of the property there is a low level flat roof that looks to have had bitumen added previously indicating that it is likely to be leaking. A close inspection needs to be carried out to check its condition. You may of course know about dampness that is occurring internally which we are not party to. Unfortunately it was too high for our set of surveyor's ladders to get a proper view.

Front low level roof looks to have had bitumen previously indicating that it has leaked

ACTION REQUIRED: We consider liquid bitumen (often known as RIW) to be a temporary fix and we would suggest you set aside the sum of £500 - £1,000 to carry out proper repairs on the roof. It looks to be a rolled lead roof so the work may be more expensive as lead is a costly material and it depends upon how much needs to be replaced; quotations required.

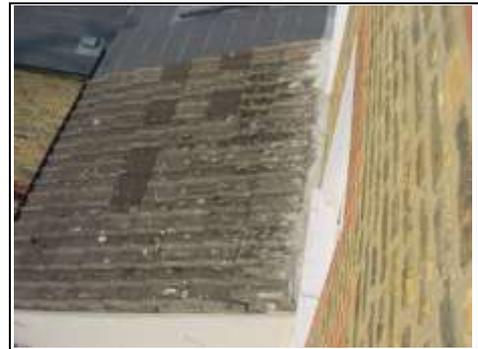
These are recent modern extensions; we noted what looked to be a cement flashing.

Cement flashing to rear single storey roof extension

ACTION REQUIRED: It would also be a good opportunity replace this flashing along with the others with a lead flashing.

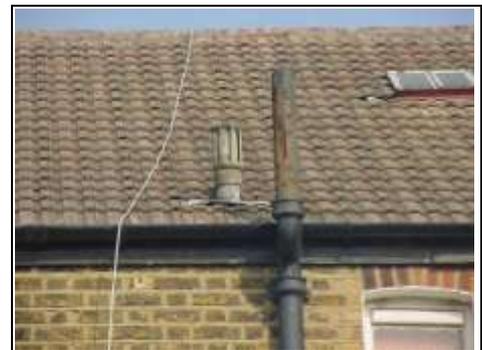
We can see some rusting to the soil and vent pipe.

Rusting top to the soil and vent pipe would benefit from repair

ACTION REQUIRED: We would recommend work is carried out to this too; quotations required.

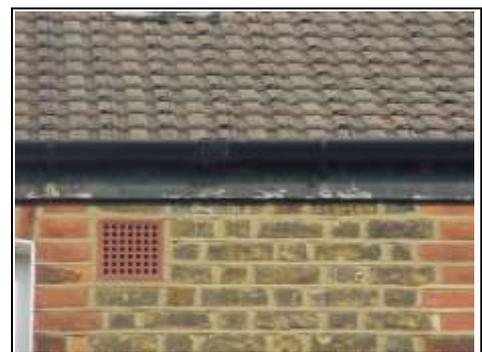
Relatively speaking from ground level the fascias and soffit boards look in reasonable condition albeit that they need painting, however it would be prudent to take the opportunity whilst the scaffolding is up to repair/replace them dependent upon their overall condition.

Repair/replace fascias and soffits

ACTION REQUIRED: Repair/replace fascias and soffits.

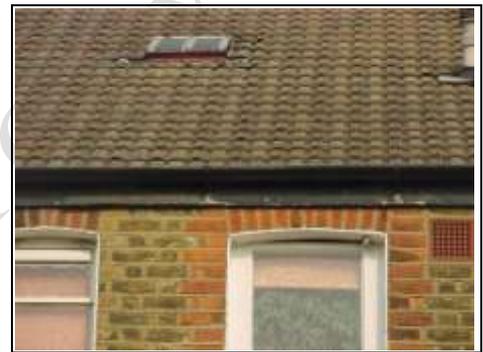
There is a roof light to the rear of the property which would benefit from the opportunity to repair it or renew it.

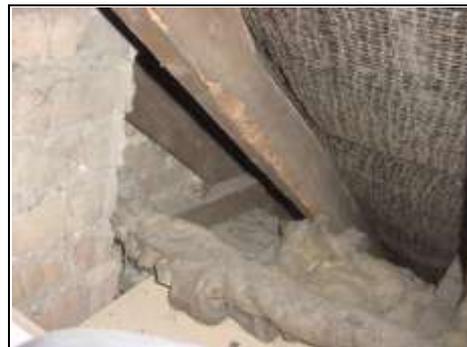
Woodworm was found in the rear left hand side of the roof. Bearing in mind the stored items in the roof and the general difficulty of configuration it is worth emptying the roof to have a more detailed inspection. Whilst we are a great believer that it takes a lot of woodworm to affect a roof structure of this age, it is certainly to your advantage not to have active woodworm in a roof.

Woodworm in roof

ACTION REQUIRED: You need to empty the roof and check and inspect for woodworm.

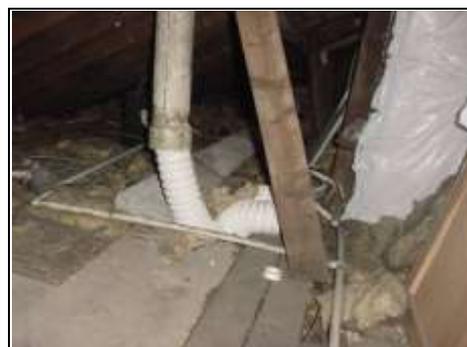
We found some asbestos in the roof. We generally recommend that all asbestos is removed from the property as in our experience it can affect the value of the property as people get more and more concerned over asbestos.

Asbestos in roof

ACTION REQUIRED: Remove asbestos. The Local Authority will have a list of approved asbestos removers.

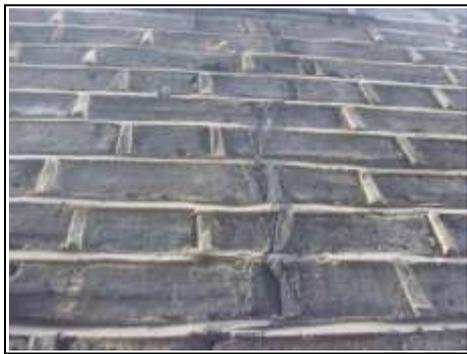
You have signs of old movement to the left hand side of the property and new movement between the main building and the rear wall. We would recommend that you advise the insurance company that you have recently had a survey carried out with regards to maintenance work required and old problems have been identified on the left hand gable that you were unaware of that you wish to bring to the attention of your insurers and also that there is a crack and movement between the main building and the rear wall, is this covered by insurance?

Old historic crack on left hand side of main property

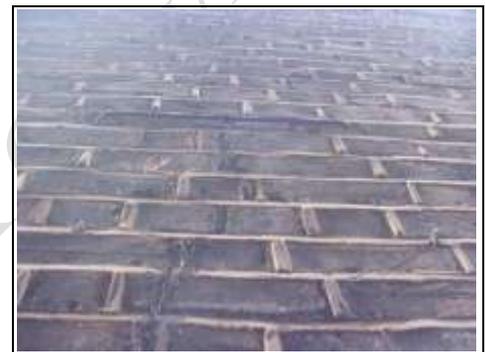
Crack going to metal stitch

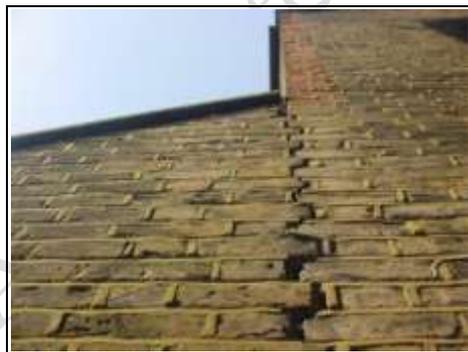
Cracking to left hand side of building between corner of property and boundary wall

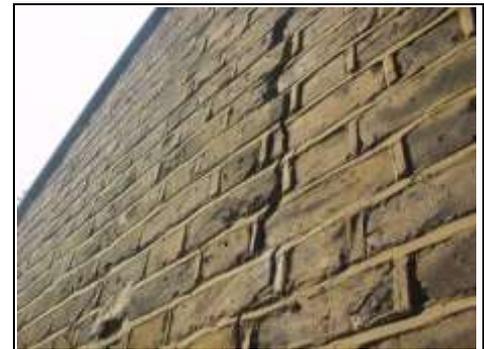
Close up of crack

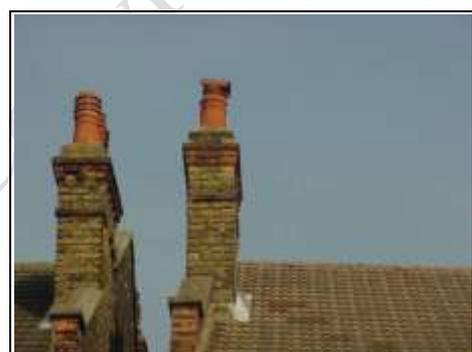
From what we can see from ground level the pointing to the chimneys is weathering which has led to some dampness getting into the property. Whilst we had the benefit of an optical zoom on the camera equipment we use, it is not a replacement for scaffolding the building and viewing the chimney close up. We generally think repointing will be sufficient but in some cases for example the right hand side chimney it may be necessary to partially rebuild as we can see a lean on the chimney.

Right hand chimney needs repointing and possibly partly rebuilding (all directions given as you face the front of the property)

ACTION REQUIRED: You do need to carry out repointing where the mortar joints are weathered such as to the chimneys and some areas of the walls. We would recommend this is carried out in an appropriate lime based mortar. You need to ensure that the builders really do use this as even where specified we have found builders are not using it. The advantages are that the softer lime based mortar doesn't cause deterioration the same way as cement mortar does to the walls.

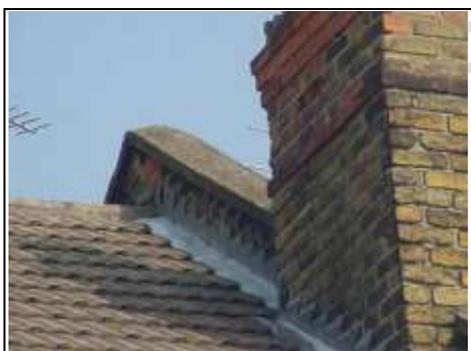
Left hand chimney

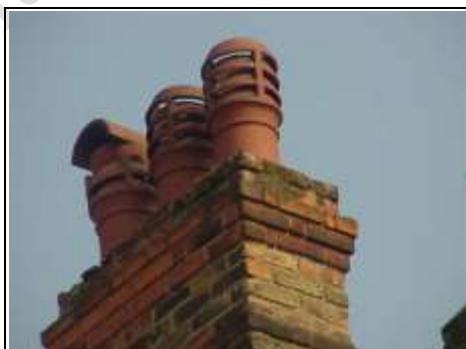
Close up of left hand chimney

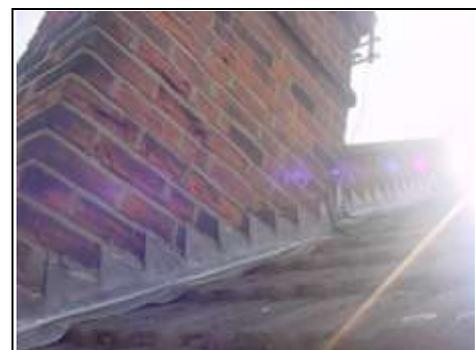
Close up of spalling brickwork to front left hand chimney

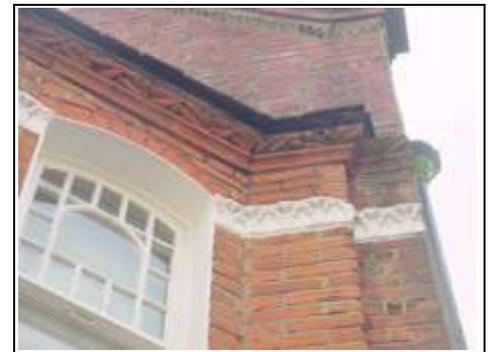
Badly repointed brickwork in cement mortar

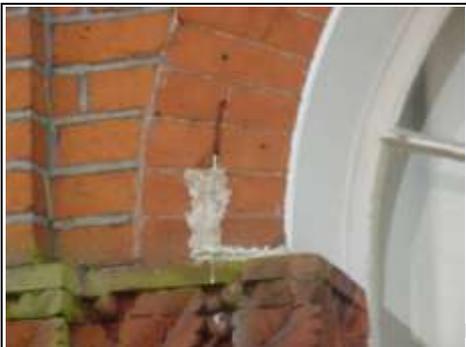
Range of different pointing to brickwork

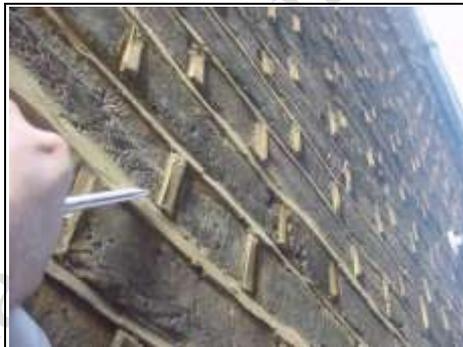
Proud pointing on brickwork on left hand side

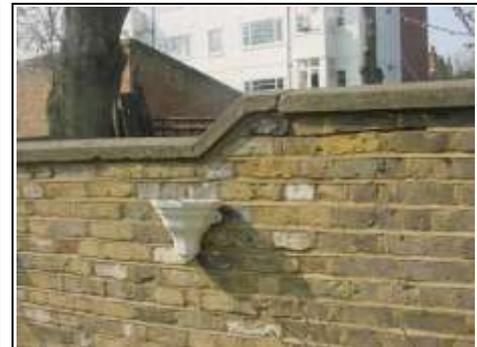
Raking pointing on rear of left hand garden wall

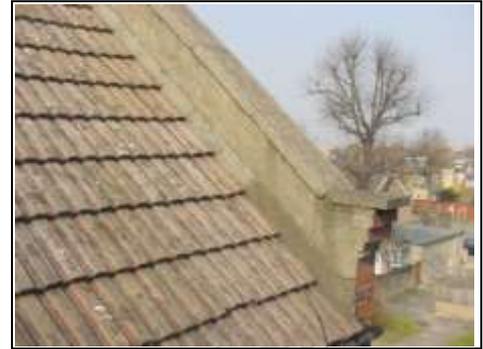
Concrete fillet flashing to front gable

ACTION REQUIRED: We would recommend that all the cement fillets are removed and replaced with lead flashings and that you check the existing lead flashes are correctly bedded in soakers.

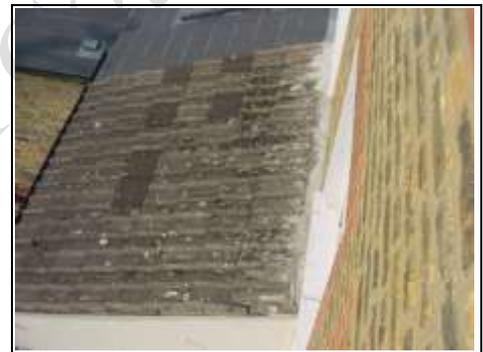
Cement flashing to rear single storey roof extension – not an ideal photo

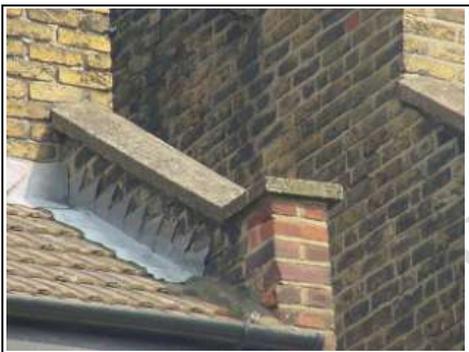
Parapet wall left hand side with cement flashing

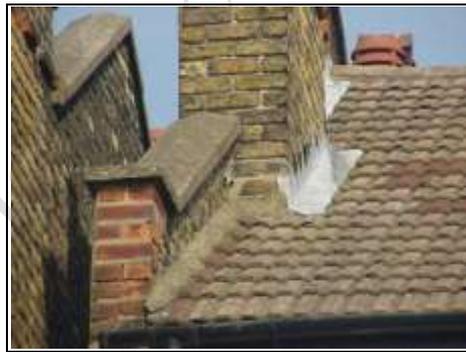
Parapet wall right hand side with cement flashing

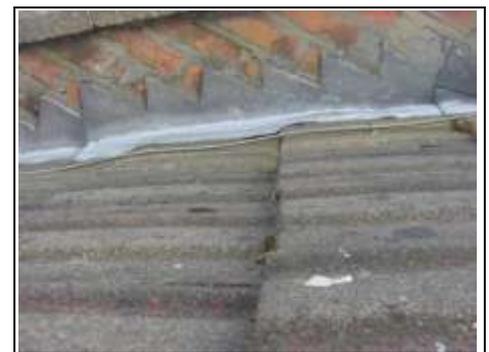
We were pleased to see stepped flashings to parapet wall

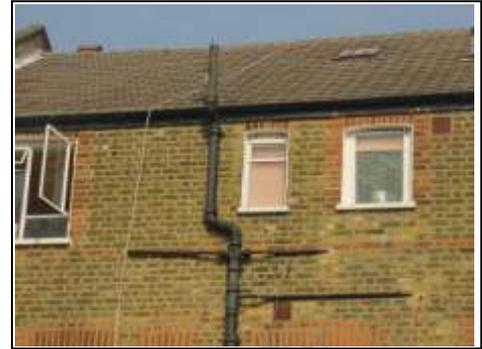
Rusting soil and vent pipe

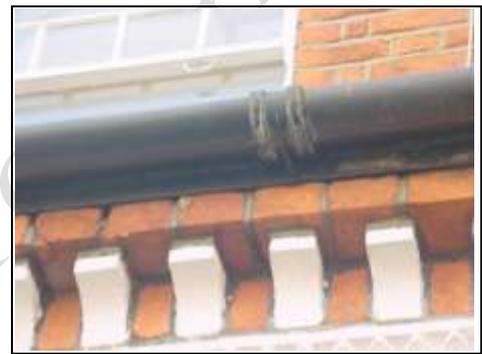
Leaking plastic gutters

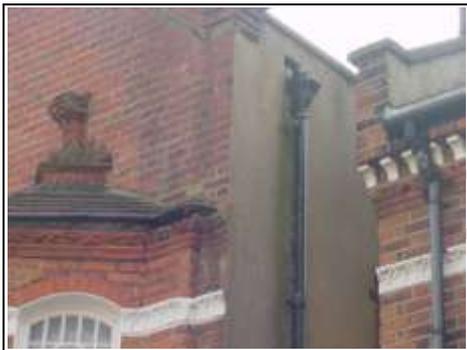
Hopper head leaking to front right hand corner

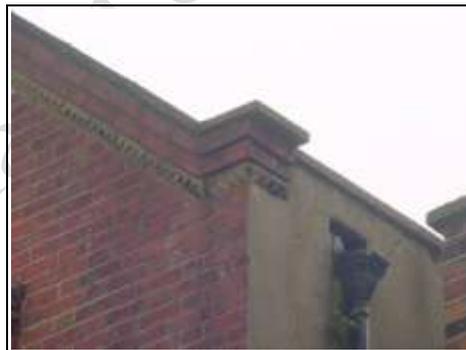
Close up of leaking hopper head

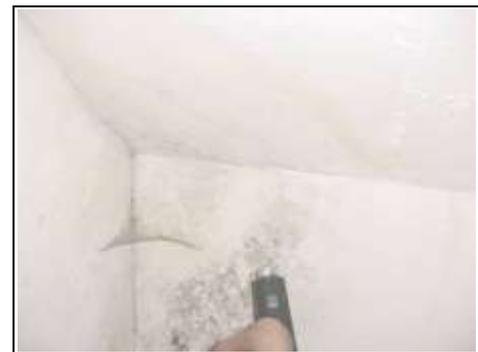
Damp readings to front right hand corner that relate to hopper head

Room	Readings Obtained	Typical Readings
Bedroom 2 – front right hand side	70-80 adjacent to hopper head and downpipe area 60's adjacent to right hand wall	30-60
Office – front middle	60-80 on valley gutter	30-60
Front left hand bedroom	30 on chimney but this was blown plaster. 31 beneath window	
Rear left hand reception room	30 in rear left hand corner where visible staining can be seen and blown plaster. 60 on rear wall.	30-60
Kitchen on rear right hand side	60's in rear right hand corner 30's and 40s in chimney	30-60
