SPECIFIC DEFECTS REPORT

Relating to mould within the front first floor bedroom

Surrey

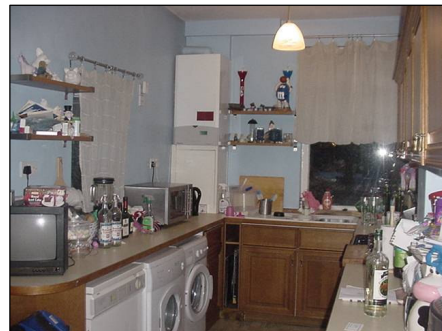
Ground Floor Kitchen

Both the kitchen and bathroom are typically high humidity generating areas that require good ventilation which they do not presently have. You need to reduce the moisture and humidity from around the building generated from the kitchen and bathroom areas. We would specifically recommend:

The reason for carrying out this work, the moisture generated within these rooms is travelling throughout the property and depositing moisture on to the walls with this in turn becoming mould.

ACTION REQUIRED: We noted that there was no mechanical 150mm extract fan with humidity thermostat control from the kitchen which we recommend is added.

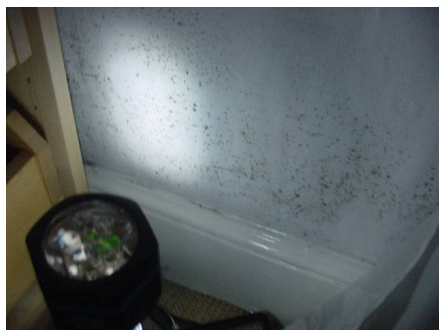
Mould adjacent to cupboard first floor bedroom

ACTION REQUIRED: We would recommend a Programme of Work to first reduce the moisture within the moisture generating rooms of the property i.e. the bathroom and the kitchen and secondly ensuring that all drying of washing is carried out outside and/or via a drier vented to outside air, thirdly windows are added with trickle vents.

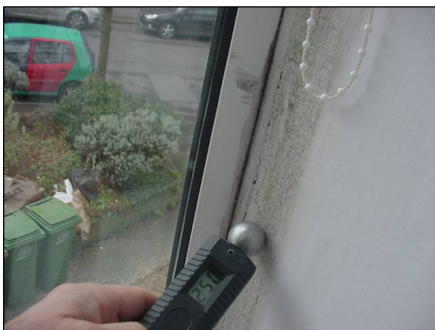
Mould and damp reading next to window front bedroom

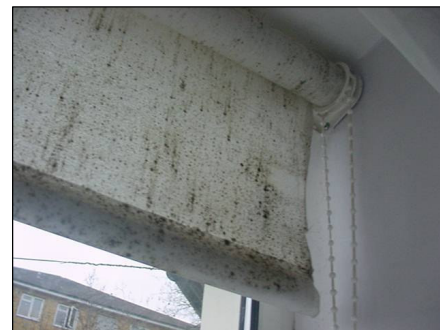
Mould on blind in front first floor bedroom

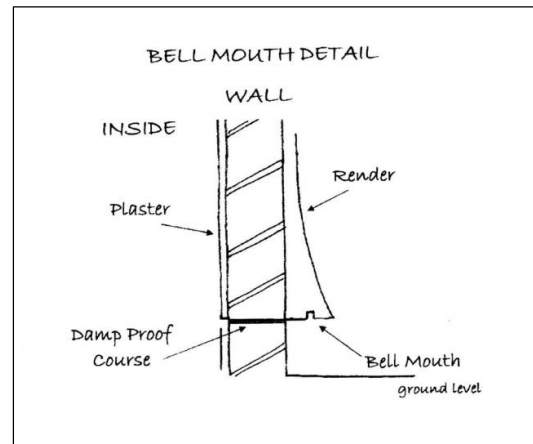
To the front of the property it has been rendered in a modern cement hard waterproof render therefore stopping the wall breathing (we also note that it is poorly detailed, no drips above the window and no bell mouth to the base as well as having hairline cracking all of which would benefit from attention, initially we would carry out sealing of the hairline cracks and redecoration).

ACTION REQUIRED: Initially we would carry out filling of the hairline cracks and redecoration but ultimately we would recommend drips are added above the windows and bell mouth detailing to the base of the property.

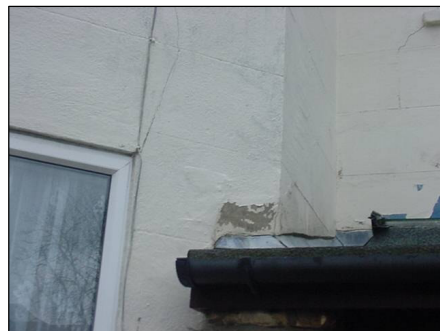
Hairline cracking around window to entrance area

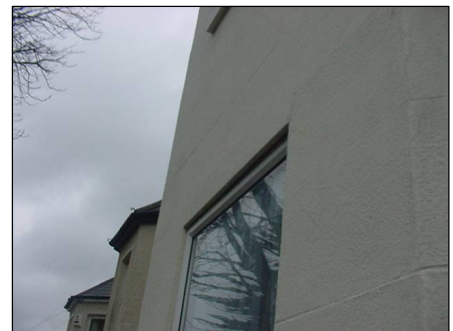
Drip to window

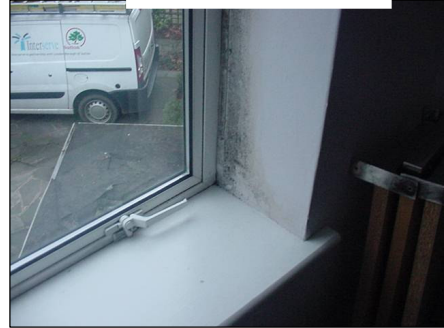
Double glazed window first floor bedroom

We note to the front of the property that an older style double glazed plastic window has been used without trickle vent.

ACTION REQUIRED: Adding windows with trickle vents would help considerably to the front first floor bedroom and the ground floor lounge.

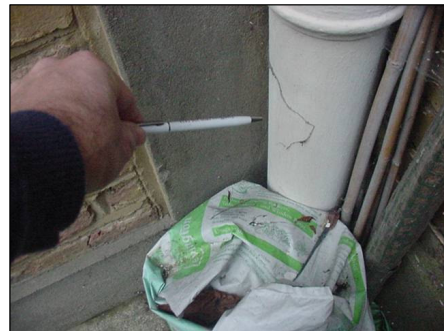
We noted particularly high readings to the right hand side wall which are in line with a leaking gutter, we noticed generally around the property that it has cast iron gutters and these are rusting and we could also see that paint is flaking on fascias/soffit boards indicating that they are leaking (we also noted cracking to some of the downpipes).

Cracking to cast iron downpipe

ACTION REQUIRED: Clear the gutters and downpipes to ensure that they are watertight and transferring water away other than discharging it down the building, you may well need to add new guttering and downpipes.

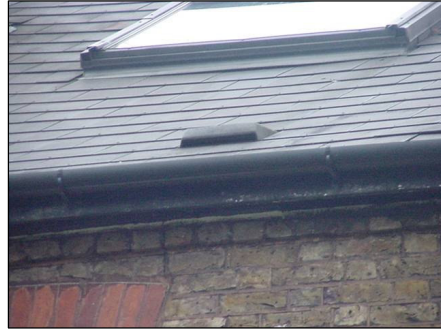
We noted only low level vents to the roof (although there maybe some at high level as builders get particularly good at hiding these although we cannot see them). Modern Building Regulations require further ventilation and better insulation and we tend to find there is heat loss during the winter months and heat gain during the summer months in loft conversions of this era which again can attract moisture.

Low level vent only visible to the loft conversion

ACTION REQUIRED: We would recommend additional vents are added to the roof.

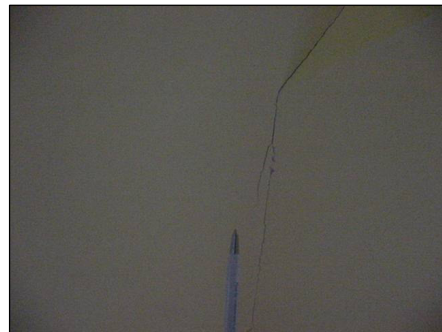
Hairline cracking within top floor bedroom

i. ceilings – hairline cracking was noted in the top floor room, we believe this relates to new insulation with thermal gain in the summer and thermal loss in the winter.

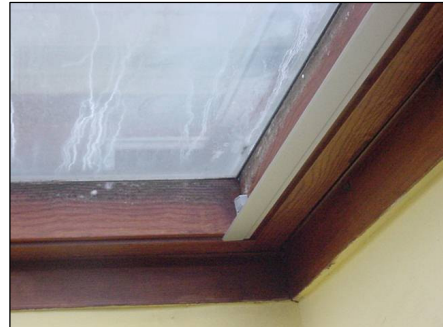
We also noted that condensation was occurring to the roof light on the top floor.

Condensation to top floor loft conversion bedroom window

ACTION REQUIRED: We recommend regular airing of the property.

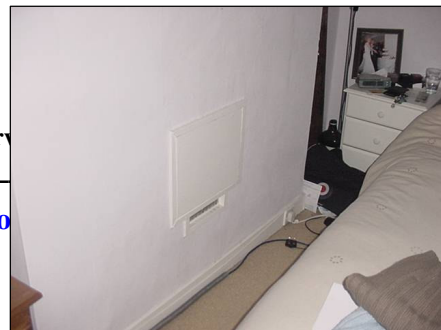
Years ago when we had open fires in properties there was natural air ventilation. When chimneys are blocked they do need to have vents.

Chimney vent partially blocked
in front bedroom

ACTION REQUIRED: All chimneys should be vented.

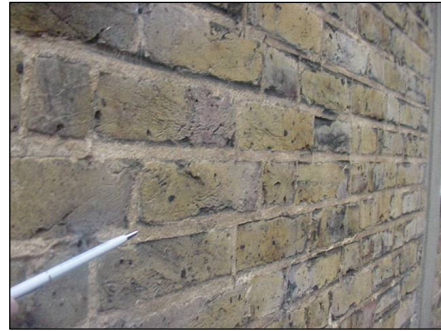
Older properties are often repaired with older materials which do not have the breathability that we have mentioned earlier such as cement based renders, cement based repointing to the brickwork and plastic based paint which does not allow breathing and the property to work in the manner it was originally meant.

Cement pointing to brickwork

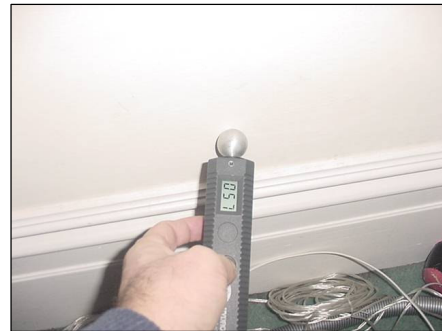
This means that the majority of the readings were in line with what we would expect however there are some high reading areas to the right hand side of the property which we have identified in our Executive Summary as we believe these may relate to leaking guttering. In addition here the high reading in the roof indicates there may be a roof leak, we cannot be certain without opening up the structure.

Damp readings with a Gann meter
