SPECIFIC DEFECTS REPORT

Relating to front and rear
extension work

We have been asked to provide an independent report with regard to front and rear single storey extensions that have been built at XXXX Surrey XXX

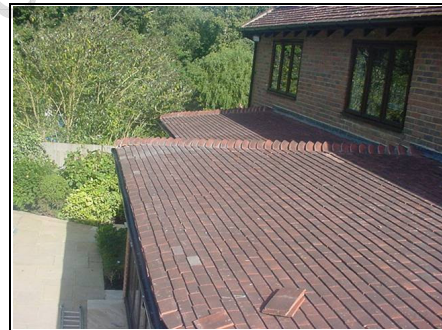
Currently the roof is allowing water into the property due to poor ridge detailing and gutter detailing. The valley gutters are starting to deteriorate.

Rear shallow pitched roof

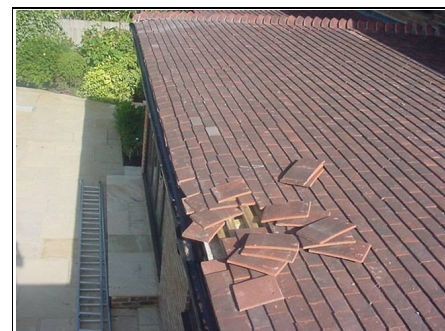
Due to the shallow pitch of this roof it has effectively a double roof. The top roof is tiled and the second under roof is in GRP (Glass reinforced plastic). We are concerned that the batons will not be suitably vented to avoid rot although they are likely to be treated batons we feel it would be more normal to carry out a cross battening and have a vent at the fascia board.

Roof opened up to expose the GRP layer below

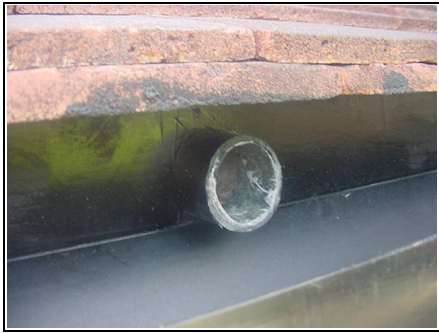
Poor gutter detailing

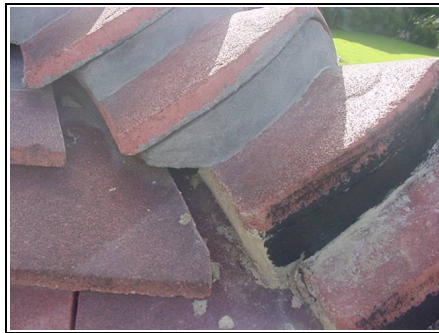
Poor ridge tiles detailing

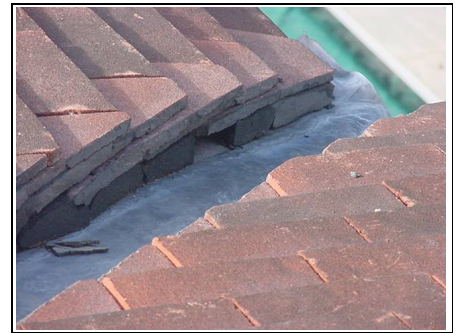
Valley gutter starting to deteriorate

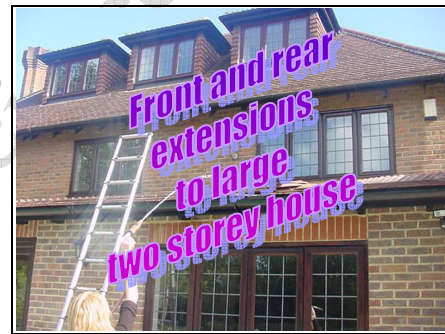
We sprayed the roof above the kitchen area and carried out a basic water test using electronic resistance meters internally.

This showed that the water is coming into the kitchen area and the dining room area.

Water test

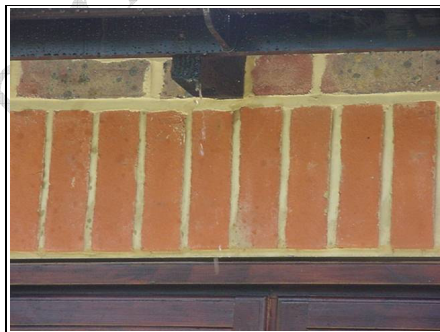
In addition water is travelling down the roof covering at missing the guttering transferring down the walls to the area beneath.

Water missing the gutters and coming down the wall

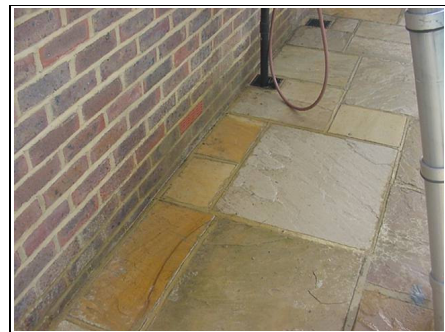
Water missing the gutters and coming down the walls

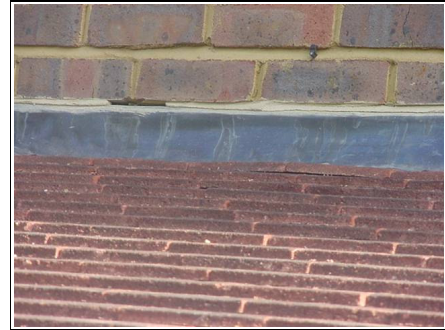
The lead flashing is bedded in a cement mortar. We note that there are areas where the surface mortar is coming away. The lead needs to be bedded to a depth of 25mm plus and ideally a mastic such as Plumbmate should be used as well as a lead plug.

Poor flashing detail not only is the flashing not high enough it has also not been bedded correctly. The cement fillet has come away from the lead flashing.

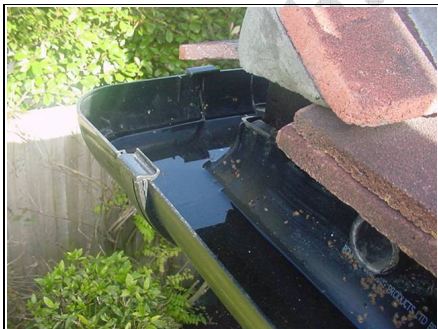
The guttering requires some work, the present layout we believe will lead to over flowing to the rear right hand side.

Gutters not clearing rainwater rear right hand corner, the fall also needs to be checked

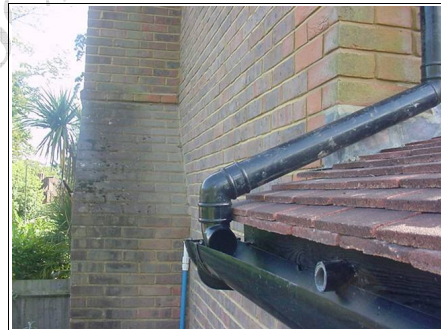
Overflowing to the rear right hand side

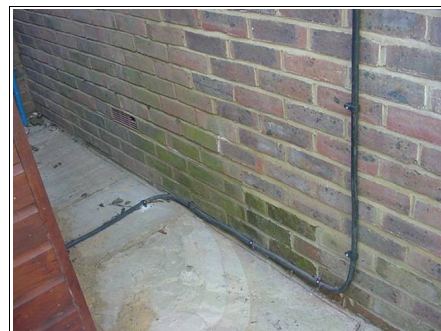
Result of overflowing

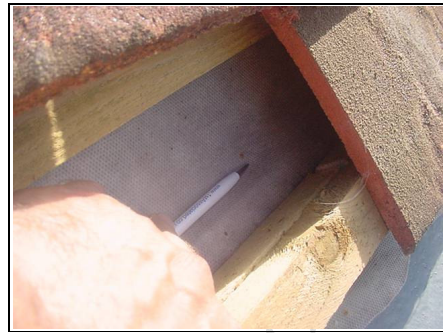
1.2.1) Return where the flat roof meets the pitched roof is not sufficient to stop water getting in particularly snow approximately 100mm above roof level.

Return on GRP to pen which is not high enough

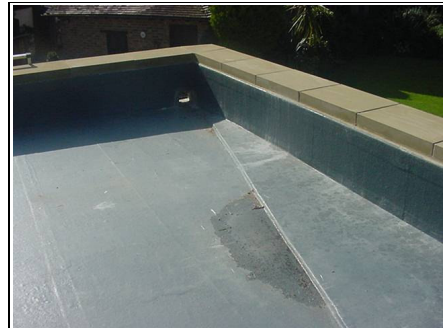
1.2.2) There is a lack of fall to the flat roof resulting in ponding. The flat roof is flat.

No fall on roof towards the hopper heads and downpipes

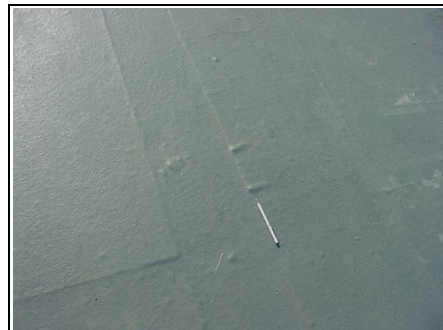
1.2.3) There is blistering to the flat roof.

Blistering in the flat roof

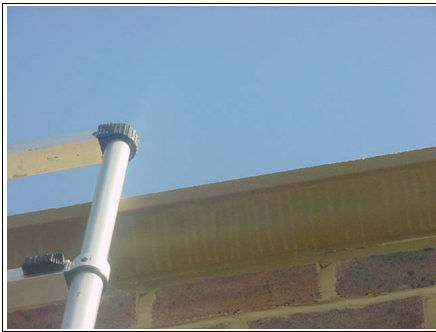
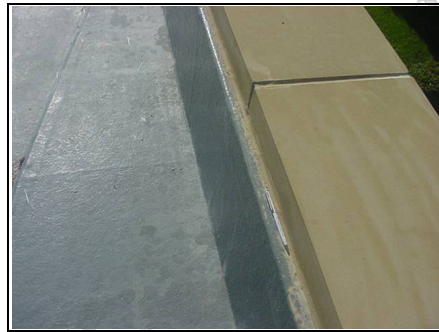
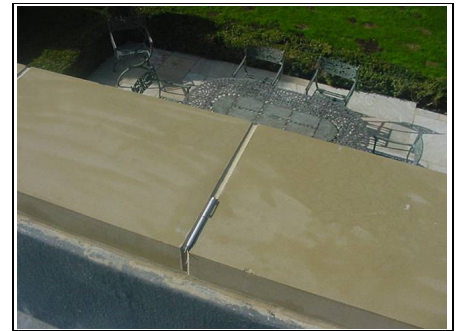
1.2.4) The coping stones do not have a drip detail and we are advised do not have a DPC (damp proof course) detail (the latter would only be a hundred per cent confirmed

No drip detail to the front of the coping stone allowing water ingress into the property

No DPC to coping stone a way around this would be capping the coping stone or removing it and adding a DPC and replacing it with a suitable coping stone.

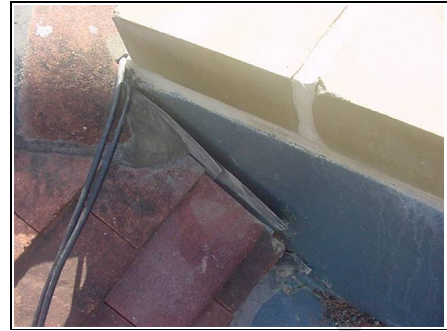
1.2.5) Not watertight lead detailing around the roof generally.

But specifically at the ends of the parapet wall and poor detailing into the hopper heads.

Poor lead gutter detail

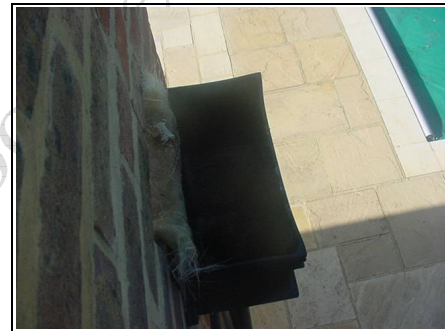
Junction detail to the hopper head not finished correctly

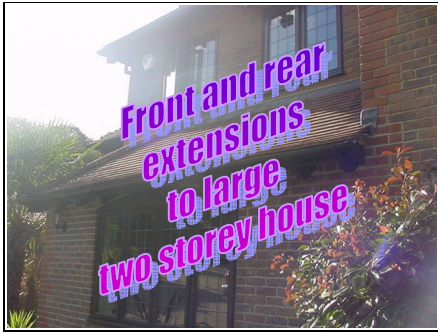
Where the new opening have been formed in the building the cavity tray typically needs to be installed to transfer any dampness that gets into the property from the walls back out.

Front view, has a cavity tray been installed?

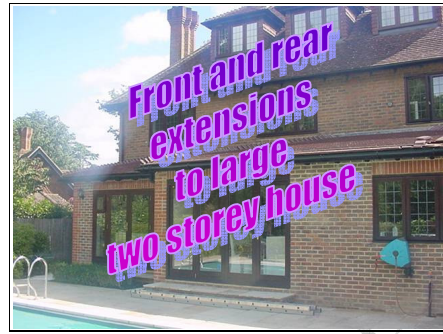
Has a cavity tray been installed under any of these windows?

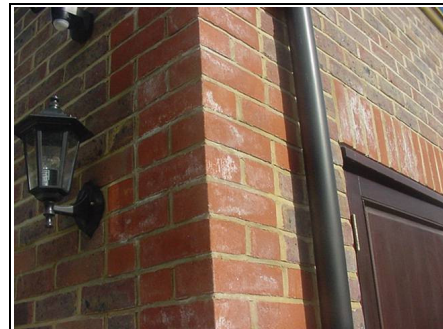
Dampness is getting into the structure both internally and externally and is visible in the form of efflorescence on the brickwork outside and internally although at present we did not notice any blown areas of plaster it will blow eventually.

Efflorescent on the bricks

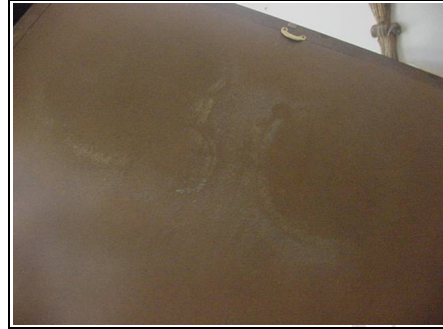
We could see that mould is visible to the back of the pictures which is an indication that there is a lot of dampness in this area.

Mould appearing on the back of the pictures in the lounge

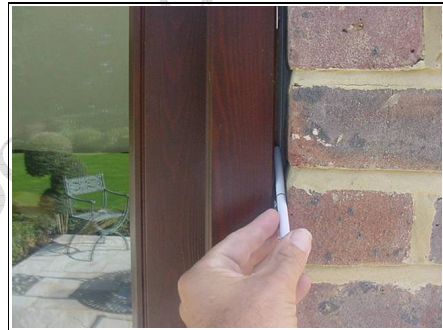
The perimeter detail to the windows has not had mastic applied. This will allow dampness in and heat out.

Mastic not applied

Mrs X has since had mastic replaced.

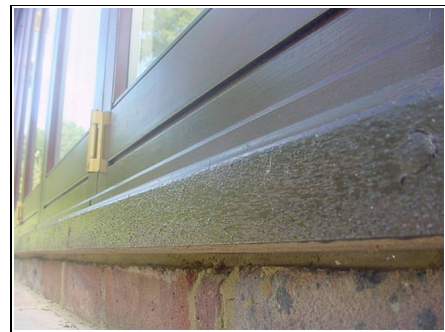
Wood under the window has not been stained

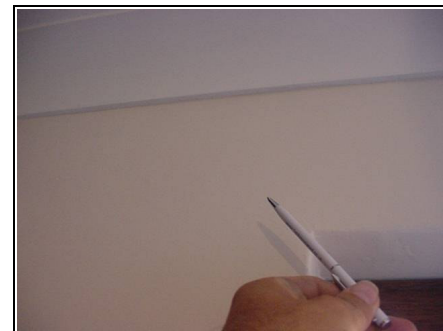
Cracks visible in the adjacent bedroom

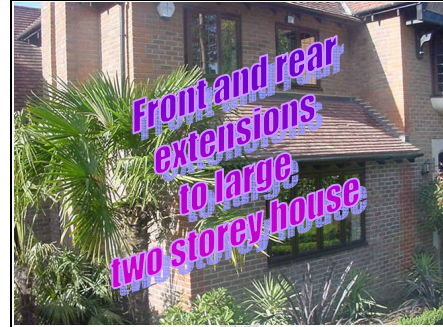
1.1.2) We are advised (by Mrs X) that the lead is not appropriately bedded 25mm into the joint.

1.1.3) The protective underlayer does not consistently lap into the gutters appropriately which would be good practice.

General view front extension

Item 1.1.2 is not visible and is in line with what we found to the rear roof.
