SPECIFIC DEFECTS REPORT

**Relating to Dampness and Structural
Alterations
At a Residential Property in West Sussex**

**Specific Defects Report
of a residential property in West Sussex**

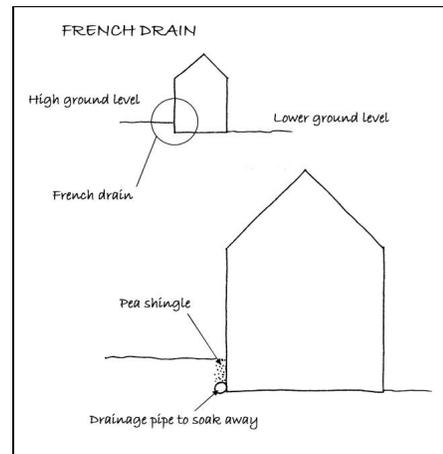
1. We believe the problem to relate to a combination of issues primarily the ground level being too high but also the fact that to the rear of the property the water also appears to run towards the building and also it seems to be shaded from the sunlight.

ACTION REQUIRED: We would recommend that the ground levels to both the front and rear of the property are lowered and a proper French gully added. Please see the adjoining sketch and please note our article in the Appendices about French ponds which you should avoid!

ANTICIPATED COST: £2,000 - £3,000; you do need to obtain your own quotations.

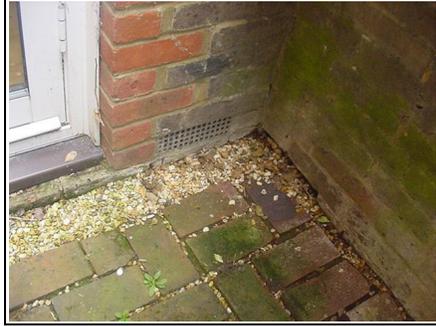
As you can see in the adjoining photos there is moss to the brick paves and also to the brick wall which indicates the area has been damp for a long time. It may have affected the suspended timber floor to the property. The suspended timber floor is to the front of the property and there is a concrete floor to the rear of the property.

Moss to the wall and brick paves indicates this area is damp and doesn't get much sun on it

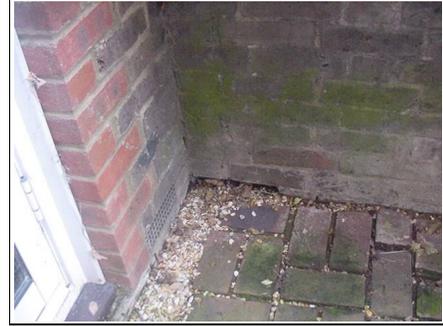
Cutting back of the brick where it is adjacent to the main property indicates that water may flow through this area

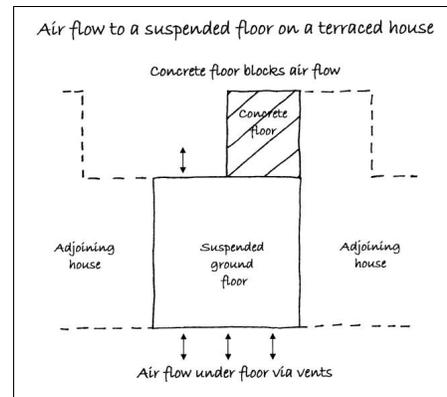
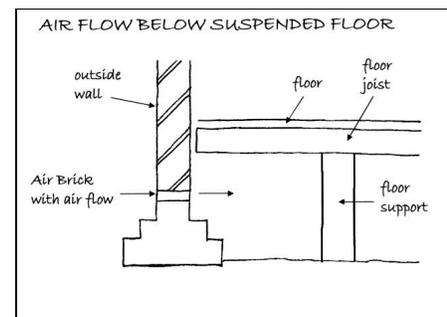
The suspended timber floor requires airflow underneath it, you only have a few airbricks to the front and one airbrick to the rear as far as we can see. This means that the concrete is affectively acting like blotting paper for any dampness in the structure (please see the first sketch).

ACTION REQUIRED: We would recommend that you add additional air ventilation or even running vents internally where the timber floor meets the concrete floor.

Additionally we would recommend that you open up the floor to check its condition.

ANTICIPATED COST: £250 - £1,000 possibly more depending upon the amount of work required when opening up the floor; quotations required. Also it may be worth adding a running gulley internally as well as the airbricks.

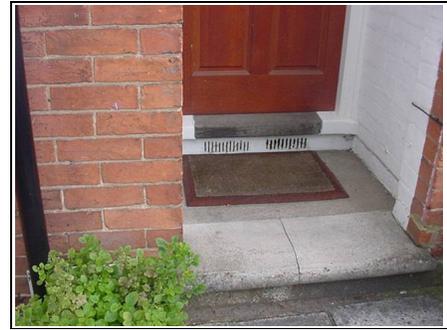
Air vent under front door

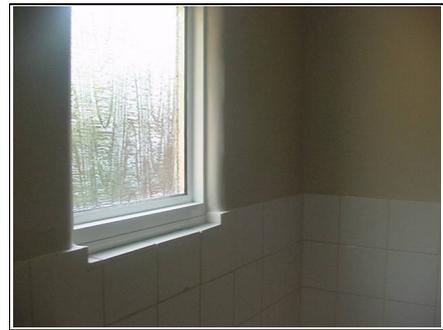
The bathroom extension has been built in a single brick wall so it was probably the old coal shed or similar storage area. We would expect dampness to occur in this type of construction. It would not meet current Building Regulation requirements for this type of building.

Single brick walls in bathroom

ACTION REQUIRED: The best way to keep this dry-ish (note we haven't said dry) is to have the French gulley to the side of it.

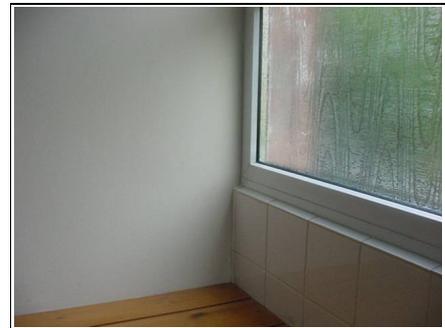
Single brick walls to bathroom

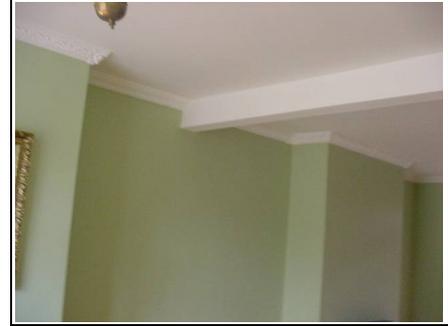
Where a structural alteration has been carried out not to Building Regulations it would be more normal to have a pier both sides of any removed wall to give support to the lintel and the floor and structure above.

There is no pier in this instance therefore we feel it is unlikely that Building Regulation approval would have been obtained.

Missing pier where wall taken down

ii. On the removed internal wall we noted there was no pier to the left hand party wall, (all directions given as you face the property) therefore it is unlikely that this will have building regulations approval. We would advise that it also needs party wall approval as you are taking support from a dividing wall also known as a party wall which falls under the Party Wall Act 1996.

ACTION REQUIRED: The only way we can mathematically establish if the lintel is acceptable is to have it opened up and the structure examined and calculations carried out to be submitted to Building Control to obtain retrospective advice. However we would comment that the structural alteration has clearly stood the test of time without any major bending or stress marks in the wall although do see our previous comments about it looking relatively newly painted and plastered.

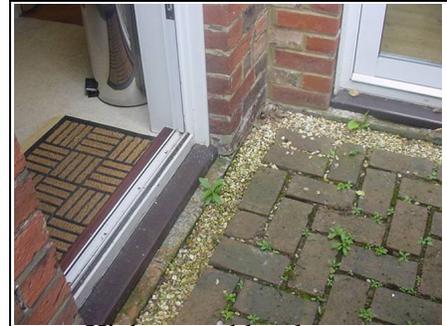
- i. High ground levels to the front and rear with a slope towards the rear of the property.

High ground level to rear

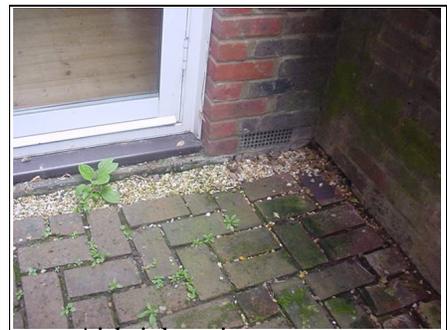
- ii. High ground levels have also exposed the airbricks to act as gutters.

Airbrick acting as gutter

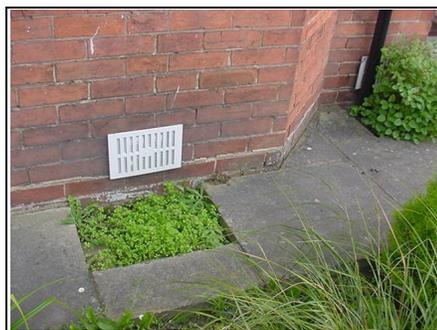
Damp proof course to front of property too low due to high ground level

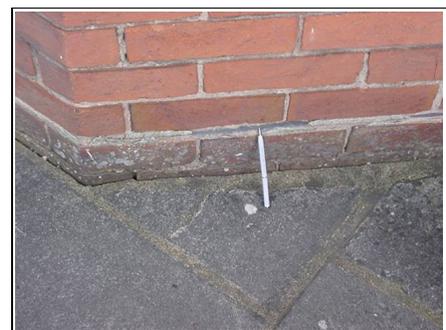
Close up of damp proof course

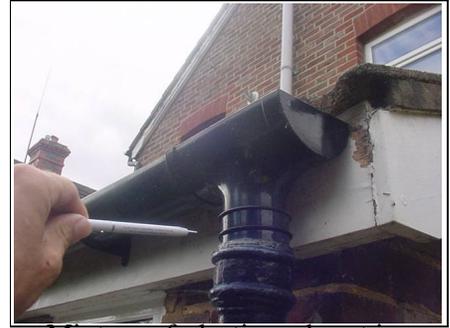
vi. We noted to the rear single storey bathroom part of the structure that there was a mixture of plastic gutters and cast iron downpipes which do tend to leak.

Mixture of plastic and cast iron gutters and downpipes

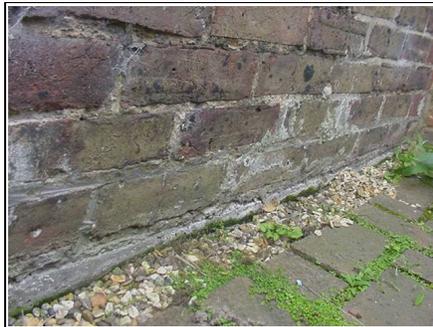
Marks to wall indicates that water runs down the side of the wall

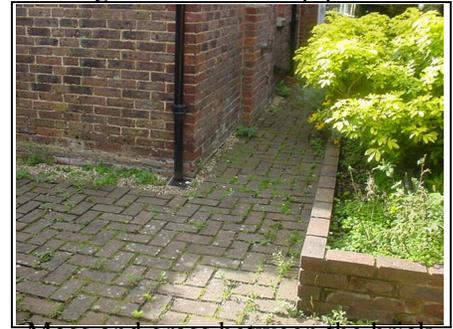
Moss and grass between the brick paves indicates that water sits in this area possibly from adjacent overflowing drains

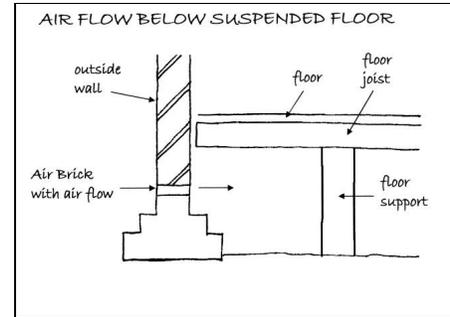
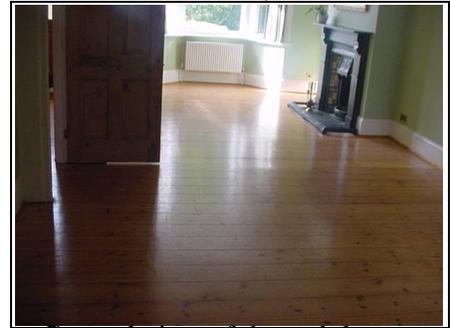
- iii. It was noted there was a suspended timber floor with joists running front to back in the through lounge area with a solid concrete floor in the kitchen and bathroom area therefore there is no through flow of air underneath the property (one airbrick was noted but we don't believe this is sufficient).

General view of through lounge with joists running front to back

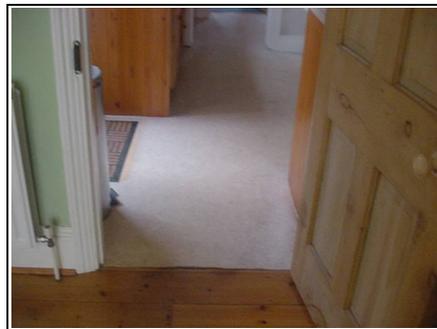
Timber suspended floor construction meets concrete in kitchen

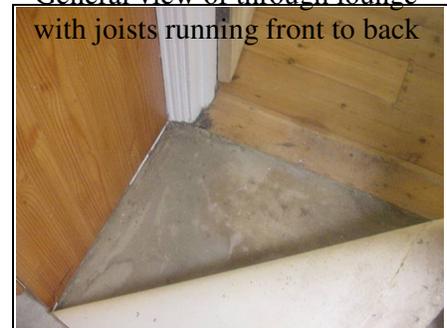
Concrete between timber floor and the kitchen floor

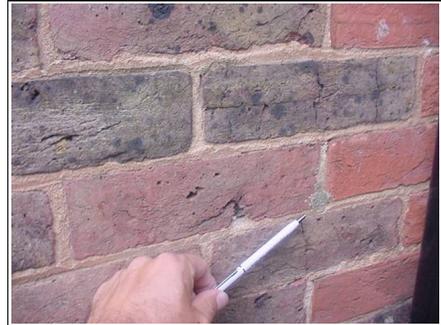
1. A circular cement plug to the rear cavity wall indicating insulation may have been added or a check for wall tie problems or somebody filling up a hole where bees or wasps have got in. We would recommend your legal advisor needs to specifically ask if cavity wall insulation has been added or wall tie replacement. This can affect our comments within this report.

Drill hole that has been resealed with a modern cement mortar indicating some work has been carried out

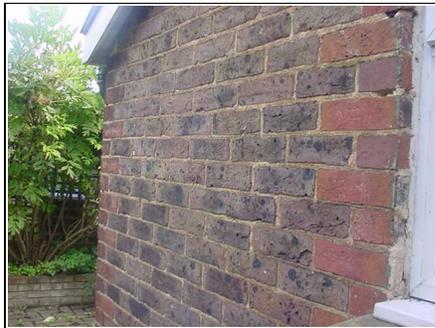
Old stretcher bond brickwork indicating cavity wall

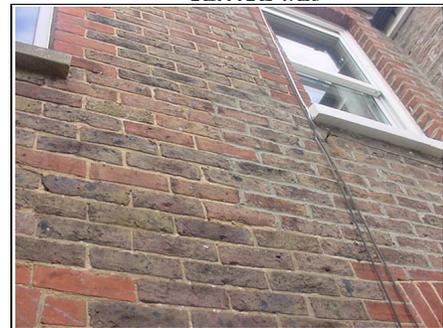
Shows that there has been repointing to the brickwork to the right hand side of the photo in a slightly greyer darker modern cement mortar

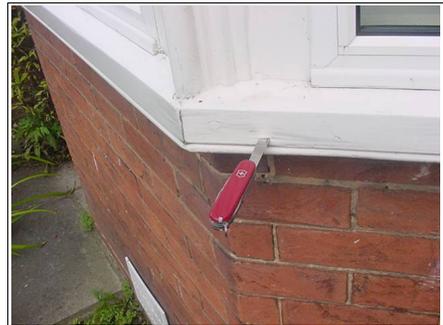
To the front bay window the timber surround with the double glazing within it rot was found.

Wet rot to timber frame to front bay window
