# **SCHEDULE OF CONDITION**

## **Large Commercial Building, Berkshire**

The Schedule of Condition offers a detailed description of the condition of the property at the time of our inspection on 16<sup>th</sup> December 2011.

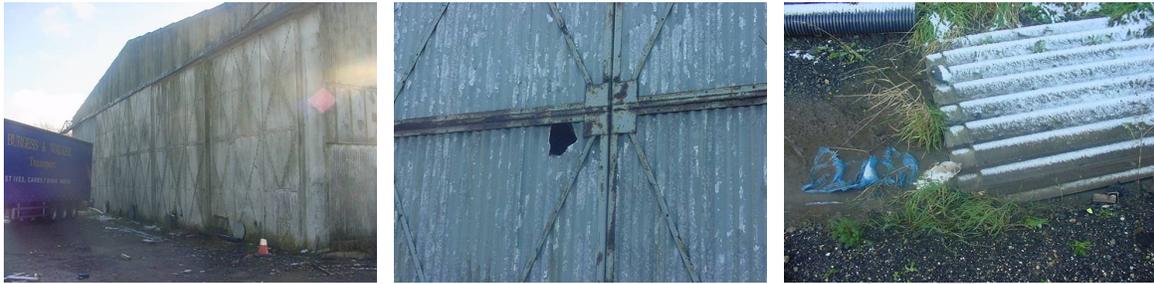
## REAR ELEVATION

DESCRIPTION	CONDITION	ACTION REQUIRED
<p><b>Roofs:</b></p> <p>Not visible</p>		See Roof Schedule
<p><b>Gutters and Downpipes:</b></p> <p>None</p>		
<p><b>Walls Structure:</b></p> <p>Formed of six hanger doors.</p> <p>Primary structural frame not visible however the structural frame to the hanger doors can be seen in the form of a triangulated framework.</p>		<p><b>URGENT:</b> Independent high level check to ensure that the hanger door fixings are safe. They may require removal if deterioration can be seen</p>

A plinth covers the hanger door runners forming a ledge that we believe deterioration is occurring on, although not visible at ground level

Deterioration can be seen to the front of the plinth (we believe it is also to the top of the plinth) and areas surrounding the hanger doors.

Repair plinth as deterioration will affect the stability of the hanger doors.

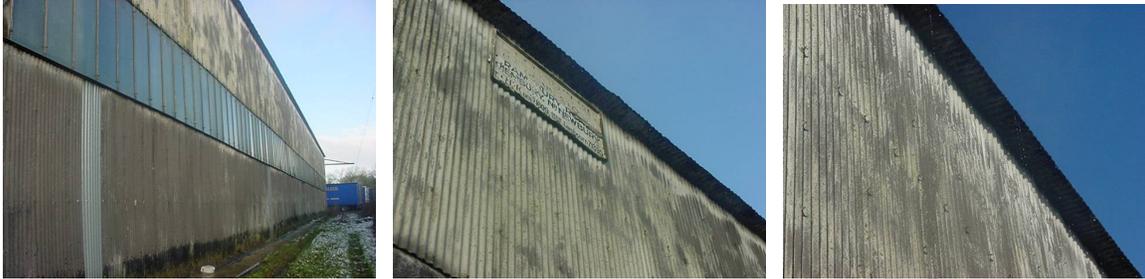
## RIGHT HAND SIDE ELEVATION

DESCRIPTION	CONDITION	ACTION REQUIRED
<p><b>Roofs:</b></p> <p>Not visible</p>		See Roof Schedule
<p><b>Gutters and Downpipes:</b></p> <p>No gutters.</p>	<p>The rainwater runs off the end detail / overhand and discharges onto a concrete gutter below.</p> <p>We note protective coating at roof level has come away and rusting is visible</p> <p>This area is heavily corroding</p>

<p>We recommend a close inspection at high level in summer of 2012.</p>

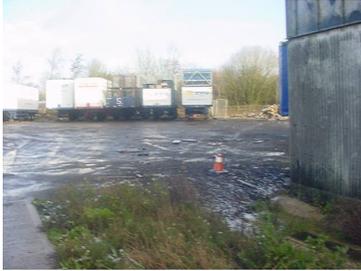
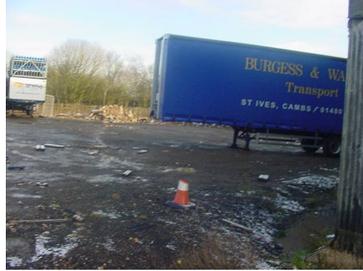
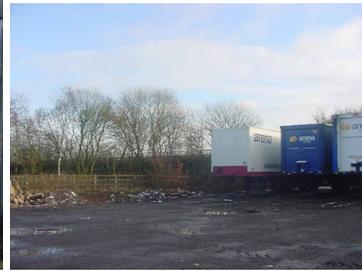
## REAR UNMADE AREA

We noted general debris was being left which we assume is associated with those parking and we noted that a drainage run had been laid to the rear of the subject building.

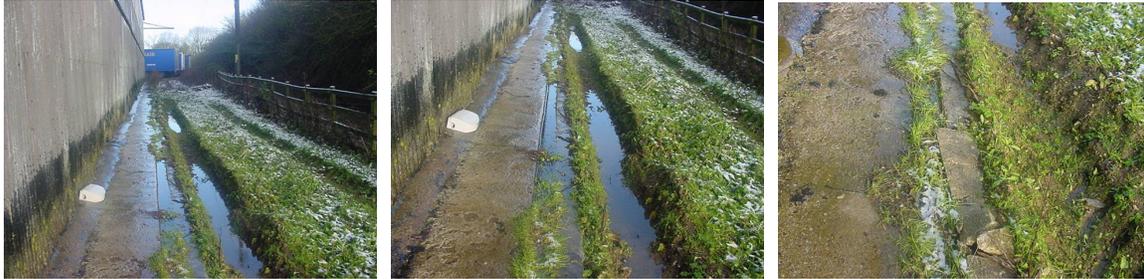
## RIGHT HAND GRASSED AREA

To the side of concrete gully is a grassed area; approx three to four metres in width.

Waterlogged at time of survey with deep tyre tracks.

Boundary line to be confirmed

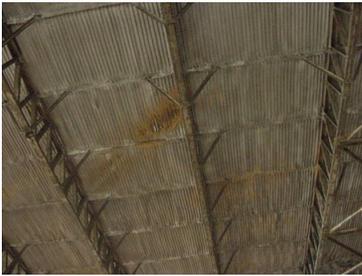
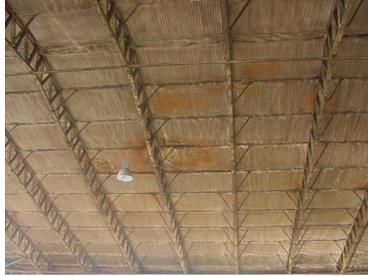
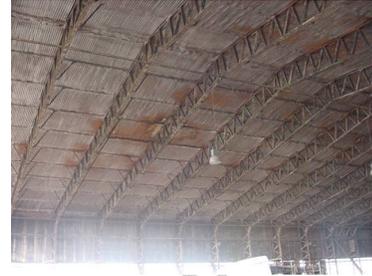
## Roof - Internal

DESCRIPTION	CONDITION	ACTION REQUIRED
<p><b>Roof Covering:</b></p> <p>Corrugated metal roof with a fire cladding internally.</p> <p>Externally we have been unable to view it but we assume it may have a similar protective coating to the walls, although the difficulty of doing it may have precluded it</p> <p><b>Staining and discolouring:</b></p> <p>Rusting / orange in some areas</p>	<p>A fire protective coating has been applied. The fire protection may have an asbestos content</p> <p>The roof covering is orange in some areas which indicates rusting from main roof above.</p> <p>The light snow and rain came through the roof and left ponding on the concrete floor, indicating that the roof is leaking.</p>	<p>Test for asbestos content and make roof watertight and a joint inspection of the roof</p> <p>Inspection required</p> <div style="text-align: center;">

<p>Wind bracing to roof central section</p> <p><b>Vermin:</b></p>	<p>Internal rusting can be seen to the lattice work beams.</p> <p>We refer you to the Guide to WWII Hangers by the MOD that indicates in certain weather conditions these buildings can be problematic.</p> <p>Rear Section has bird netting which was being taken down at the time of our survey indicating there are holes in the roof area. Rats were also noticed during the course of the survey, which we are advised is common in grain storage areas.</p>	<p>Operational procedures need to be put in place with regard to how to operate the property in certain weather conditions.</p>
<p><b>Services:</b></p> <p>Four down lighters and eight lights to each of the side walls</p>	<p>No electricity at time of the survey</p>

<p><b>% Assessment of Deterioration:</b></p> <p><b>Cladding:</b></p>	<p>The white fire protection was visible to approx 95% of the ceiling</p> <p>Approx 30% of the area is yellow indicating there is rusting / orange indicating problems with the roof and water penetration</p> <p>Lattice work beams spanning roof are starting to rust and deteriorate in approx 20% of cases.</p>	
--	---	--

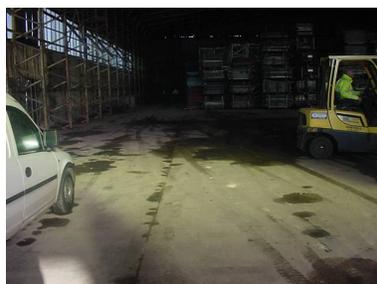
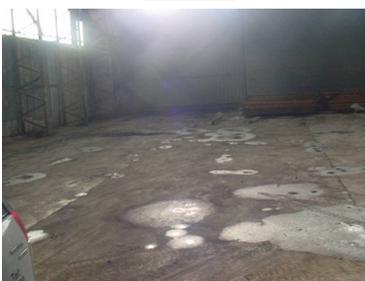
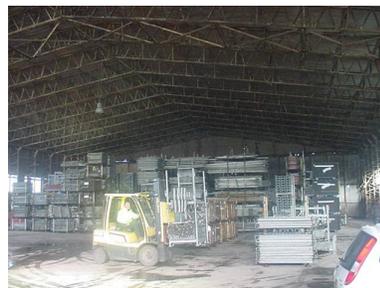
## Floor

DESCRIPTION	CONDITION	ACTION REQUIRED
<p><b>Floors:</b> The floor is divided into nine concrete bays of approximately equal widths, with the exception of the two smaller perimeter bays.</p> <p>All bays run from front to back of the property without any construction or other expansion joints.</p> <p>We have numbered the bays 1 to 9, from left to right, as you face the property.</p>	<p>Semi-smooth finish generally</p> <p>Bays cracked one quarter of the way along their length. All bays covered by stored materials to the far end and therefore were not visible.</p>	
<p><b>All Bays:</b></p> <p><b>Limitations:</b> The stored items covered approx half the rear of this property and therefore we cannot comment on these areas. All comments below relate to the front half of the hanger/old grain store.</p> <p>Originally when in use as a grain store this would have had concrete blocks surrounding it to take the weight of the grain.</p>	<p>This has left marks around entire perimeter of the property, particularly visible in Bay 1 and Bay 9</p>	<p>Make good damage to perimeter bays where concrete blocks used to be fixed</p>

<p><b>Bay 1</b></p>	<p>Old fixing points and concrete blocks used as part of grain storage to ensure that the outer walls of the hanger were not pushed out by the weight of the grain.</p> <p>Marked to three quarter point of building as a whole</p> <p>Cracking running approx to the front side of the half way mark</p>	
<p><b>Bay 2</b></p>	<p>Cracking running approx to the front side of the half way mark</p> <p>Considerable levels of dampness, indicating that rain is coming through the roof.</p>	
<p><b>Bay 3</b></p>	<p>Cracking running approx to the front side of the half way mark</p> <p>Considerable levels of dampness, indicating that rain is coming through the roof.</p> <div data-bbox="717 1278 972 1470" data-label="Image"> </div> <p>Dampness coming in through roof</p>	
<p><b>Bay 4</b></p>	<p>Cracking running approx to the front side of the half way mark</p>

<b>Bay 5</b>	Large cracking; 5mm plus to approx 50mm.	
<b>Bay 6</b>	<p>Spalling on junction of Bay 6 and also within Bay7.</p>

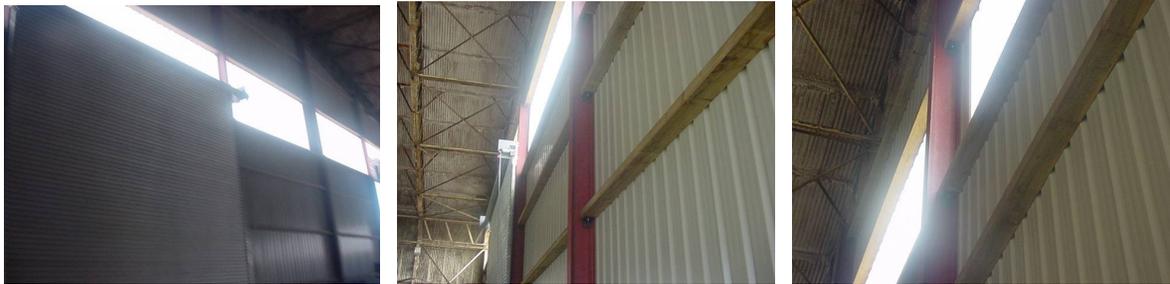
## Front Internal Elevation

DESCRIPTION	CONDITION	ACTION REQUIRED
<p><b>Walls Structure:</b></p> <p>Vertical “T” beams with horizontal purlins fixed with angle irons and they in turn are fixed with anchor bolts to the profile metal sheet</p> <p><b>Top:</b></p> <p>Profile metal sheeting and plastic windows, following the profile pattern</p> <p><b>Middle:</b></p> <p>Profile metal sheeting</p> <p><b>Bottom:</b></p> <p>Profile metal sheeting.</p>	<p>As new</p>

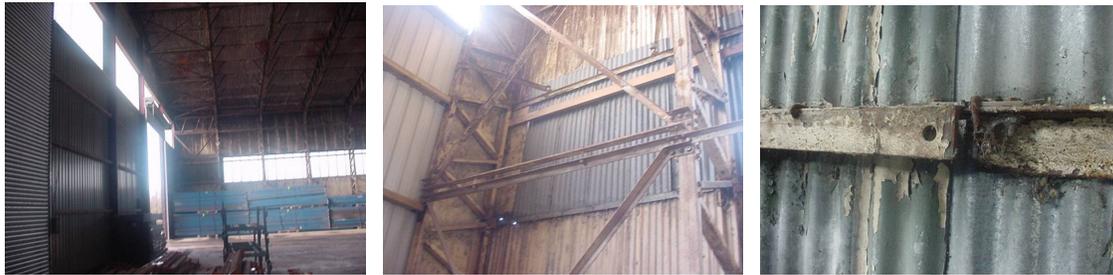
## Left Hand Side Internal Elevation

DESCRIPTION	CONDITION	ACTION REQUIRED
<p><b>Walls Structure:</b></p> <p>Lattice steel portal frame</p> <p>Divided into 23 number bays.</p> <p>First, middle and last bay have wind bracing.</p>		
<p><b>Walls Cladding:</b></p> <p>Corrugated metal with a paint finish</p> <p>The primary structure is the lattice steel portal frame</p>	<p>Bottom 300mm of this cladding has been replaced. Some rust deterioration around this area.</p>

<b>% Assessment of Deterioration:</b>		
<b>Portal frame</b>	Rusting to approx 10% of the frame, as viewed from ground level	
<b>Cladding:</b>	Corrugated metal cladding. Metal visible in approx 60% of cases.  The remainder divides into green and magnolia paint, of which approx 20% is flaking.  Rust visible to cladding in approx 20% of the area.

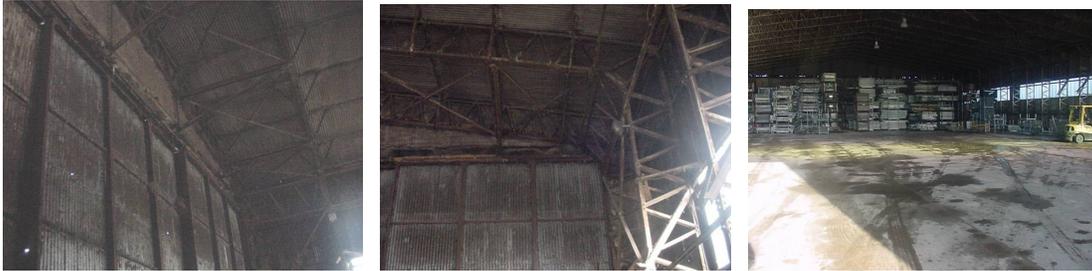
## Rear Internal Elevation

DESCRIPTION	CONDITION	ACTION REQUIRED
<p><b>Walls Structure:</b></p> <p>Six hanger doors in sections</p> <p>Assumed that the hanger doors are supported on a top hung rail with a guiding runner to the base: not viewed</p>	<p>Deterioration had been noted externally and rusting can be seen internally</p>	<p><b>URGENT:</b> This needs to have an independent high level check to ensure the hanger door fixings are safely holding the hangers in place</p> <p>.</p> <p>We can see deterioration to the external area, which has been patch repaired over the years.</p>

<p><b>% Assessment of Deterioration:</b></p> <p><b>Cladding / Hanger Doors:</b></p>	<p>Metal sheeting to approx 30% of area</p> <p>Green and magnolia protective coating paint to approx 60% of which half is flaking.</p> <p>10% has vents</p> <p>Wood section at high level looks to have been sprayed with an asbestos based material</p>	
---	--	--

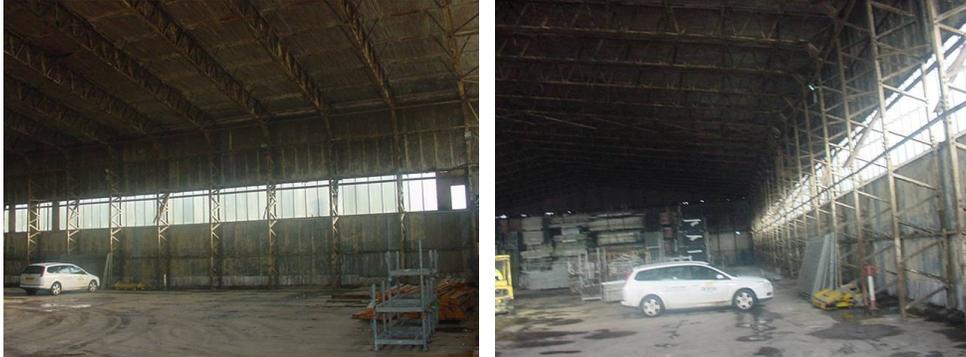
## Right Hand Side Internal Elevation

DESCRIPTION	CONDITION	ACTION REQUIRED
<p><b>Walls Structure:</b></p> <p>Lattice steel portal frame, divided into 23 number bays</p>	<p>First, middle and last bay have wind bracing.</p>	
<p><b>Walls Cladding:</b></p> <p><b>Concrete fillet to all bays</b> Approx 300mm in height</p>	<p>Wind bracing Part of old grain shoot, which is the angled section, in timber</p> <p>All bases of bays replaced to bottom 300mm</p> <p>Can see metal sheeting where paint flaked off altogether.</p>

<b>% Assessment of Deterioration:</b>		
<b>Portal Frame:</b>	Rusting to approx 10% of the frame, as viewed from ground level	
<b>Cladding:</b>	<p>Metal sheeting to approx 30% of area</p> <p>Magnolia protective coating paint to approx 60% of which half is flaking.</p> <p>10% has vents</p>
