SCHEDULE OF CONDITION

Public House Surrey

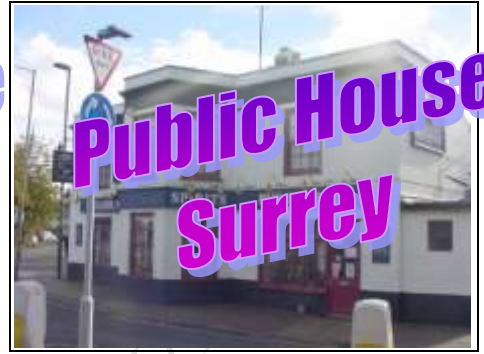
FRONT EXTERNAL ELEVATION

DESCRIPTION	CONDITION	ACTION REQUIRED
<p>Chimneys:</p> <p>Two chimneys visible: Front left – render with one flue and one chimney pot</p> <p>Front middle – brick with two chimney pots and one flue</p>

<p style="text-align: center;">Dampness coming in through middle chimney</p>	<p>Resolve dampness and make watertight</p>
<p>Parapet wall:</p> <p>Parapet wall with asphalt box gutter</p>

<p style="text-align: center;">Dampness coming in through parapet wall</p>	<p>Resolve dampness and make watertight</p>

<p>Turnerised/masticed repairs</p>	<p>Slate roof is in poor condition with deterioration and displaced slates. In need of a general overhaul and making watertight. Associated detailing such as the flashings need to be checked.</p> <p>There may also be some deterioration to the roof structure within the property. We can see some dampness from our view in the roof space.</p>
<p>Gutters and Downpipes:</p> <p>Hidden box gutter</p>	<p>Leaking water into the walls</p>	<p>Ensure the box gutter is watertight and falling towards the downpipes.</p>
<p>Walls:</p>

<p>Deteriorating paintwork, paint flaking and dated.</p> <p>Higher ground level causing dampness within the property.</p>	<p>Repair, prepare and redecorate render.</p> <p>Lower and add French drain.</p>

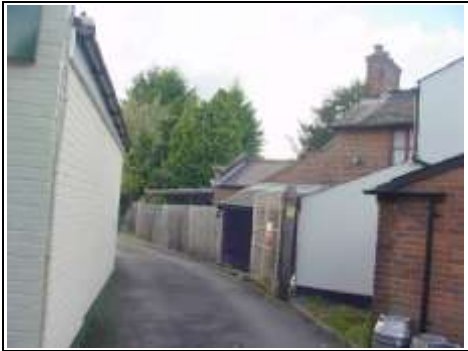
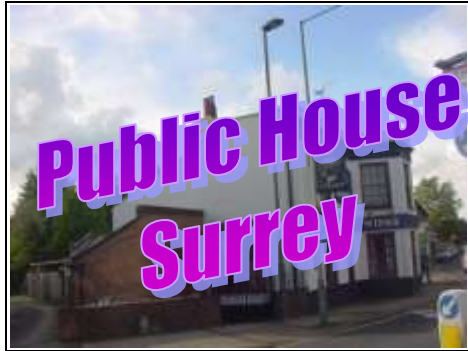
LEFT HAND EXTERNAL ELEVATION

<p>Roof window</p> <p>Low level roofs: Two low level slate roofs</p>	<p>Poor.</p> <p>Poor.</p>	<p>Slate roof is in poor condition with deterioration and displaced slates. In need of a general overhaul and making watertight. Associated detailing such as the flashings need to be checked.</p>
<p>Gutters and Downpipes:</p> <p>Cast iron hopperhead and downpipe Cast iron and plastic gutters and downpipes</p>	<p>Leaking and need realigning</p>

<p>Paint flaking around hopperhead indicating dampness is coming through</p>	<p>Ensure all gutters are watertight and falling towards the downpipe.</p> <p>Repair and secure as necessary, ensure downpipes are clear.</p>

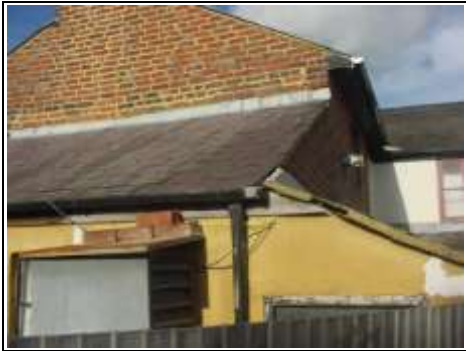
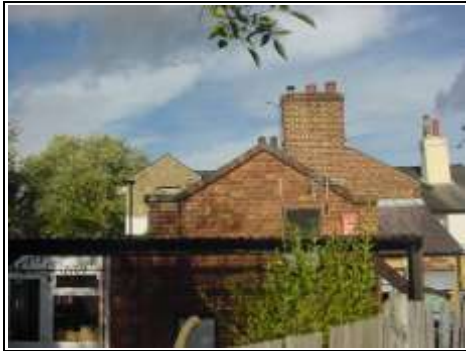
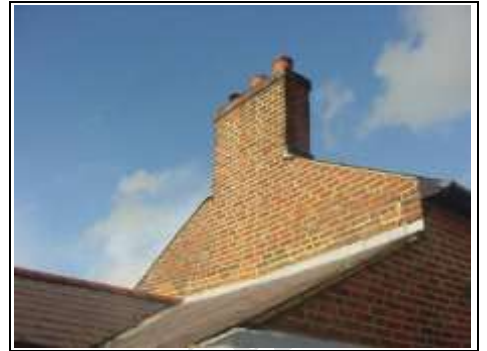
REAR ELEVATION

<p>Rear view of middle chimney with two chimney pots and one flue</p>	
<p>Roofs:</p> <p>Main Roof: Pitched, clad with slates with holes from displaced slates</p>

<p>Displaced slates</p>

<p>Slates completely displaced</p>

<p>Roof in poor condition Slate roof is in poor condition with deterioration and displaced slates. In need of a general overhaul and making watertight. Associated detailing such as the flashings need to be checked.</p>

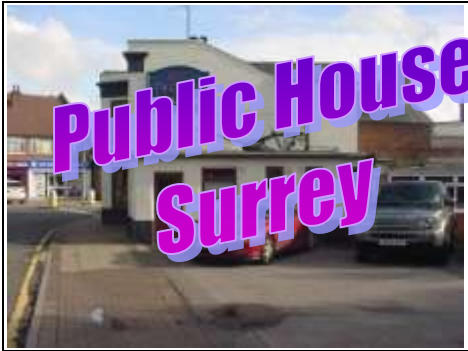
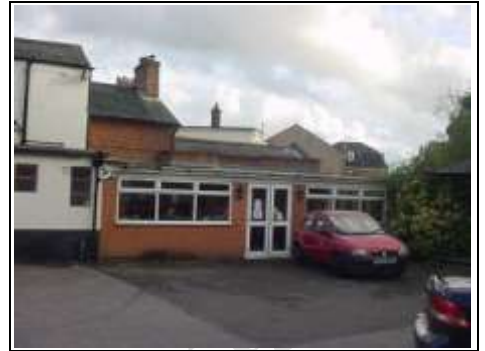
RIGHT HAND EXTERNAL ELEVATION

<p>Turnerised roof</p> </div> <div style="text-align: center;">

<p>Slate roof over kitchen</p> </div>	<p>Slate roof is in poor condition with deterioration and displaced slates. In need of a general overhaul and making watertight. Associated detailing such as the flashings need to be checked.</p>

<p>Dampness to walls</p> <p>Dampness coming through to rear right hand bedroom due to box gutter</p>

<p>Running gulley allowing dampness to base of wall</p>	<p>Resolve dampness to walls Repair, prepare and redecorate.</p> <p>Resolve running gulley problems</p>
<p>External Detailing:</p> <p>Windows:</p> <p>Timber windows painted</p> <p>Metal windows painted,</p> <p>Plastic windows to conservatory</p>		<p>Repair, prepare and redecorate.</p>

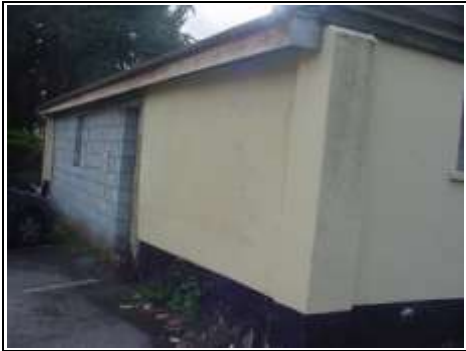
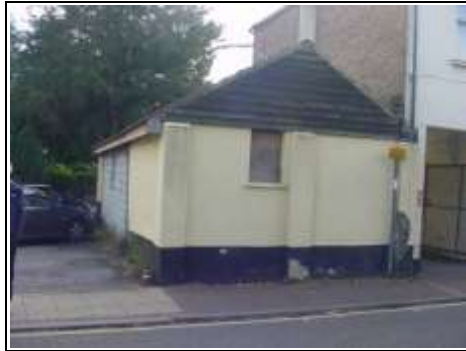
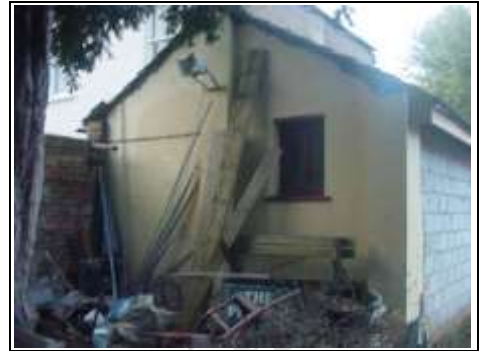
OUTBUILDING - EXTERNAL

DESCRIPTION	CONDITION	ACTION REQUIRED
<p>Roofs:</p> <p>Pitched roof clad in concrete tiles</p> <p>Hidden valley gutter to right hand side causing dampness into adjoining property</p>	  Valley gutter allowing dampness into property	<p>Make box gutter watertight.</p>
<p>Gutters and Downpipes:</p> <p>None</p>	  No gutters	<p>Add gutters and downpipes and soakaway.</p>

<p>Vertical crack on painted render to front left hand side</p>

<p>Crack</p>

<p>Exposed blockwork needs to be rendered</p>
<p>External Detailing:</p> <p>Fascias and soffits: Untreated timber</p> <p>Windows:</p> <p>Doors: Timber</p>	<p>Some windows boarded</p>	<p>Repair, prepare and redecorate.</p> <p>Repair, prepare and redecorate.</p>

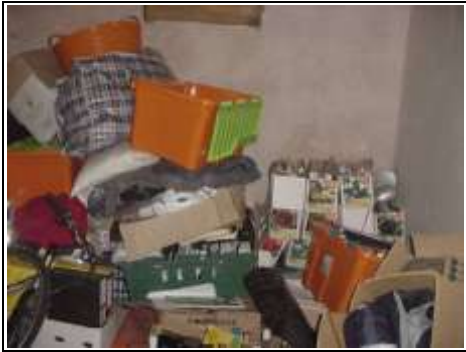
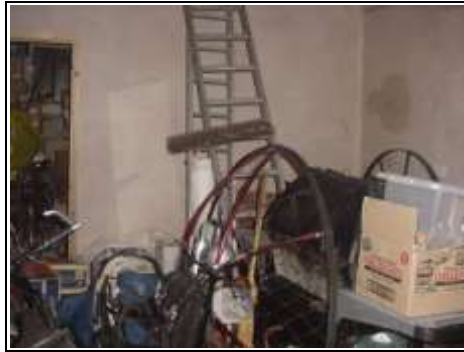
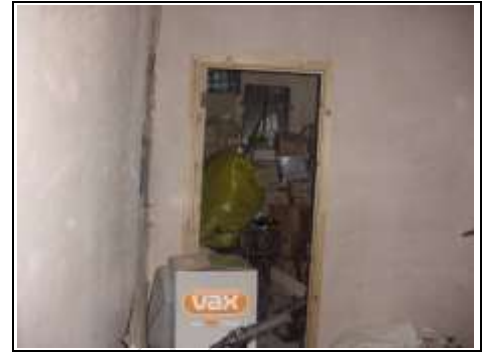
OUTBUILDING – INTERNAL
Generally stored items – limited view and rear not accessed

Dampness	Resolve dampness issues. Repair, prepare and redecorate.
Floors: Concrete		Carpet
Detailing: Windows:		Add windows
Services:	We are advised that no services have been installed.	
Stored Items: Full of stored items, owner advised were owned by third party.		Clear.

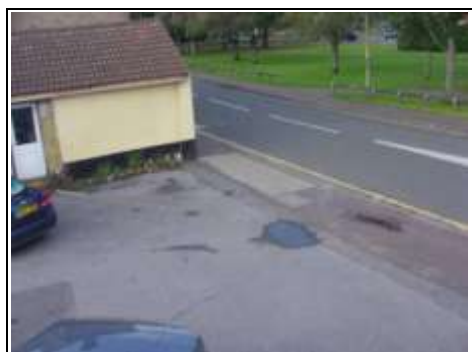
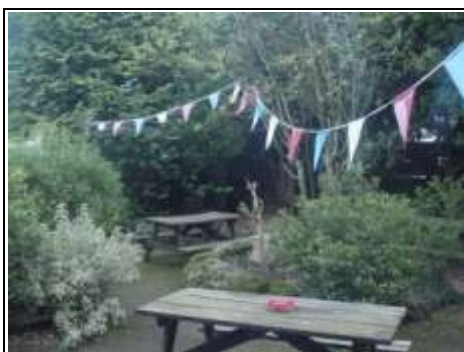
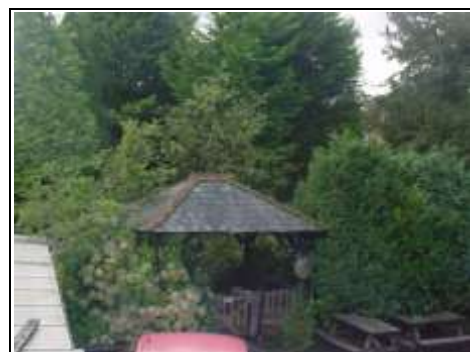
OUTSIDE AREAS

<p>Car park</p>	<p>Car park generally drains towards the pub. Some ponding</p>

<p>Crossover</p>	<p>Drainage is required, ad hoc repairs and white lines.</p>
<p>Surface water drainage</p> <p>Water from car park discharges against the building causing dampness.</p>

<p>Water discharging against building and causing dampness</p>	<p>Improve running gulley, possibly replacing with a French Drain that drains into the main drains.</p>

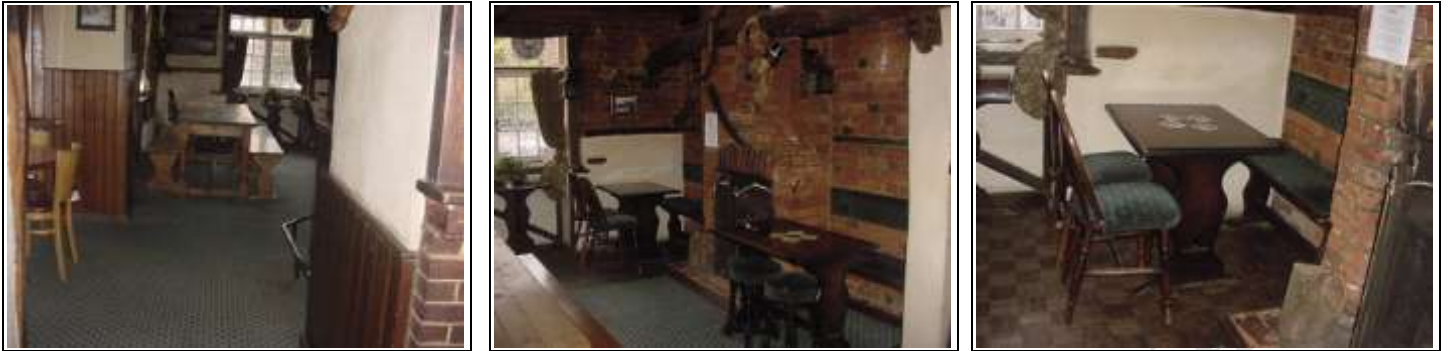
Left hand side of L shaped bar

Dated.	<p>Repair, prepare and redecorate.</p>
<p>Walls:</p> <p>Exposed brickwork Painted render</p>	<p>Dated. Dampness found.</p>	<p>Resolve dampness. Repair, prepare and redecorate.</p>
<p>Floors:</p> <p>Carpet Wood block section to far left hand corner</p>	<p>Worn</p>	<p>Clean and/or replace. Sand and re-stain</p>

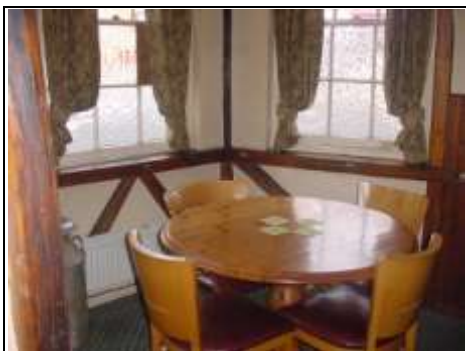
Bay section of bar (central)

Dated.	Repair, prepare and redecorate
Walls: Painted render	Dated. Dampness found.

Rising damp	Repair, prepare and redecorate
Floors: Carpet	Worn	Clean or replace.
Detailing: Windows: Bay window with three sliding wash windows 6 x 6 panes, opaque glass to base Doors:	Dated	Repair, prepare and redecorate

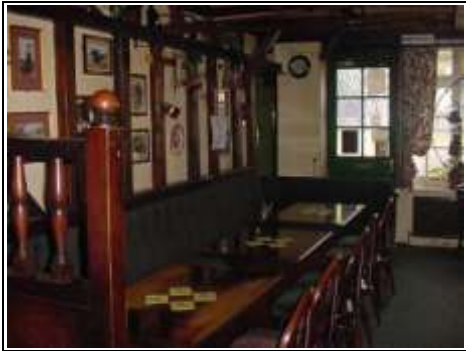
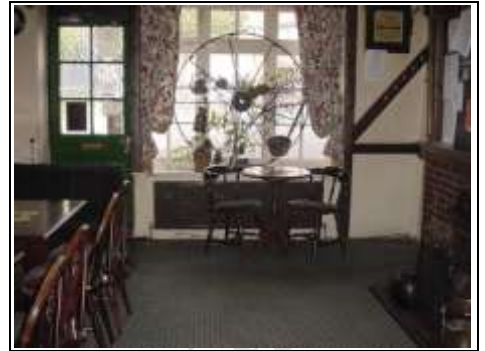
Bar right hand side near toilets

Dated.	Repair, prepare and redecorate
<p>Walls:</p> <p>Painted render</p>	Dated. Dampness found.	Resolve dampness. Repair, prepare and redecorate
<p>Floors:</p> <p>Carpet</p>	Worn	Clean or replace.

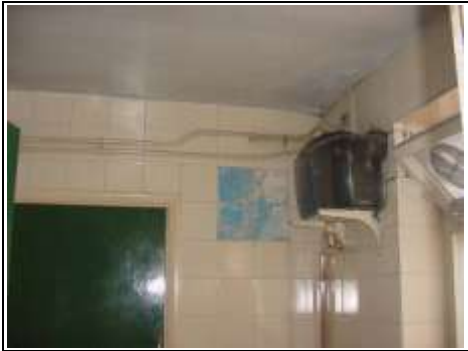
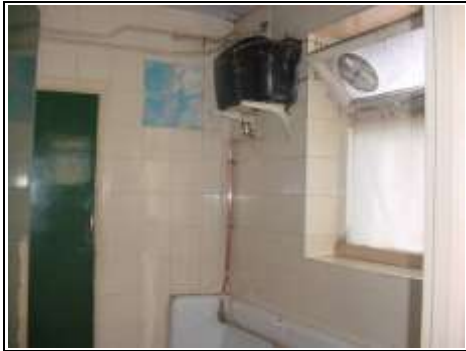
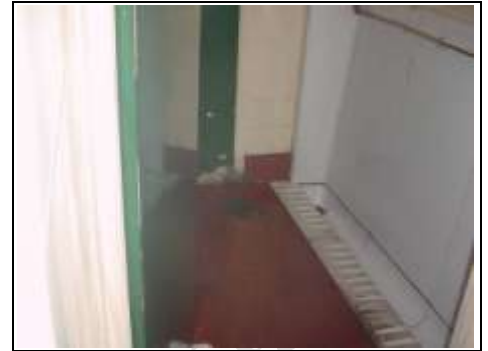
Gentlemen's Toilets

DESCRIPTION	CONDITION	ACTION REQUIRED
<p>Ceiling:</p> <p>Painted</p>	<p>Pattern staining from flat roof above</p>	<p>Repair, prepare and redecorate.</p>
<p>Walls:</p> <p>Floor to ceiling tiles</p>

<p>Dampness found within walls.</p> <p>Tiles missing and blown tiles due to dampness to walls</p>	<p>Resolve dampness.</p> <p>Replace missing tiles, clean and re-grout. General deep clean.</p>
<p>Floors:</p> <p>Red quarry tiles</p>

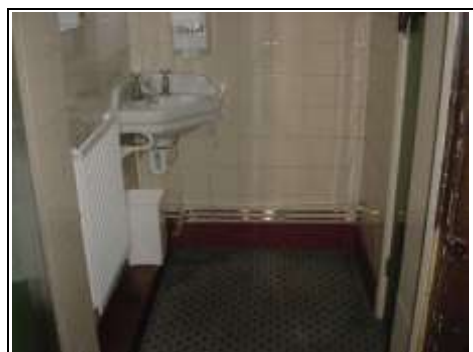
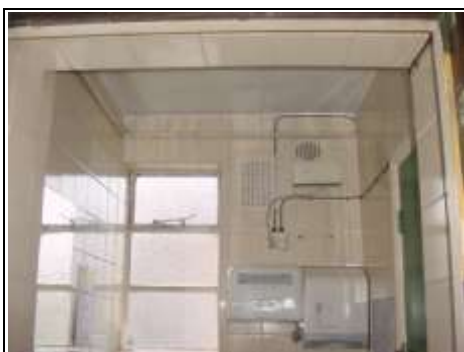
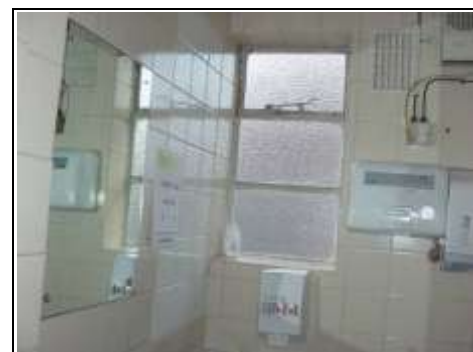
Lobby to ladies' Toilets

Tiles missing due to dampness to walls	Replace tiles. Clean grout.
Floors: Carpet	Worn	Clean or replace
Sanitary Ware: Wash hand basin Hand dryer		Deep clean.
Detailing: Small windows Vent	Dated	Repair, prepare and redecorate.
Services: Dimplex water heater

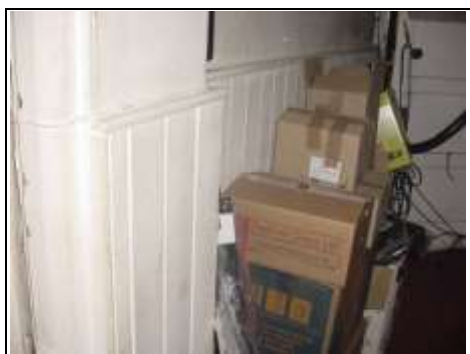
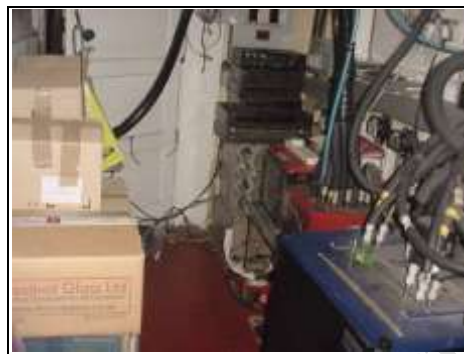
Python room

Flaking paint to ceiling	Resolve any dampness from roof above. Repair, prepare and redecorate
<p>Walls:</p> <p>Painted Close boarding to approx 1.2m</p>	Dated	Repair, prepare and redecorate
<p>Floors:</p> <p>Altro style flooring</p>	Average	Clean and/or replace
<p>Joinery:</p> <p>Doors Painted panel door</p>	Dated.	Repair, prepare and redecorate
<p>Services: See Services section</p> <p>Dated fuse boards.</p>

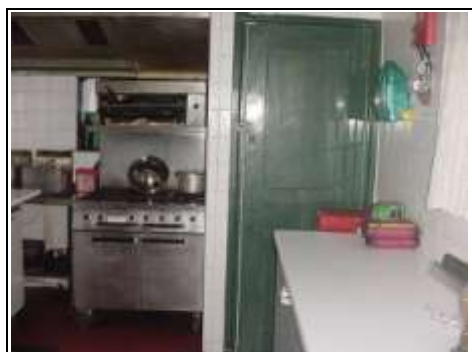
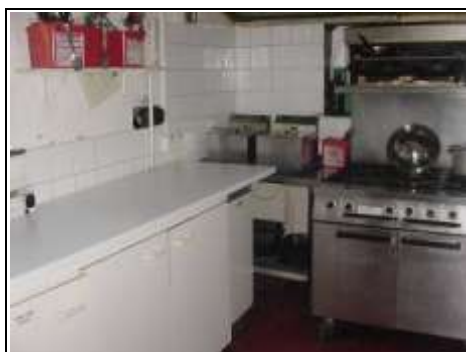
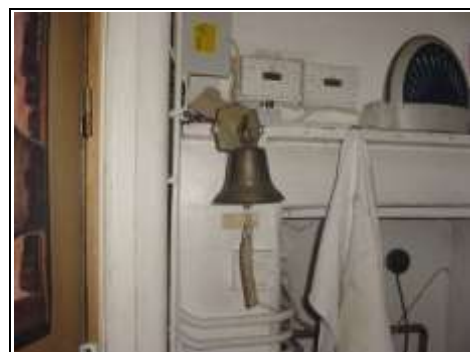
Catering kitchen cooking area

<p>Part of ceiling paintwork coming down</p>	<p>Repair, prepare and redecorate</p>
<p>Walls:</p> <p>Floor to ceiling tiling Painted to left hand wall</p>

<p style="text-align: center;">Ingrained dirt and grease</p>	<p>Signs of movement noted and investigated by landlord.</p>

<p style="text-align: center;">Dampness coming through, generally greased and stained</p>

<p style="text-align: center;">Raking hairline crack to inner door</p>	<p>Resolve damp issues.</p> <p>Deep clean, clean grout and re-grout.</p> <p>Repair, prepare and redecorate.</p>

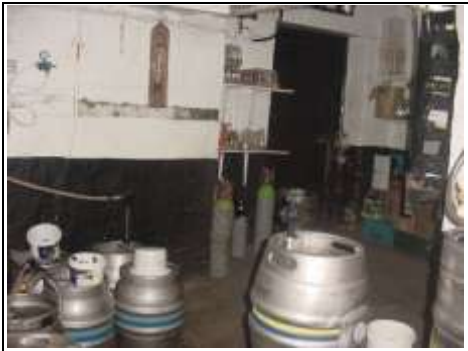
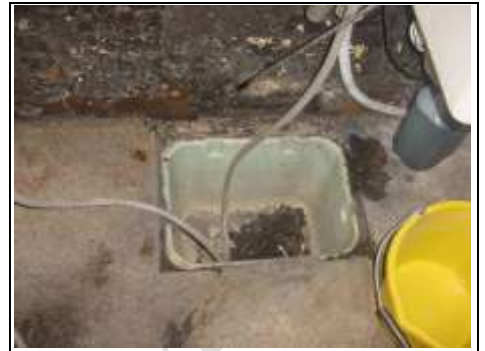
Cellar

Dated, stained, dirty	Repair, prepare and redecorate.
<p>Walls:</p> <p>Painted</p>

Damp	Resolve dampness. Repair, prepare and redecorate.

<p>Floors:</p> <p>Concrete</p>   <p>Damaged floor</p>	  <p>Cracked and undulated Advised there is high water table level which does flood cellar</p>	<p>Level and screed, paint floor</p>
<p>Joinery:</p> <p>Doors</p>	  <p>Painted door to cellar</p>	<p>Repair, prepare and redecorate.</p>
<p>Services: See Services section</p>   <p>Electric fuse board – IEE test and report required.</p>   <p>Sump pump This has not been tested. We are aware from discussions that the property does flood.</p>   <p>Belfast sink</p>

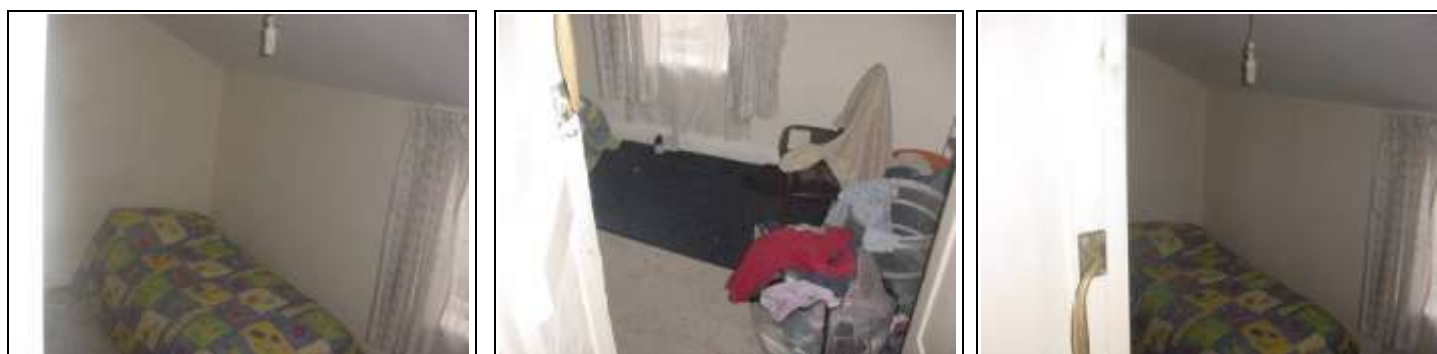
Bedroom rear left

DESCRIPTION	CONDITION	ACTION REQUIRED
Ceilings: Wood chip paper	Paper coming off	Make roof watertight. Repair, prepare and redecorate.
Walls: Painted paper

Damp to chimney	Repair, prepare and redecorate.
Floors: Carpet over carpet	Dated and paint stained	Replace
Detailing: Windows: Sliding sash single glazed 6 x 6 windows Doors: Painted panel entrance door Two painted panel doors to cupboards	Dated. Dated.	Repair, prepare and redecorate. Repair, prepare and redecorate.

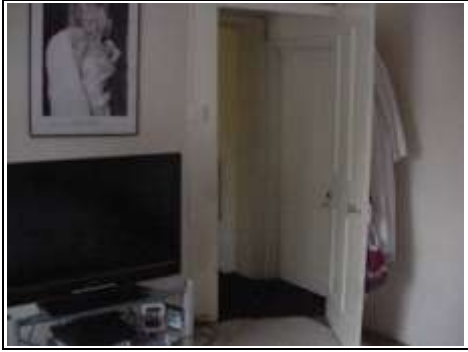
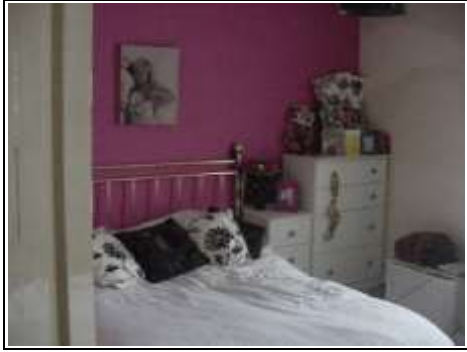
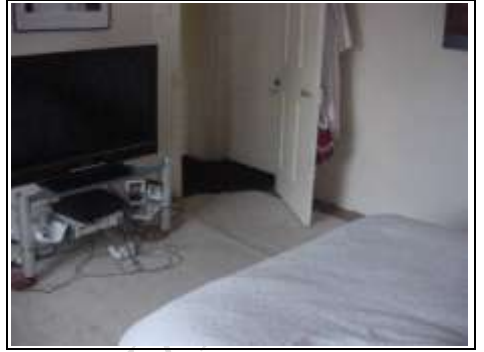
Bedroom rear right hand side (pink)

<p>Dampness visible front right hand corner</p>	<p>Make roof watertight. Resolve dampness, repair, prepare and redecorate.</p>
<p>Walls:</p> <p>Painted</p>	<p>Dampness</p>

<p>Front corners obtaining readings over 100, should typically be 30-60</p>	<p>Resolve dampness. Repair, prepare and redecorate.</p>
<p>Floors:</p> <p>Carpet</p>	<p>Worn</p>	<p>Replace</p>

<p>Signs of mould due to dampness</p>	<p>Repair, prepare and redecorate.</p>
<p>Services:</p> <p>Fireplace</p> <p>Radiator with microbore pipes</p>	<p>Unvented</p>	<p>Add vent if not being used.</p> <p>Clean and redecorate.</p>

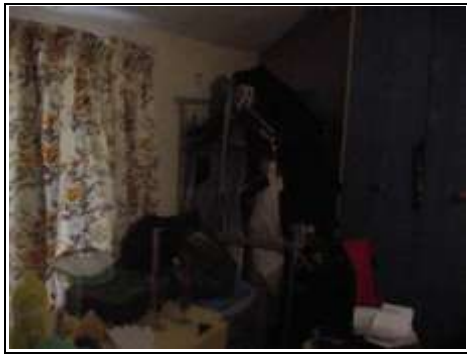
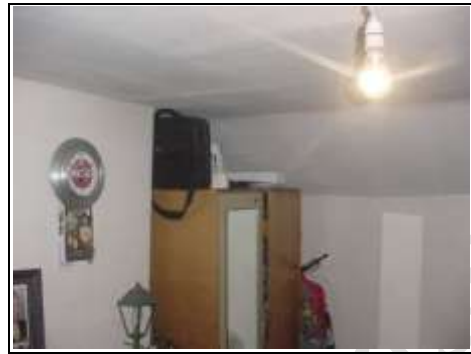
Bedroom rear middle

Ceiling where there will be cold bridging Hairline cracks	Possible cold bridging issues
Walls: Woodchip paper	Dated	Repair, prepare and redecorate.
Floors: Carpet	Worn	Clean or replace.
Detailing: Windows: Doors:	Dated	Repair, prepare and redecorate

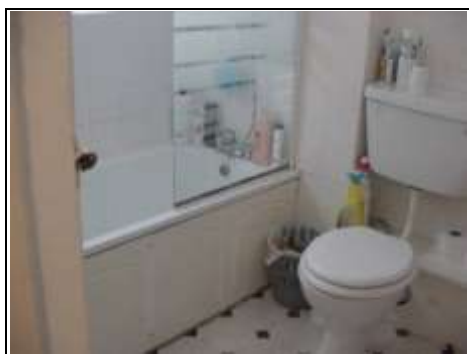
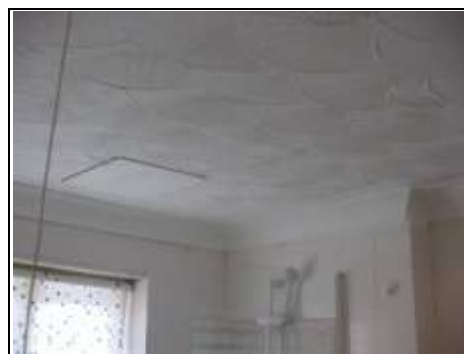
Bathroom rear right hand corner

Repaired hole	Make roof watertight. Repair, prepare and redecorate
Walls: Floor to ceiling tiles painted	Dated	Clean and re-grout.
Floors: Vinyl	Worn	Clean or replace.
Detailing: Windows:	Dated.	Repair, prepare and redecorate.
Doors: Painted timber	Dated.	Repair, prepare and redecorate.
Sanitary Ware: Bath W.C. Wash hand basin	Old style	Deep clean and/or replace.
Services: Vent, no extract fan

No extract	Add humidity controlled extract fan
