SCHEDULE OF CONDITION

Swimming Pool

London

We have been instructed to provide a Schedule of Condition with regard to XXXX Swimming Pool to establish its condition at the time that XXXX took occupation of the premises. We have been briefed on the project and walked around the premises with XXXXXXXX.

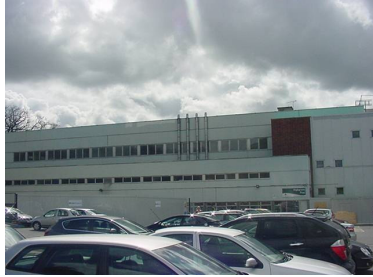
Hairline cracking (plant room area)

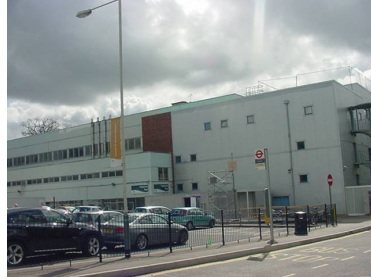
Pattern staining

Pattern staining and signs of old graffiti

Hairline cracking right hand side

Condition would indicate this would benefit from full repair / redecoration or overcladding

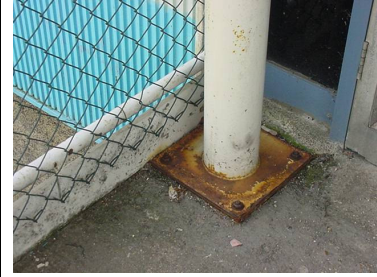
Corrosion to base of entrance canopy

Metal supports to canopy rusting

Repair, prepare and redecorate

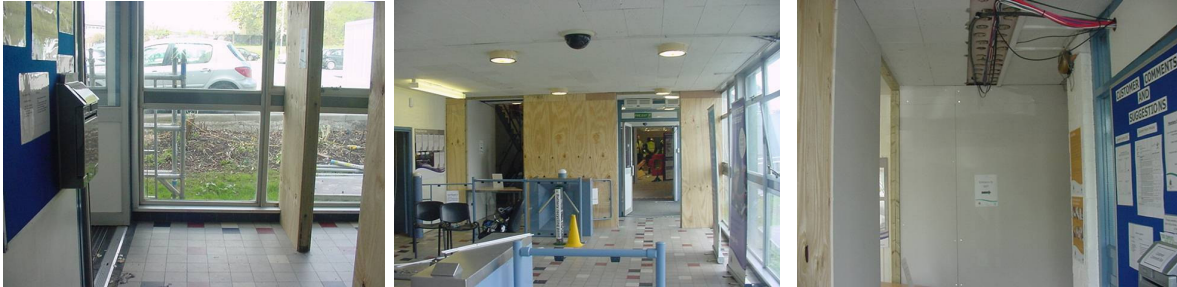
The studwork division partition was being erected at the time of our survey

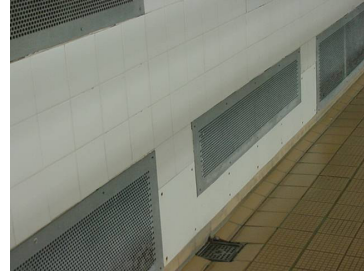
Corrosion to fixing screws around vents

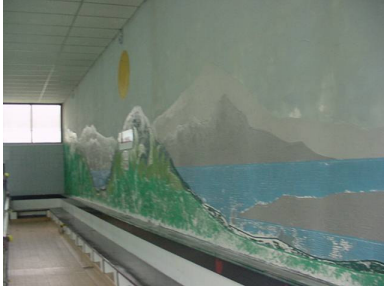
Original tiles showing through in numerous areas.

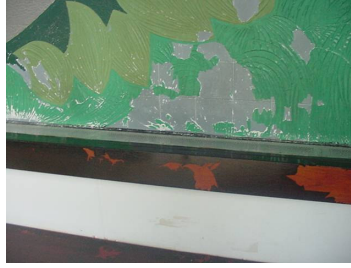
Damage to bench and mural showing tiles beneath

Reinstate mural

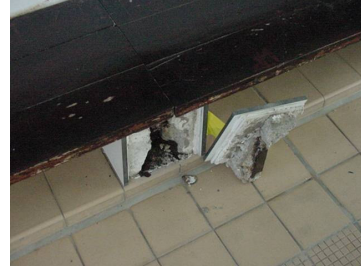
Damage at low level

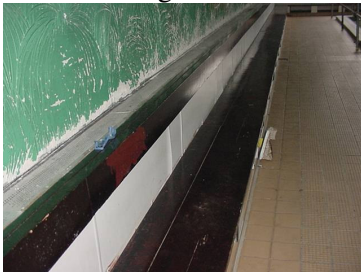
Areas of deterioration to bench seating showing red paint

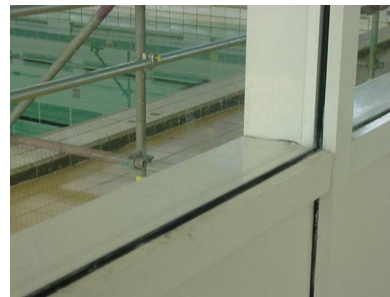
Flaking and deterioration is occurring to the proprietary finish to the transoms and mullions, particularly where they join.

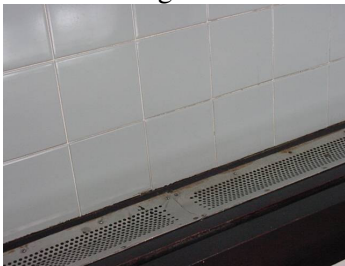
Various areas of deterioration.

Make good.
