SCHEDULE OF CONDITION

Large Commercial Building, Berkshire

The Schedule of Condition offers a detailed description of the condition of the property at the time of our inspection on 16th December 2011.

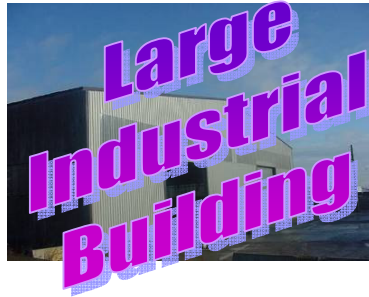
<p>External Detailing:</p> <p>Roller Shutter Doors: (not tested)</p> <p>Two roller shutter access doors: Not tested. One was open at time of our inspection.</p> <p>Left hand roller shutter door: concrete to base</p> <p>Right hand door:</p> <p>Metal clad person door</p>	<p>Protective trim around both roller shutter access doors.</p> <p>Old runners still in place and ponding occurring</p>

<p>Runners and ponding to left hand door</p> <p>Concrete uneven, with a step in front of the roller shutter door.</p>

<p>Step to right hand roller shutter door</p>	<p>Remove original runners and provide a smooth access/ egress</p> <p>Remove step in concrete and provide a smooth access / egress.</p>
---	--	---

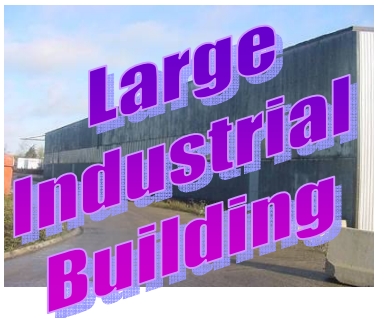
End detail / overhang	The rainwater runs off the end detail / overhand and discharges onto a concrete gutter below. This area is corroding	Inspect/replace/repair in summer of 2012, with anticipated life of two to five years as deterioration is occurring
Walls Structure: Not visible externally

General deterioration to external protective coating and rusting to metal cladding

Impact damage to both upper corrugated section and window approx one third of length.

Clean and re-apply protective coat

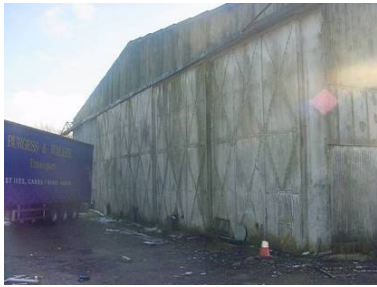
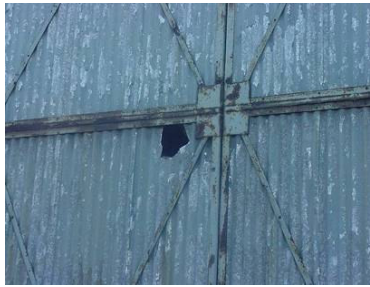
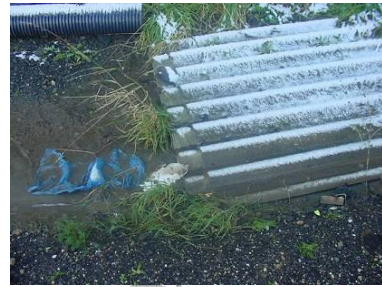
A plinth covers the hanger door runners forming a ledge that we believe deterioration is occurring on, although not visible at ground level

Deterioration can be seen to the front of the plinth (we believe it is also to the top of the plinth) and areas surrounding the hanger doors.

A percentage of the hanger doors and the frame are showing signs of rust and general deterioration. Holes visible in the cladding; the largest to the right hand side.

Repair plinth as deterioration will affect the stability of the hanger doors.

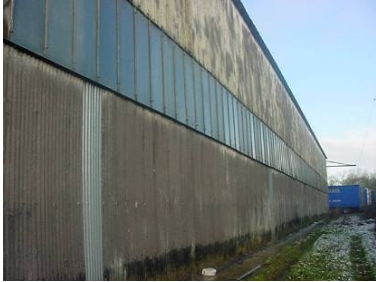
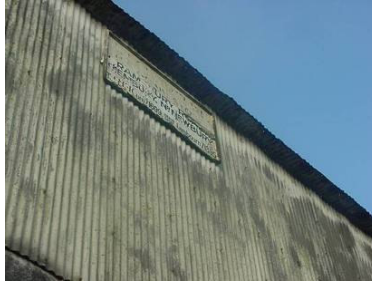
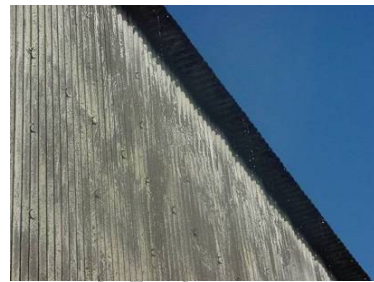
DESCRIPTION	CONDITION	ACTION REQUIRED
Roofs: Not visible		See Roof Schedule
Gutters and Downpipes: No gutters.	<p>The rainwater runs off the end detail / overhand and discharges onto a concrete gutter below.</p> <p>We note protective coating at roof level has come away and rusting is visible</p> <p>This area is heavily corroding</p>

<p>Protective from roof level that has come away</p>

<p>We recommend a close inspection at high level in summer of 2012.</p>

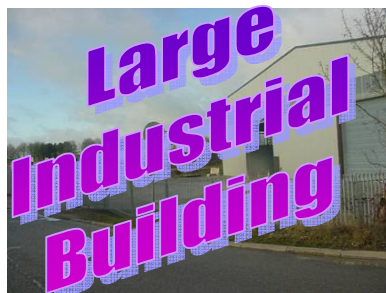
Heavy ponding to left hand side.

Ponding next to landscaped area

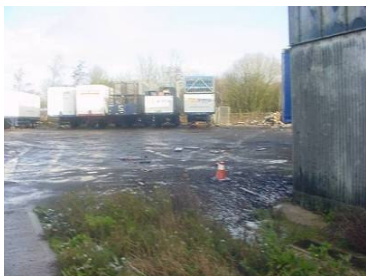
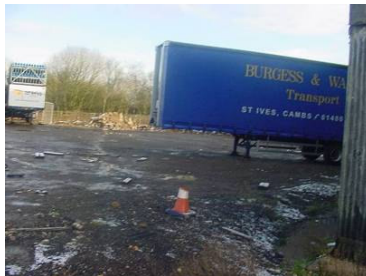
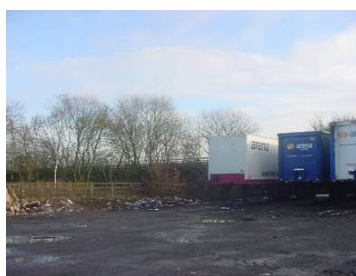
We noted general debris was being left which we assume is associated with those parking and we noted that a drainage run had been laid to the rear of the subject building.

General debris and possible asbestos sheets?

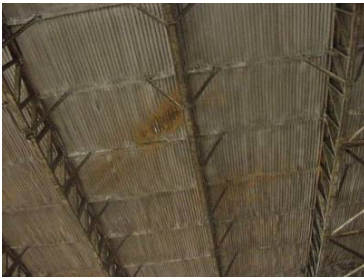
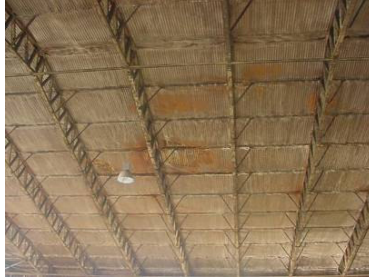
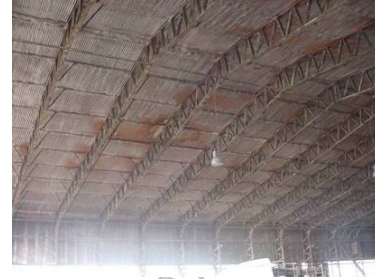
<p>Water leaking in from the roof on to the concrete floor</p> </div>

<p>Wind bracing to roof central section</p> <p>Vermin:</p>	<p>Internal rusting can be seen to the lattice work beams.</p> <p>We refer you to the Guide to WWII Hangers by the MOD that indicates in certain weather conditions these buildings can be problematic.</p> <p>Rear Section has bird netting which was being taken down at the time of our survey indicating there are holes in the roof area. Rats were also noticed during the course of the survey, which we are advised is common in grain storage areas.</p>	<p>Operational procedures need to be put in place with regard to how to operate the property in certain weather conditions.</p>
<p>Services:</p> <p>Four down lighters and eight lights to each of the side walls</p>	<p>No electricity at time of the survey</p>

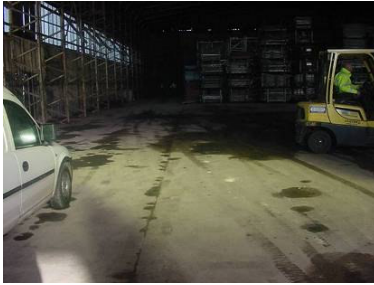
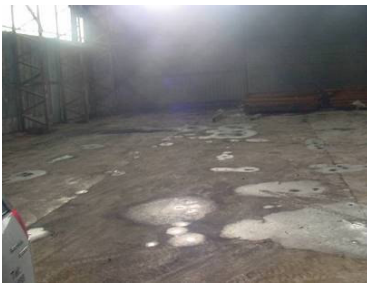
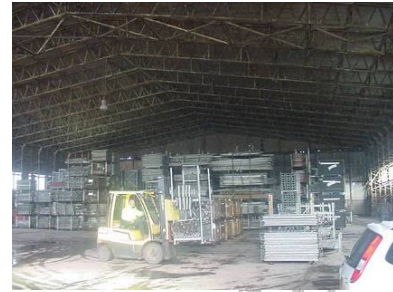
<p>Dampness coming in through roof</p>	
Bay 4	<p>Cracking running approx to the front side of the half way mark</p>

Bay 5	Large cracking; 5mm plus to approx 50mm.	
Bay 6	<p>Spalling on junction of Bay 6 and also within Bay7.</p>

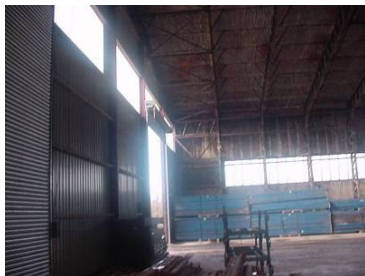
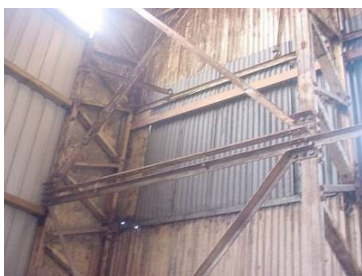
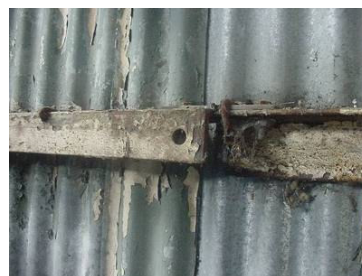
<p>Door</p> <p>Signs of rust noted in majority of cases and in some cases these bolts have been replaced</p>

<p>Wind bracing rear left hand corner – bay 23</p>
<p>All Bays: Bays 1 to 23.</p>	<p>General The majority of bays have concrete fillets All panels have an element of rusting</p>	
Bay 1	Wind bracing	
Bay 2	Percentage of rusting particularly at base	
Bay 3	Rusting rectangular iron	
Bay 4	Percentage of rusting particularly at base	
Bay 5	Percentage of rusting particularly at base	
Bay 6	Percentage of rusting particularly at base	
Bay 7	Rusting rectangular iron	
Bay 8	Percentage of rusting particularly at base

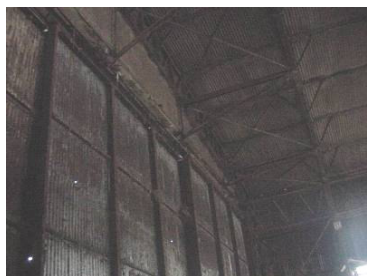
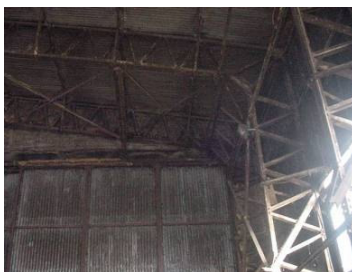
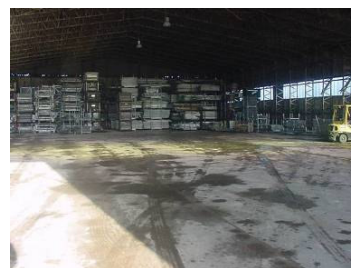
<p>Rusting to metal sheets</p> <p>New metal cladding sections 13 onwards</p>	<p>High level panels may have asbestos content</p>

<p>Fire insulation spray</p> <p>Rusting and impact damage</p>

<p>Impact damage to rear</p>	<p>Full asbestos report to the entirety of the property</p>

<p>Rusting at ground level</p>
<p>All sections:</p> <p>18 full sections and 2 small bays to either end</p>	<p>General</p> <p>The majority of sections have concrete fillets</p> <p>All panels have an element of rusting to the base</p>	
<p>Section 1 Door</p>	<p>Rusting to base Wind bracing</p>	
<p>Section 2</p>	<p>Percentage of rusting particularly at base</p>	
<p>Section 3 Vent</p>	<p>Rusted through and daylight visible</p>
