SCHEDULE OF CONDITION

**Maidstone,
Kent,
ME16 xxx**

GEM Associates Limited

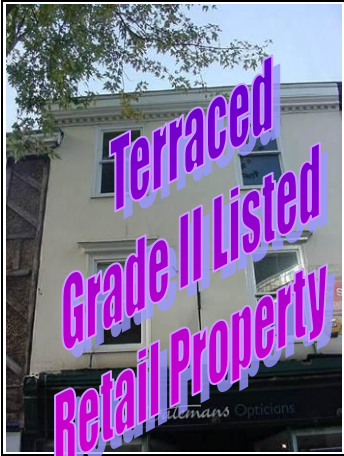
Top of building

| DESCRIPTION | CONDITION | ACTION REQUIRED |
|--|--|---|
| <p>Roofs:</p> <p>We had a very limited view of the roof. Hipped clay tiles hidden from view</p> | <p>Based upon the condition of the timbers seen within the roof dampness is coming in</p> <p style="text-align: center;">Roof hidden from view</p> | <p>Make watertight</p> |
| <p>Parapet wall and box gutter:</p> <p style="text-align: center;">Box gutter</p> | <p>From the dampness within the top rooms the guttering is leaking</p> <p style="text-align: center;">Box gutter behind parapet wall</p> | <p>Make watertight</p> |

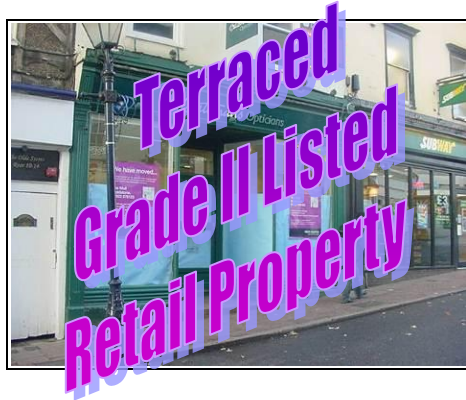
Shop front

| <p>External Detailing:</p> <p>Windows: Timber single glazed sliding sash windows</p> <p>Sliding sash window</p> <p>Shop front and associated signage and canopy:</p> <p>Painted single glazed double shop front with central entrance door</p> <p>Canopy to shop front</p> <p>Canopy</p> <p>Signage</p> | <p>Dated</p> <p>Glass has been pushed out of position.</p> <p>Bare wood visible in areas and damage to the top</p> <p>Damaged canopy</p> <p>Previous owners signage remains</p> | <p>Repair, prepare and redecorate</p> <p>Re-bed glass and make secure. Repair, prepare and redecorate</p> <p>Repair, prepare and redecorate</p> <p>Remove signage</p> |

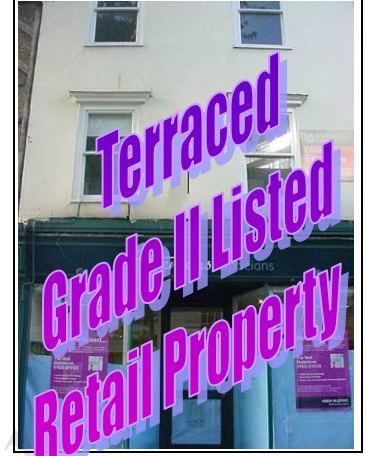
Whole of building

| <p>Walls:</p> <p>Modern cement render</p> <p>Structural frame – timber frame assumed</p> | <p>A cement render can accelerate deterioration to a timber frame (assuming there is a timber frame beneath</p> | <p>Take samples of the render to determine its composition.</p> <p>Should be re-decorated as part of the yield up clause within the lease and due consideration given.</p> <p>Open up to check condition of the structure below the render before taking on lease</p> |

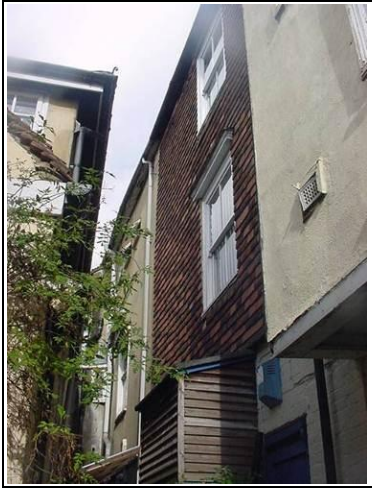
Vertical tiling to top

| <p>Walls:</p> <p>Vertical tiling : high level Painted brickwork : low level</p> <p>Wooden ship lapped boxed area</p> <p>Structural Frame Timber frame assumed</p> | <p>Tiles and painted brickwork</p> <p>Wooden ship lapped boxed area</p> | <p>Repair, prepare and redecorate</p> <p>Repair, prepare and redecorate</p> <p>Open up and check condition prior to legally committing to lease.</p> |

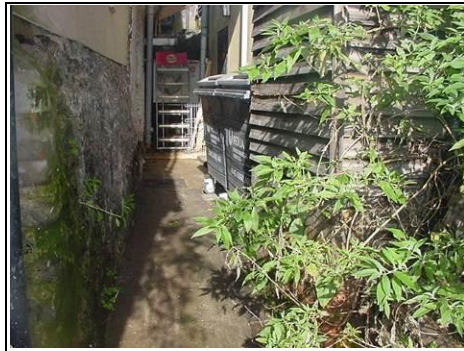
Rear of property

| DESCRIPTION | CONDITION | ACTION REQUIRED |
|---|---|--|
| <p>Gutters and Downpipes:</p> <p>Plastic</p> | <p>Average – re-routing recommended</p> | <p>Ensure all gutters are watertight and falling towards the downpipe. Repair and secure as necessary, ensure downpipes are clear.</p> |

| <p>External Detailing:</p> <p>Windows: Single glazed sliding sash windows</p> <p>Painted timber door</p> | <p>Dated</p> <p>Dated</p> | <p>Repair, prepare and redecorate</p> <p>Repair, prepare and redecorate</p> |

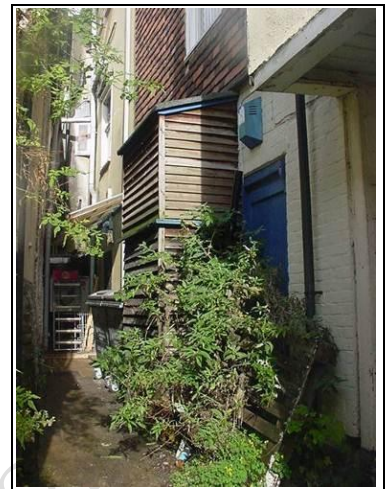
Rear view- shiplap boarding needs re-staining

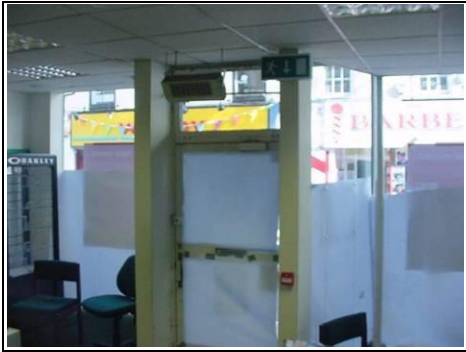
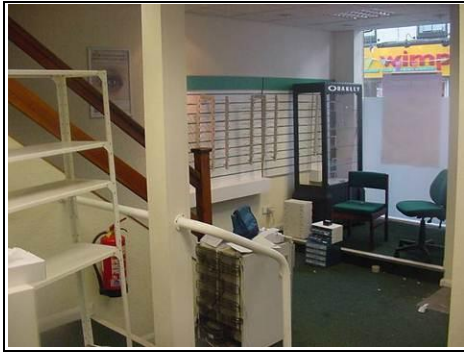
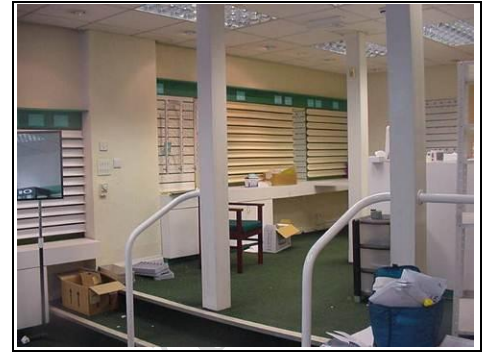
| DESCRIPTION | CONDITION | ACTION REQUIRED |
|---|---|---|
| <p>Ceilings:</p> <p>Suspended ceiling tile with exposed grid</p> <div style="text-align: center;"> <p>Suspended ceiling tiles</p> </div> | <p>Water staining to ceiling tiles</p> <div style="text-align: center;"> <p>Water staining</p> </div> <div style="text-align: center;"> <p>Above ceiling tiles</p> </div> | <p>Replace. Unlikely to be able to find matching tiles therefore allow for replacing the entirety of the suspended ceiling system</p> |

| <p>Walls:</p> <p>Textured wallpaper onto a false wall</p> <p>Dry lining</p> <p>Shop fitted units and floor mounted units</p> <p>Reception counter to far right hand side with access to cellar area behind it</p> | <p>Dry lined</p> <p>Checking for dampness and discovering the walls were dry lined</p> <p>Existing reception counter to rear</p> | <p>Dampness anticipated behind the false walls from the general conditions throughout the property</p> <p>Leaseholders/Landlord to remove existing fixtures and fittings</p> <p>Leaseholders/Landlord to remove existing fixtures and fittings</p> |
| <p>Floors:</p> <p>Carpeted Joist and floorboard beneath</p> <p>Two steps to a high level rear</p> | <p>Deflection to the floor Woodworm and rot to timber beneath noted from within the cellar</p> | <p>Clean / or replace carpet. Support floors</p> |

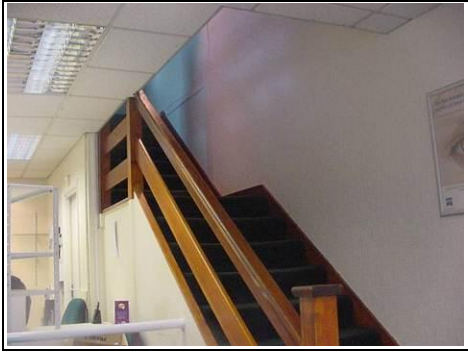
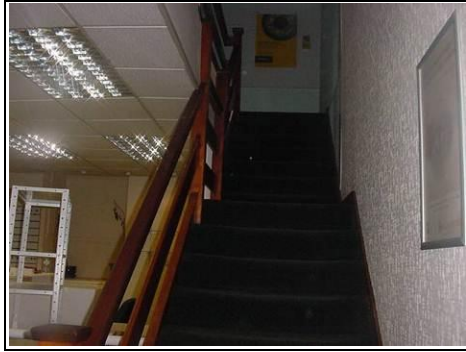
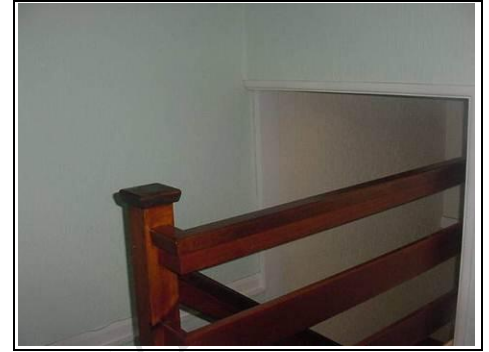
| DESCRIPTION | CONDITION | ACTION REQUIRED |
|--|---|--|
| Ceilings: Painted plaster (which is the underside of the staircase from the first to second floor) | Marked | Repair, prepare and redecorate |
| Walls: Textured wallpaper | Dated | Repair, prepare and redecorate |
| Handrail: Wooden | Dated | Clean handrail and balustrade and re-varnish |
| Floors: Carpet | Used | Clean/ or replace |

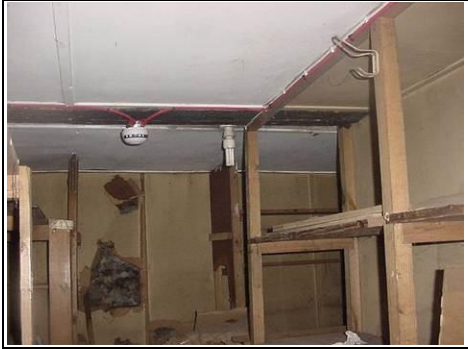
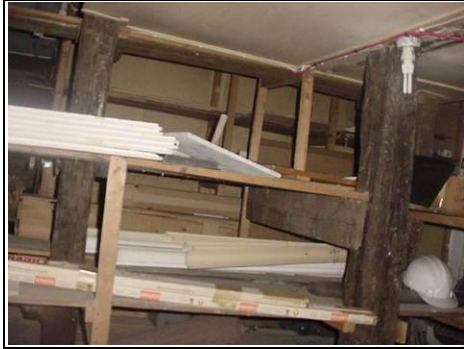
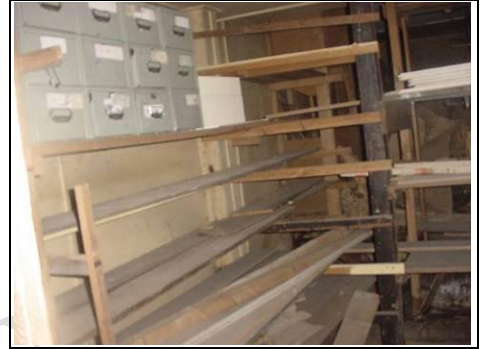
| DESCRIPTION | CONDITION | ACTION REQUIRED |
|---|---|---|
| <p>Ceilings:</p> <p>Boarded with timber trims on the joints</p> <p>Joists are horizontal</p> | <p>Damp deterioration and woodworm</p> <p style="text-align: center;">Woodworm</p> <p style="text-align: center;">Floorboards with joists</p> | <p>Repairs and additional work required for strengthening of floors</p> |

| <p>Walls:</p> <p>Brickwork with a render with lime wash</p> <p>Studwork – one sided- it divides the basement</p> <p>Metal frame to the front of the basement</p> | <p>Signs of woodworm and wet rot</p> <p>Wet rot in timbers</p> <p>Dampness coming through to cellar</p> <p>Metal frame given support to the entrance door area</p> | <p>Repair and replace timbers</p> <p>Landlord to confirm this has Listed Building approval</p> |
| <p>Floors:</p> <p>Concrete and timber</p> <p>One step three quarters of way in Two steps to rear section</p> | <p>Trip hazard</p> <p>Step</p> | <p>Make the floor safe and good</p> |
| <p>Sanitary Ware:</p> <p>Old sink to front left hand side</p> | <p>Damaged</p> | <p>Replace</p> |

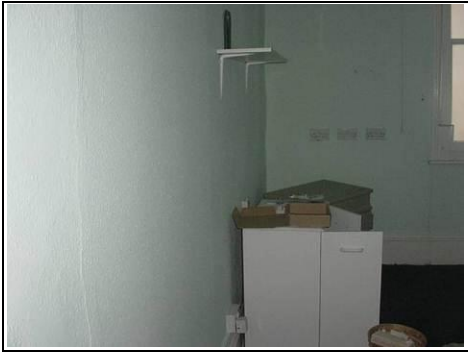
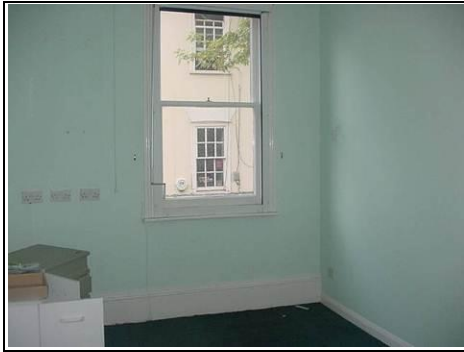
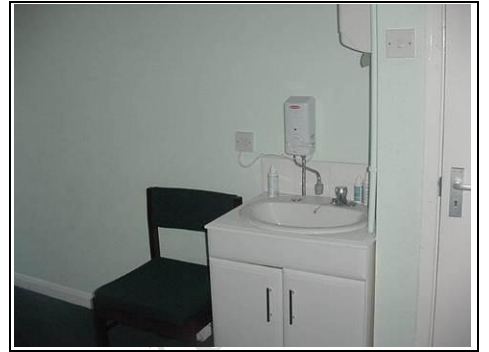
Front right hand office

| DESCRIPTION | CONDITION | ACTION REQUIRED |
|---|---|---|
| Walls: Woodchip paper | Crack to middle of right hand wall Undulation to front right hand corner Old fixing holes | Repair, prepare and redecorate |

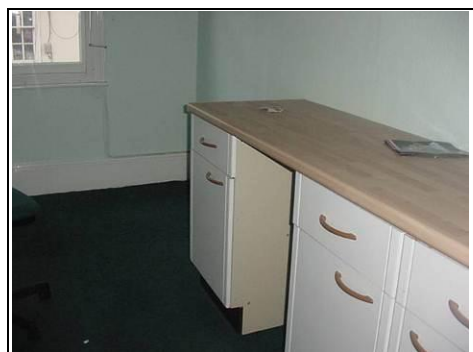
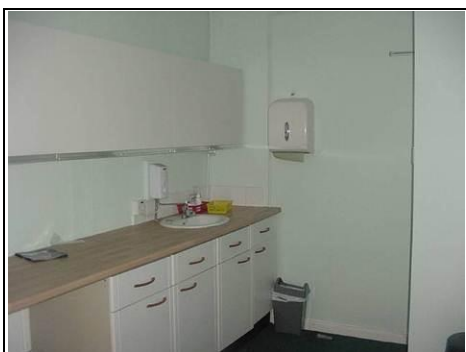
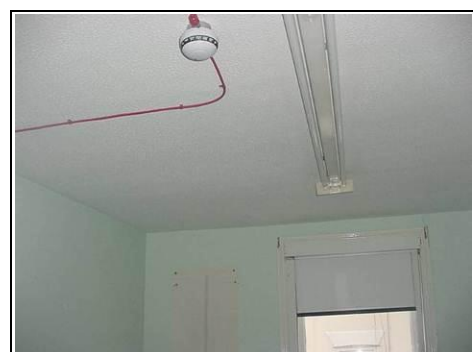
Front left hand office

| DESCRIPTION | CONDITION | ACTION REQUIRED |
|---|--|--|
| Services: Florescent Lights | No diffuser on lights | Provide diffuser and clean |

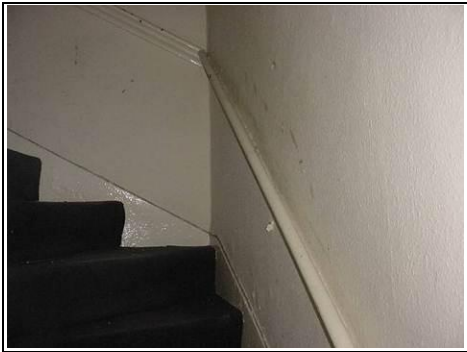
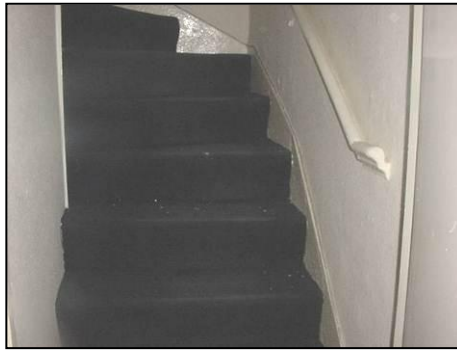
| DESCRIPTION | CONDITION | ACTION REQUIRED |
|--|---|--|
| <p>Ceilings:</p> <p>Painted</p> | <p>Marked with undulations, indicating lath and plaster ceiling</p> <p>Ladder access</p> | <p>Make roof watertight before carrying out work</p> <p>Repair, prepare and redecorate</p> |
| <p>Walls:</p> <p>Woodchip paper</p> | <p>Heavily marked</p> <p>Dampness visible</p> | <p>Repair, prepare and redecorate</p> |

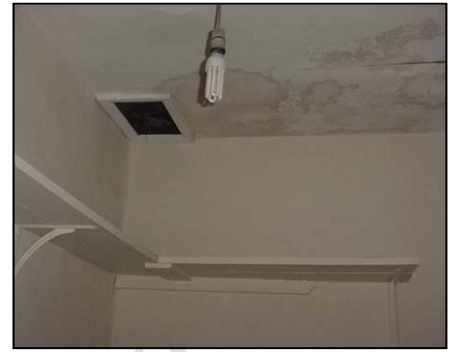
Dampness above staircase area

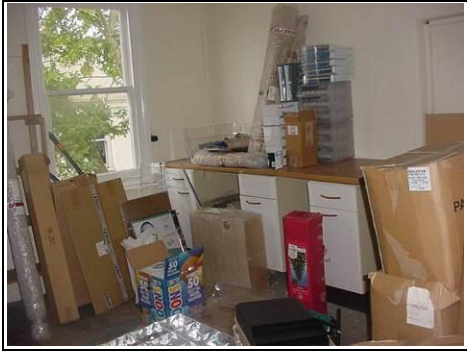
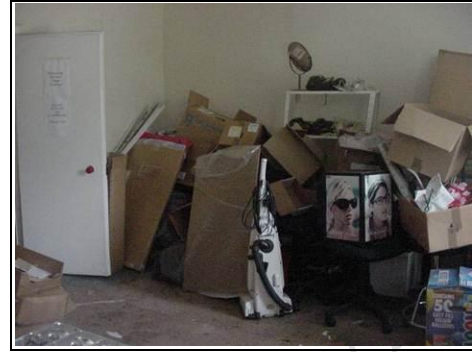
| DESCRIPTION | CONDITION | ACTION REQUIRED |
|---|--|--|
| <p>Ceilings:</p> <p>Painted</p> | <p>Dampness coming in to front of right hand window</p> <p>Dampness next to window</p> | <p>Make roof, parapet wall and box gutter watertight prior to carrying out work</p> <p>Repair ceiling Prepare and redecorate</p> |
| <p>Walls:</p> <p>Painted</p> | <p>Dampness to rear right hand side dividing wall</p> | <p>Repair walls Prepare and redecorate</p> |
| <p>Floors:</p> <p>Floorboard</p> | <p>Deflection This may relate to embedded timbers or woodworm and wet rot</p> | <p>Strengthen floors</p> |

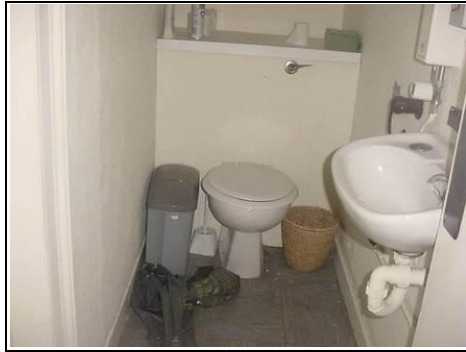
Gent WC

| DESCRIPTION | CONDITION | ACTION REQUIRED |
|--|---|---|
| Floors: Poly vinyl | Marked | Clean /or replace |
| Sanitary Ware: One WC, one wash hand basin | WC encased Dated wash hand basin | Deep clean |

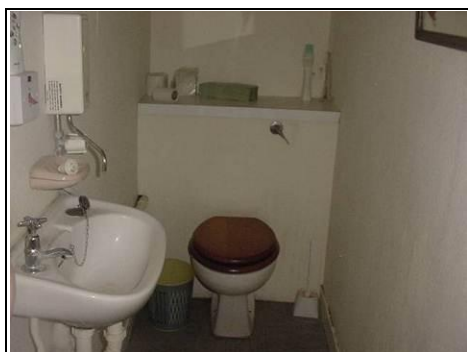
Ladies WC

| DESCRIPTION | CONDITION | ACTION REQUIRED |
|---|--|--|
| Floors: Poly vinyl | Dated and deteriorating | Clean /or replace |

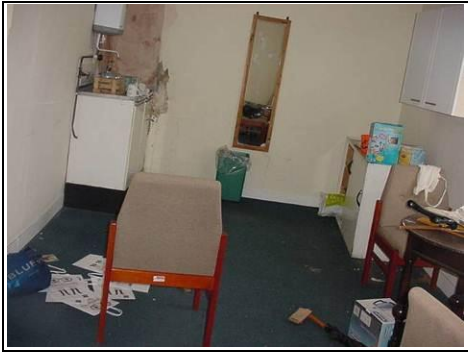
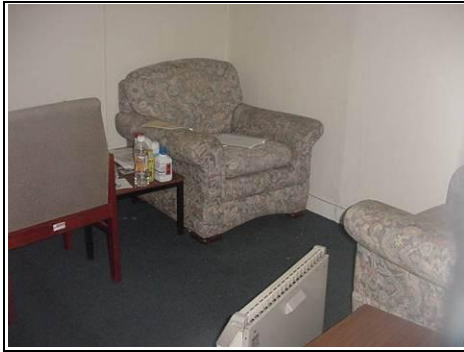
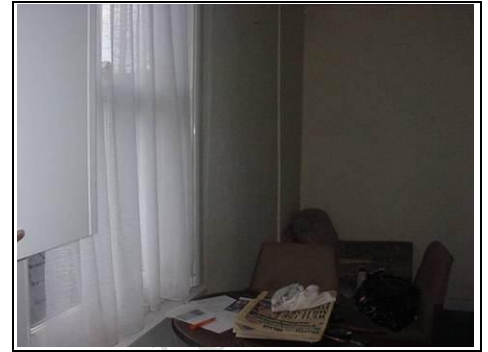
| DESCRIPTION | CONDITION | ACTION REQUIRED |
|---|---|---|
| Walls: Painted | Dampness to left hand side Damp coming through on left hand side from the roof and the wall | Repair, prepare and redecorate |
