# SCHEDULE OF CONDITION

**Internal Only Inspection  
relating to insurance claim  
and reinstatement work  
carried out for  
Mr & Mrs X by  
XXXX  
at**

**XXXX  
Chadderton,  
Oldham,  
Lancashire.  
OL9 XXX**

## **Part of an Independent Report**

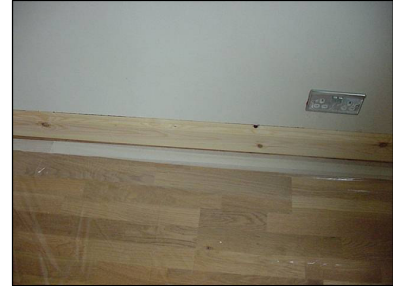
Very thin protective coat that has been applied over the timber flooring, note that the walls still need decorating as do the walls and the skirtings.

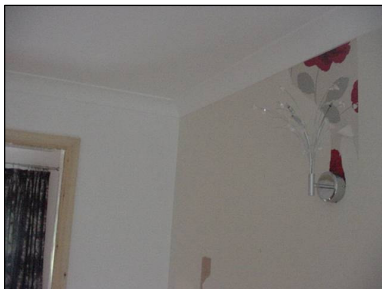
Wall paper removed due to poor standard and paintwork did not match that specified by client

<b>2.0</b>	<p><b>Lounge</b></p> <p>Remove skirting board and install new to match sample provided by Mr &amp; Mrs X.</p> <p>Strip poorly installed wallpaper and install new –same pattern. Allow for attendant loosening of electrical sockets etc.</p> <p>Plastic section conduit for heating pipes to be removed and replaced. New section to be approved by Mr &amp; Mrs X prior to installation and left unpainted.</p> <p>New solid oak threshold detail to be supplied for doorway into the hall.</p> <p>Engineered oak floor to be removed and re-laid on green expanded foam insulation and vapour barrier as per original floor. This will remove the gap beneath the bottom of the architraves and the top of the oak flooring.</p> <p>Note: XXX confirm that they have laid the new floor to manufacturers' specifications/recommendations. If the new method of installation contravenes the manufactures recommendations Mr &amp; Mrs X understand that there can be no future re-call of XXX for issues caused by the prescribed method.</p> <p>Sealant around upvc window to be replaced.</p>

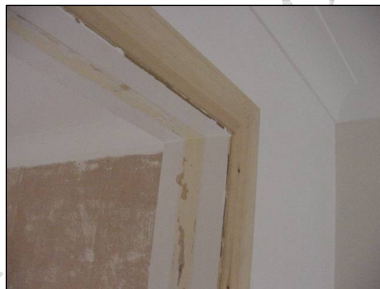
New architrave added as original one did not match

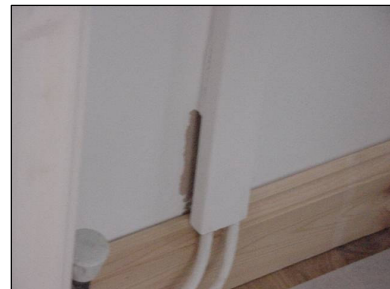
Plastic conduit painted over

<p>Plastic section conduit for heating pipes to be removed and replaced. New section to be approved by Mr &amp; Mrs X prior to installation and left unpainted.</p> <p>The specification with the contractors hand written notes allows for stripping of the textured coating and skimming of the walls. The textured coating has been removed, the contractor considered that the underlying plaster was of sufficient quality for the walls to have lining paper applied and the then decorated. Mr &amp; Mrs X are not happy with this solution and have requested that the walls</p>

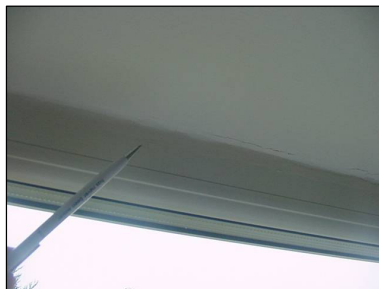
Painted over plastic window

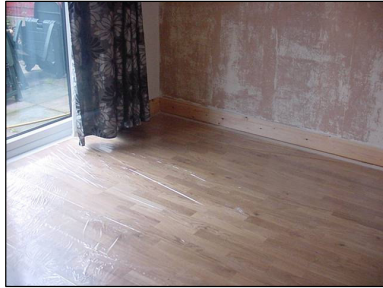
Dining room wall stripped  
of paper

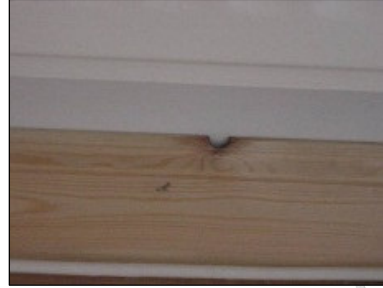
Dining room poor selection  
of skirtings with more than  
average number of knots

<b>3.0</b>	<b>Dining Room</b>
	<p>Remove skirting board and install new to match sample provided by Mr &amp; Mrs X</p> <p>Strip poorly installed wallpaper and install new –same pattern. Allow for attendant loosening of electrical sockets etc.</p> <p>New solid oak threshold detail to be supplied for doorway into the kitchen. It was pointed out that there is a change in level between the dining room floor and the kitchen floor. This will be exaggerated by the installation of the green insulation board beneath the oak flooring. Mr &amp; Mrs X understand this will be the case.</p> <p>Engineered oak floor to be removed and re-laid on green expanded foam insulation and vapour barrier as per original floor. This will remove the gap beneath the bottom of the architraves and the top of the oak flooring.</p> <p>Fine crack in paint work where the in fill panel to side of the opening between the arch and kitchen door is to be filled during decoration works.</p>

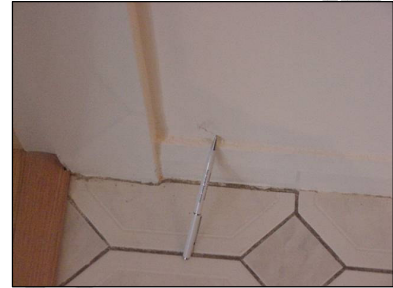
Re-plastering to Kitchen

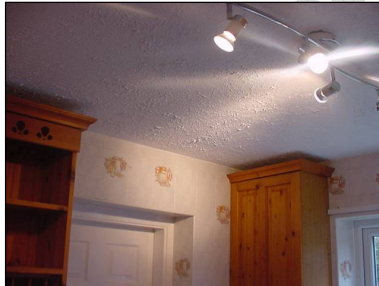
Kitchen ceiling

DESCRIPTION	CONDITION	ACTION REQUIRED
<b>Ceilings:</b> Artex style to the ceiling which has been repaired and redecorated.	Concern that the ceiling has been water damaged and Artex needs to be removed and ceiling checked and then removed or prepared and redecorated.	XXXX to advise how they have checked whether there is damage and deterioration to the ceilings.
<b>Walls:</b> Some re-plastering has taken place. Mr & Mrs X concerned that a timber batten had been left in the wall and the work was generally not up to standard. We feel the question is - was the wall satisfactorily dried out before work commenced?

<b>4.0</b>	<b>Kitchen &amp; Pantry</b>
	<p>The kitchen ceiling is to be re-skimmed, with wall units taken down and re-fixed as required for access. Allow for light fittings to be dropped and refitted.</p> <p>Skirting boards to be removed and replaced.</p> <p>Door to hall to be eased and adjusted, repainted as required.</p> <p>Infill panel to underside of stair cupboard (where crack exists) to be removed and replaced. Underside of stairs to be inspected and photographs taken to show condition. Walls and ceilings to be painted. Confirm colour details etc with Mr &amp; Mrs X. Temporary removal and safe packing of content items required.</p> <p>Wall between kitchen and lounge. This area was originally covered in vinyl wallpaper. This has been reinstated with lining paper and painted. This shows the integral blemishes on the underlying plaster. Two options were discussed and a final decision is required from Mr &amp; Mrs X</p> <p>Opt 1. The lining paper can be removed and the underlying plaster re-painted. This is likely to leave the integral blemishes visible.</p> <p>Opt 2. Mr &amp; Mrs X choose replacement vinyl wallpaper and it is installed by XXX It is accepted that the integral blemishes may show through depending on the wallpaper chosen.</p> <p>Mrs X pointed out that it appears the infill panels on the timber doors are wrapping. XXX inspected the kitchen units and plinths, worktops and doors. It was found that there is no evidence of water damage to the base units (melamine covered chipboard) or the work tops. The plinths (kickboards) have been sat in</p>

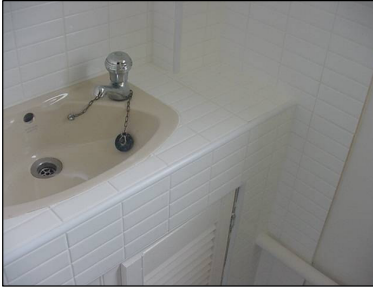
New tiles around the basin

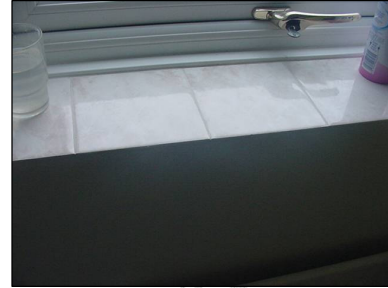
Original tiles remain on the  
window sill

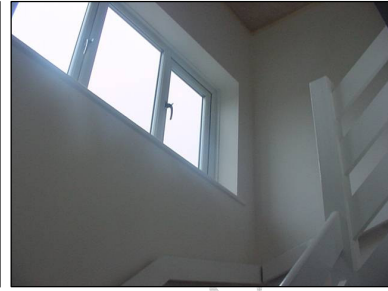
Stair walls lining paper used rather than a skim coat of plaster

<p>be skimmed and re-painted.</p> <p>XXXX of XXXX expressed some concern about the ability to obtain a good bond between the new plaster skim and the original plaster finish. We ask that once in receipt of this report they issue any concerns and possible alternative solutions formally for consideration by Mr &amp; Mrs X</p> <p>On the landing there is a plywood access panel within the flooring, this is loose and appears to have warped. XXXX are to inspect and re-secure or replace this board as required. This runs through into the front and rear bedrooms and is to receive the same treatment in those rooms.</p> <p>Post Meeting note: We understand that on removal of the board some deflection of the joists was noted. It was also noted that there are no lateral bracing pieces present between the joists (noggings), XXXX have agreed to install some.</p>
<b>8.0</b>	<b>Bedroom 1</b>
	<p>Fitted wardrobes to be installed</p> <p>Electrics, junction box etc to be fixed when wardrobes fitted</p> <p>Plaster patch repair required adjacent to the frame of the retained fitted wardrobe. Also on the window opening the top reveal appears to be slightly damp, XXX has asked a small area of plaster to be removed to inspect the edge beading and establish if there is water/moisture present prior to patch repair. Angle beading to be inspected to ensure no rust evident if moisture present.</p> <p>Laminate and insulation flooring to be installed.</p>

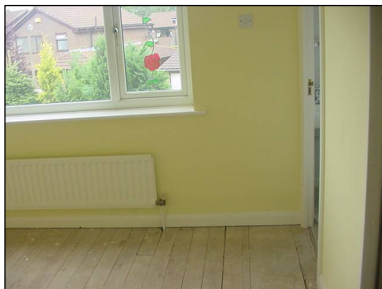
Bare floor boards

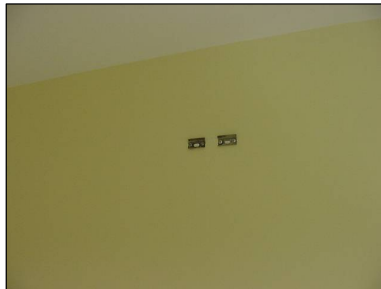
Fixings left

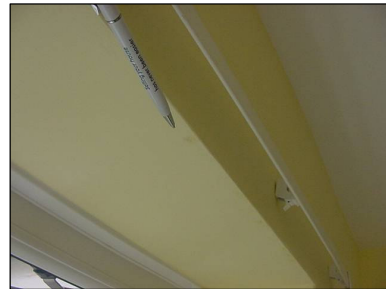
Blemishes around window area which may be due to a rusting internal corner bead

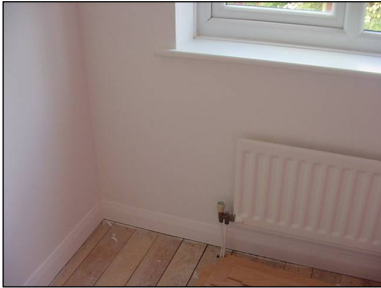
Boards laid in the incorrect  
direction

<b>11.0</b>	<b>Bedroom 3</b>
	<p>Edge trim to laminate flooring to be removed.</p> <p>Laminate flooring to be lifted and re-laid on insulation board to Mr &amp; Mrs X specification.</p> <p>New Edge trims to be installed using pin nails to secure. Glued option rejected.</p> <p>Inspection and remedial works to access board as detailed in item 7.0 above.</p>
<b>12.0</b>	<b>Bedroom 4</b>
	<p>Edge trim to laminate flooring to be removed.</p> <p>Laminate flooring to be lifted and re-laid on insulation board to Mr &amp; Mrs X specification. Damaged piece of flooring to be replaced.</p> <p>New Edge trims to be installed using pin nails to secure. Glued option rejected</p>
<b>13.0</b>	<b>Bathroom</b>
	<p>The tiling to the wall behind the bath has not been properly centred with equal “cuts” at each end as per good building practice. This has provided an untidy appearance in the corner with the external wall, with a cut piece approx 10mm wide. Also towel hoop installed in the wrong location. XXX to propose a solution to Mr &amp; Mrs X for approval.</p> <p>Tile trim to bath panel not the same as that around the window reveal. To be replaced.</p> <p>Concern was raised about the fully tiled bath panel and future access requirements. Option of having replaced with plastic panel or retaining existing is to be considered by Mr &amp; Mrs X and confirmation awaited.</p> <p>The ceiling in the corner above the W.C is out of level. Section to be dubbed out and skimmed with area feathered in to match, or the whole ceiling re-skimmed to provide flat smooth finish.</p> <p>Window reveals do not appear to have been squared off for tiling. Remove tiles and re-do square.</p> <p>Mrs X noted that the grouted joints were of irregular thickness. XXXX considered the variation to be within normal standards. Some joints widened slightly to avoid the need for cut border/feature tiles, especially on the w.c wall.</p> <p>Laminate flooring to be retained with existing underlay. However white edge trim to be removed and replaced. Replacement fixing detail to be agreed with Mr &amp; Mrs X prior to works being installed.</p>

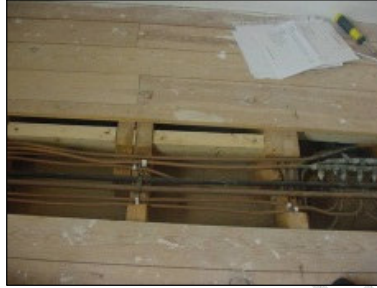
Service duct noggins

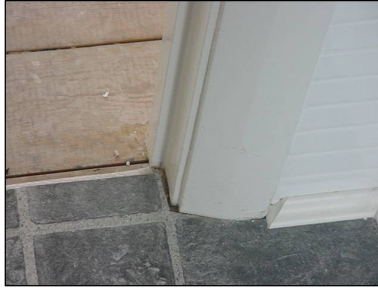
Aqua flooring has not been sealed properly.

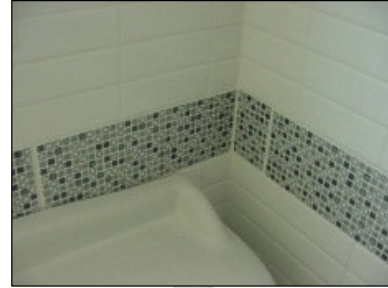
Tiles not laid out properly

<p><b>Walls:</b> Tiled</p> <p>Wall between the bathroom and the master bedroom</p>	<p>Cuts in tiles have not been laid out properly and have been tiled to a DIY standard with tiles provided by Mr &amp; Mrs X</p> <p>Identified as having mould present.</p>	<p>Advised that the walls have been skimmed.</p> <p>Confirmation required of by XXXX</p> <p>Confirmation required by XXXX that the mould has been removed and redecoration needs to take place. We have been advised that the original studwork has been left in place and it has been clad with plasterboard. This needs to be confirmed by XXX project manager.</p>
<p><b>Floors:</b> Aquaseal floor</p>	<p>Now been re-laid with correct underlay.</p> <p>Quadrant beading between wall and bath need to be secured and watertight.</p>	<p>Confirmation that this area has dried out suitably and no future problems.</p> <p>Confirmation required from XXXX</p> <p>Quadrant beading needs to be added and mastic to seal to make the floor watertight.</p>
