SCHEDULE OF CONDITION

XXX Kingston Upon Thames
Surrey. XXX

Converted late Georgian
early Victorian property

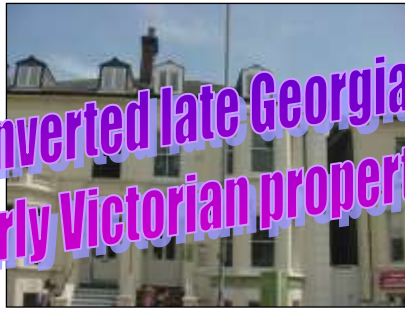
Front elevation

<p>Leaning slightly</p> <p>Average to below average</p>	<p>Exclude from lease.</p> <p>Exclude from lease or make watertight</p>
<p>Roofs: Pitched slate</p> <p>Dormer windows: Two with manmade slates to the side, roof not visible</p>

<p>Looks to have lead tingles</p>	<p>Lead tingles indicate that there is deterioration to the nail fixings. Exclude from lease.</p>
<p>Gutters and Downpipes: Plastic and cast iron</p> <p>Soil and vent pipes: Open gully detail</p>

<p>Walls: Rendered</p> <p>Splayed bay three storeys high:- lower ground, upper ground and first floor</p>	<p>Around the bay there is no drainage which is leading to dampness getting into the property. Photo looking down into the gap against the bay window with no visible means of drainage and extensive plant growth in the area</p>

<p>Amend this detail</p>
<p>External Joinery: Fascias and soffits, signs and lights: Fascias and soffits</p> <p>Signage:</p> <p>Windows: Sliding sash windows and Modern central casement window</p> <p>Entrance door: Large Georgian with two glass panels</p>	<p>Flaking paintwork</p> <p>Normally required to be removed</p> <p>Some flaking paint</p> <p>Heavily marked</p>	<p>Repair, prepare and redecorate. Remove</p> <p>Repair, prepare and redecorate. Repair, prepare and redecorate.</p>

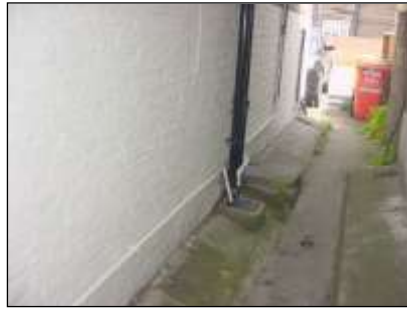
Right hand side elevation

DESCRIPTION	CONDITION	ACTION REQUIRED
Roofs: Shallow pitched slate	See front elevation	
Gutters and Downpipes: Mixture of plastic and cast iron downpipe (uncertain as limited view from ground level)	Some joints leaking

Below ground level section of the floor protected by stonework at an angle	Incorrectly re-pointed in cement mortar

Ensure all gutters are watertight and falling towards the downpipe. Repair and secure as necessary, ensure downpipes are clear.
Walls: Flemish bond (assumed) brickwork re-pointed in a cement mortar painted to the bottom 1.5m Four air cooler units fixed with angle irons

Assume leaking	Re-point in a lime mortar. Repair, prepare and redecorate.
Fascias and Soffits: Timber	Flaking paint	Repair, prepare and redecorate.

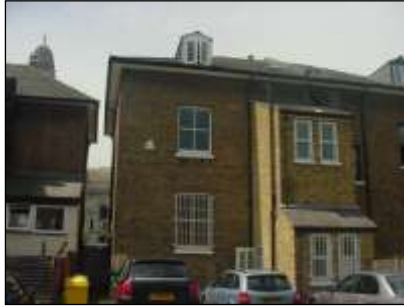
Rear elevation

<p>Gutters and Downpipes: Cast iron and plastic</p> <p>Soil and Vent pipes: Plastic</p>	<p>Leak visible at junction of gutter to downpipe with no obvious way of clearing</p> <p>Plants at the base indicating leaking</p>

<p>Ensure all gutters are watertight and falling towards the downpipe. Repair and secure as necessary, ensure downpipes are clear.</p>
<p>Walls: Flemish bond (assumed) brickwork repointed in a cement mortar</p>	<p>Dampness where walls are below ground level. Vegetation to void area</p>

<p>Comments:</p> <p>Plants at the base of the property indicate water is not draining away</p>

<p>See comments on front elevation.</p>
<p>Fascias and Soffits: Timber</p> <p>Windows: Traditional and modern sliding sash windows single glazed, security bars to all windows and rear door</p> <p>Lower ground floor windows: Rear left hand window:</p> <p>Rear right hand window:</p>	<p>Flaking paint</p> <p>Average</p> <p>Cracking visible approximately 1m vertical raking</p> <p>Raking, cracking above the left hand corner of the soldier course which goes up to the centre of the upper ground floor window</p>

<p>Repair, prepare and redecorate.</p> <p>Ease and adjust. Repair, prepare and redecorate.</p>

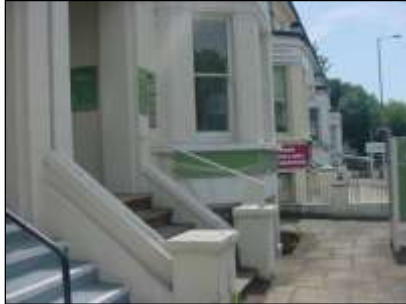
Front entrance

<p>In need of redecoration</p>

<p>Visible signs of dampness Marked</p>

<p>General ingrained dirt to rustic stone</p>	<p>Repair, prepare and redecorate.</p> <p>Clean</p>

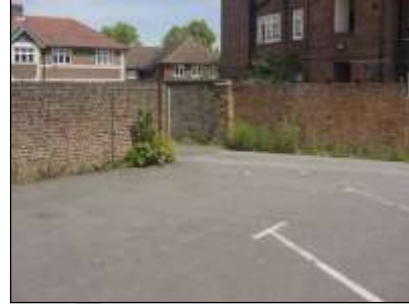
Car Park

<p>Shared entrance</p>	<p>Cracking to side car park wall Top surface starting to wear</p>	<p>Make good and re-build if necessary.</p> <p>Your legal advisor needs to check and confirm with regard as to who has responsibility on this</p>
--	--	---

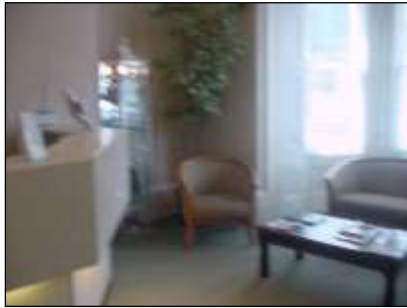
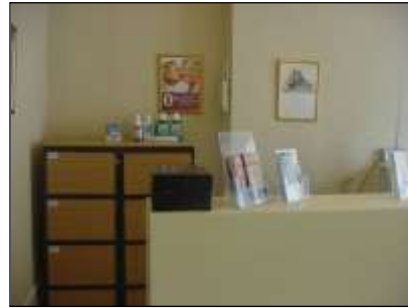
DESCRIPTION	CONDITION	ACTION REQUIRED
Ceilings: Embossed wallpaper Decorative cornicing	Average	Repair, prepare and redecorate.
Walls: Wallpaper Large skirtings	Average	Repair, prepare and redecorate.
Floors: Carpet	Marked	Clean
Joinery: Windows: Timber splayed bay with large, original, timber sliding sash window with cords Doors: Access into Reception room, Surgery One, toilets and downstairs floor Modern Three quarter reception desk against the chimney on right hand side	Paint deteriorating	Ease and adjust. Repair, prepare and redecorate.

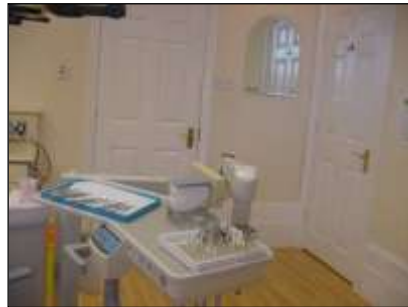
Surgery One

DESCRIPTION	CONDITION	ACTION REQUIRED
Ceilings: Embossed wallpaper	Average	Repair, prepare and redecorate.
Walls: Painted	Average	Repair, prepare and redecorate.
Floors: Vinyl	Average	Clean
Joinery: Windows: Sliding sash	Paint deteriorating	Ease and adjust. Repair, prepare and redecorate.
Services: See Services section

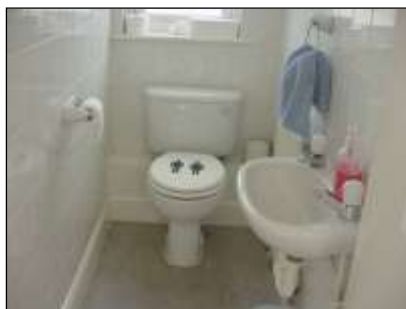
Clients' Toilets One

DESCRIPTION	CONDITION	ACTION REQUIRED
Ceilings: Painted	Stained indicating water leak.

Note on the door referring to regular drainage blockages. Your legal advisor to specifically request further information from the landlord.

Speak to the upstairs neighbours via the landlord.
Walls: Floor to ceiling tiles	Average	Clean
Floors: Vinyl		Clean
Sanitary Ware: WC and wash hand basin	Stained	Clean
Joinery: Window: Double glazed sprayed window with trickle vent and security bar system Door: Pressed panelled	Marked	Redecorate/clean

No extract fan system present – add extract system

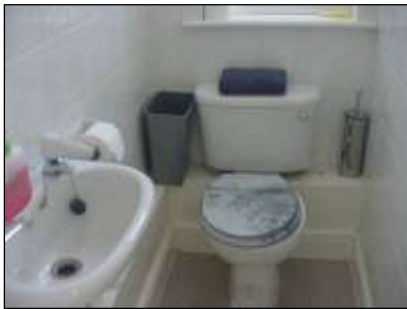
DESCRIPTION	CONDITION	ACTION REQUIRED
Ceilings: Painted Extract fan	Average	Repair, prepare and redecorate.
Walls: Floor to ceiling tiles	Average	Clean
Floors: Vinyl	Marked	Clean/replace
Sanitary Ware: WC, wash hand basin and shower		Clean
Joinery: Window: Sliding sash windows with security bar system Door: Pressed panelled	Marked	Ease and adjust. Repair, prepare and redecorate. Clean/redecorate
Services: See Services section Extract fan - clean		
Comments:

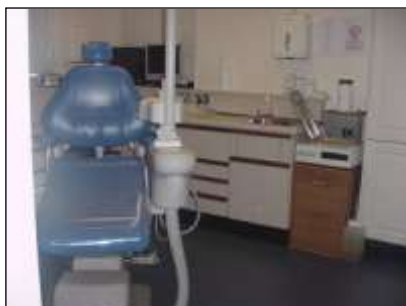
Surgery Two

DESCRIPTION	CONDITION	ACTION REQUIRED
Ceilings: Embossed wallpaper Drop beam	Average	
Walls: Painted plaster Not very accessible with exception of the left hand corner, cabinets built in	Some marks for example to the left hand side and around the desk area. Hairline cracking Damp to rear wall	Repair, prepare and redecorate. There needs to be way of ensuring that water runs away from the property as it currently sits against it. Exclude from lease.
Floors: Non slip vinyl floor	Assumed suspended timber floor, damp beneath	Clean ideally the floors need to be opened up to check the construction beneath.

<p>Joinery: Windows: Two timber single glazed sliding sash Doors: Pressed panel Fire Exit with Perco door closure</p>	<p>Average paint deteriorating</p>	<p>Ease and adjust. Repair, prepare and redecorate. Check to current Fire Regulations</p>
<p>Services: Internal Radiator Qualitar Air conditioning unit</p>		
<p>Comments: The dental equipment has not been inspected, as we are not expert in this area, you should seek expert advice. We have assumed that the dental equipment meets Local Authority approval and is appropriate for use.</p>

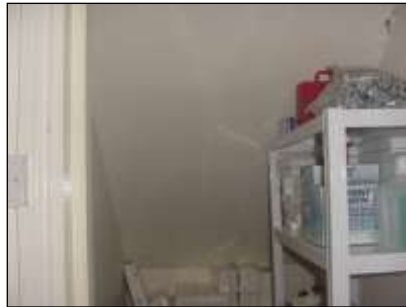
Storage cupboard

DESCRIPTION	CONDITION	ACTION REQUIRED
Ceilings: Embossed wallpaper	Average	Repair, prepare and redecorate.
Walls: Painted plaster	Crack <div style="display: inline-block; vertical-align: middle; margin-left: 10px;">

</div>	Repair, prepare and redecorate.
Floors: Concrete		
Joinery: Door: Press panelled		Repair, prepare and redecorate.

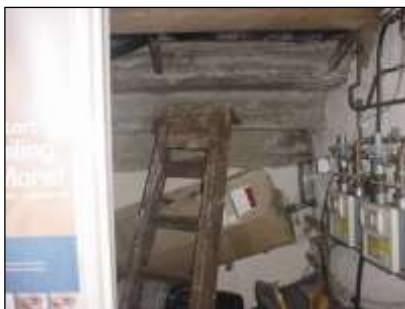
Storage cupboard off the X-ray room

DESCRIPTION	CONDITION	ACTION REQUIRED
Ceilings: Painted	Dampness is getting in	Repair, prepare and redecorate.
Walls: Brick	Dampness is getting in	Repair, prepare and redecorate.
Floors: Concrete which steps up from the X-ray room	Dampness is getting in	
Joinery: Door: Press panelled		Repair, prepare and redecorate.
Stairs: Lined	Not waterproofed	
Services: See Services section Ferroli wall mounted boiler and vented to external air Extract Vent

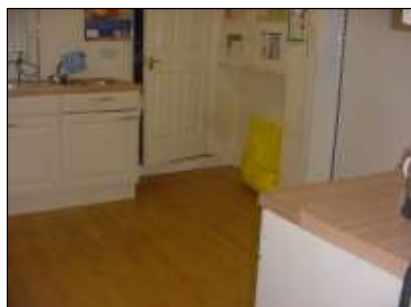
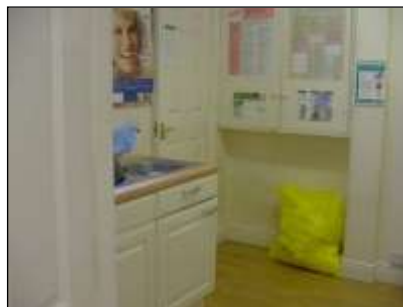
DESCRIPTION	CONDITION	ACTION REQUIRED
Ceilings: Embossed wallpaper	Average	
Walls: Painted plasterboard Failed tanking left hand wall above the single panelled radiator.	Marked and hairline cracking. Dampness found. Believe relates to the front area where there is an open drain Marked	Repair, prepare and redecorate. Make watertight Repair, prepare and redecorate.
Floors: Wood Assumed suspended timber floor		Clean
Joinery: Door: Press panelled Fire Exit with Perco door closure		Repair, prepare and redecorate.

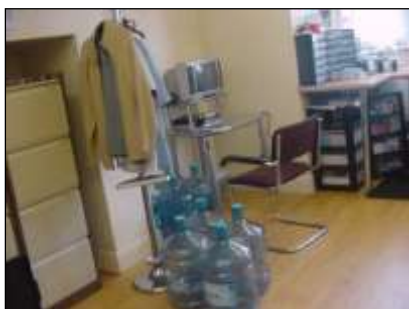
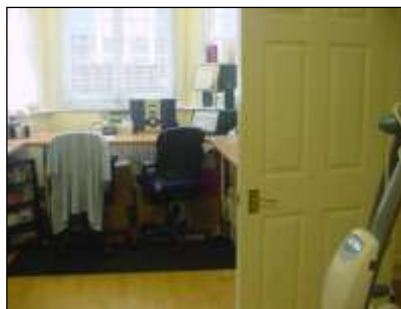
DESCRIPTION	CONDITION	ACTION REQUIRED
Ceilings: Embossed wallpaper	Average	
Walls: Painted plaster Chimney hearth – used as store for filing cabinets	Marked and hairline cracking around the chimney area	Repair, prepare and redecorate
Floors: Wood laminate flooring		Clean
Joinery: Windows: Bay window with gridded internal security system, single glazed. Door: Panelled Fire Exit	Average No Perco door closure	Repair, prepare and redecorate. Add Perco door closure
Services: See Services section Qualitar Air conditioning unit Fire Alarm System		
Comments: Limited access due to stored items no dampness found in areas we could test.
