SCHEDULE OF CONDITION

XXXX
Islington,
London. N1 XXX

Address: XXX, Islington,
London. N1 XXX

Prospective Tenant: Miss X

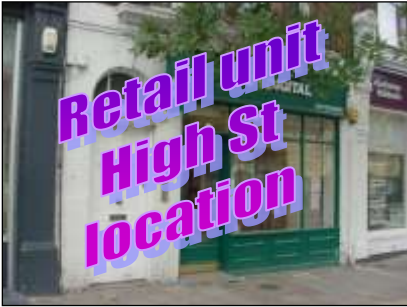
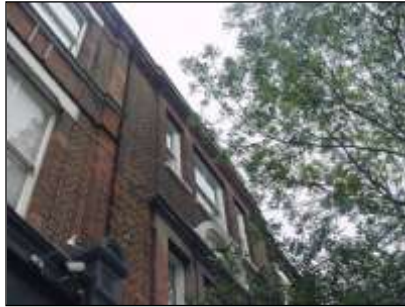
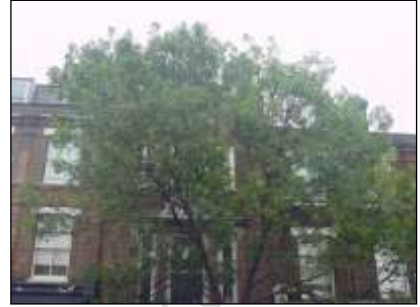
FRONT ELEVATION

DESCRIPTION	CONDITION	ACTION REQUIRED
Chimneys: Brick	Not visible due to the tree	Exclude from lease
Roofs: High level slate	Not visible due to the tree	Exclude from lease
Gutters and Downpipes: Mixture of cast iron and plastic	Not visible due to the tree	Ensure all gutters are watertight and falling towards the downpipe. Repair and secure as necessary, ensure downpipes are clear.
Walls: Flemish bond brickwork	Dirty	Clean and re-point.

<p>Fascias, signs and lights: Signage</p>	<p>Average</p>	
<p>Transom window: These are the windows above the main windows</p>	<p>Average</p>	<p>Repair, prepare and redecorate.</p>
<p>Shop front window: Painted shop front picture window and side door</p>	<p>Average</p> <p>Awkward slope to the front of the property near the door</p>	<p>Repair, prepare and redecorate.</p>

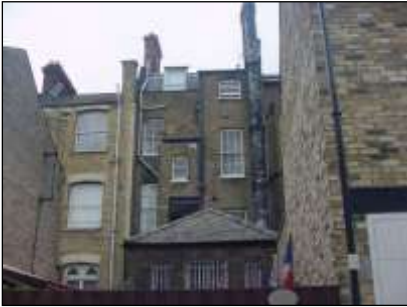
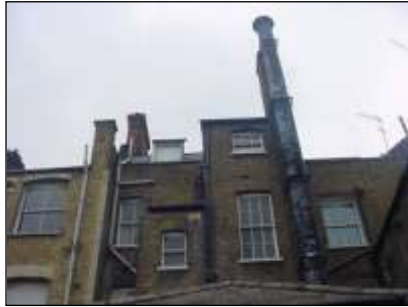
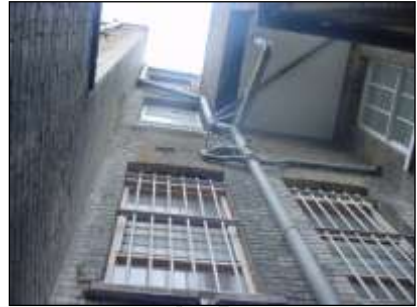
REAR ELEVATION

DESCRIPTION	CONDITION	ACTION REQUIRED
<p>Chimneys:</p> <p>Two Brick Chimneys</p>	<p>Base of left hand chimney (all directions given as you face the property from the front) has been partially removed.</p>	<p>Exclude from lease</p>

<p>Roofs:</p> <p>Main roof: slate</p> <p>Rear roof: slate</p>	<p>Slipped slates and felt patched areas that have lost their bond. Leaking.</p>

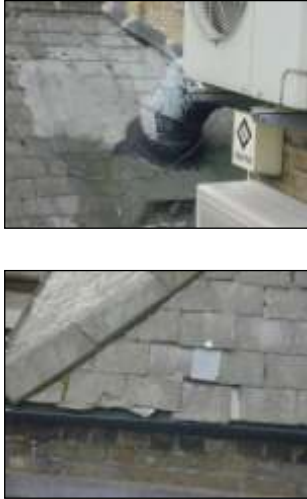
<p>Exclude from lease</p> <p>Major repairs required. Also form an access hatch into the roof for cleaning and regularly clean. Check stability. We have not been able to gain close access to this.</p>
<p>Flue: Extract flue from the kitchen that is attached to a chimney that has been partly removed</p>	<p>Extract does not look to have any access points to allow cleaning and it has been tarred which indicates there has been problems with it leaking and degrading.</p>

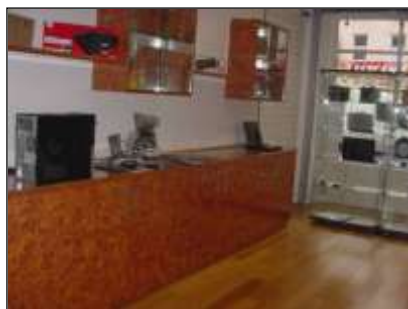
Front retail area

DESCRIPTION	CONDITION	ACTION REQUIRED
Ceilings: Painted	Average	Repair, prepare and redecorate.
Walls: Painted Dry lined	Hairline cracking visible We could not establish if there was any dampness as dry lined.	Repair, prepare and redecorate.
Floors: Wooden	Average	Clean
Detailing: Windows Doors	Average Average	Clean.
Services: See Services section

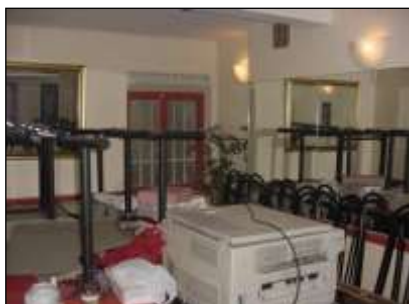
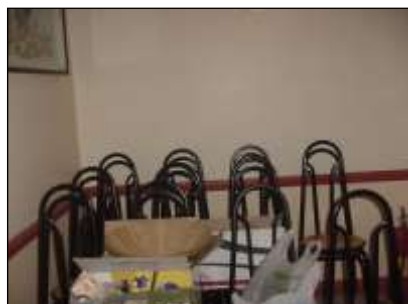
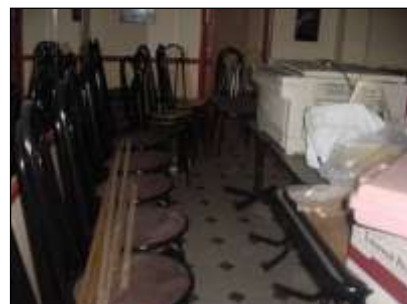
Rear restaurant area

The area had chairs and tables present which limited our view at the time of our inspection.

DESCRIPTION	CONDITION	ACTION REQUIRED
Ceilings: Painted spin beams Air handling unit to centre of ceiling	Marked Not tested	Repair, prepare and redecorate. Test
Walls: Painted	Marked	Repair, prepare and redecorate.
Floors: Tiles	Ingrained dirt	Deep clean
Detailing: Windows: Painted sliding sash	Dirty and deteriorating	Repair, prepare and redecorate.
Services: See Services section

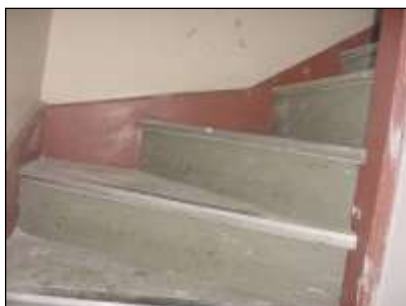
Blocked staircase

DESCRIPTION	CONDITION	ACTION REQUIRED
Ceilings: Painted	Marked	Repair, prepare and redecorate.
Walls: Painted	Marks where balustrade had been removed	Repair, prepare and redecorate.
Skirtings and architrave:	Marked	Repair, prepare and redecorate.
Floors: Vinyl	Vinyl may contain asbestos. Marked	Clean
Services: See Services section

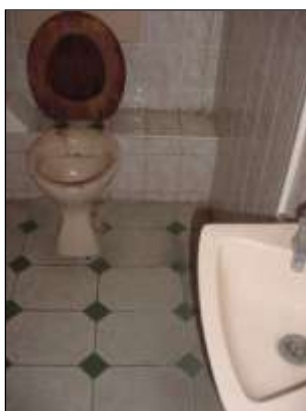
Toilet One

The toilets were not working at the time of our inspection and there was a terrible smell.

DESCRIPTION	CONDITION	ACTION REQUIRED
Ceilings: Painted	Marked	Repair, prepare and redecorate.
Walls: Tiles from floor to ceiling	Ingrained dirt	Deep clean
Floors: Tiles	Ingrained dirt	Deep clean

Sanitary Ware WC and wash hand basin Low level cistern with overflow going back into the pipework	Dirty Drains assumed blocked.	Unblock drains. Deep clean Bring up to modern standards
Joinery: Windows: Window with bars Doors		Repair, prepare and redecorate. Repair, prepare and redecorate.
Services: See Services section		
Comments: Light was not working at the time of our inspection.

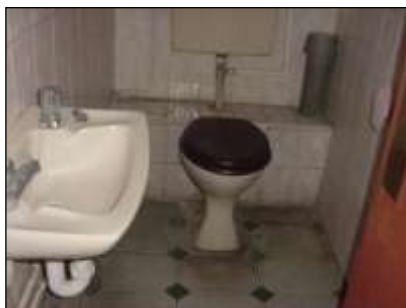
Toilet Two

DESCRIPTION	CONDITION	ACTION REQUIRED
Ceilings: Painted	Marked Crack running length of ceiling centrally	Repair, prepare and redecorate.
Walls: Tiles from floor to ceiling	Ingrained dirt	Deep clean
Floors: Tiles	Ingrained dirt	Deep clean
Sanitary Ware: WC and wash hand basin	WC blocked	Deep clean
Joinery: Windows: window with bar Doors		Repair, prepare and redecorate. Repair, prepare and redecorate.
Services: See Services section		
Comments: Light was not working at the time of our inspection. Smelt very bad

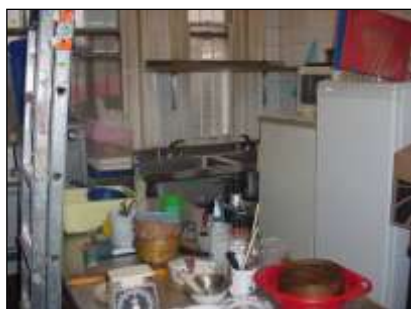
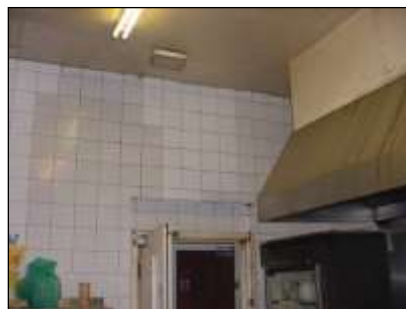
Kitchen

DESCRIPTION	CONDITION	ACTION REQUIRED
Ceilings: Plastered	Marked	Clean and redecorate
Walls: Tiled from floor to ceiling	Ingrained dirt. Some of tiles have blown.	Replace tiles. Deep clean.
Floors: Quarry tile	Ingrained dirt.	Some tiles may need to be replaced. Deep clean

<p>Detailing: Windows: Sliding sash Inner fly screen</p> <p>Fire Door to entrance</p>	<p>Degrading Dirty.</p>

<p>Intermittent strip missing.</p>	<p>Ease and adjust. Repair, prepare and redecorate. Redecorate</p> <p>Replace intermittent strip. Repair, prepare and redecorate.</p>
<p>Kitchen Equipment: Stainless steel equipment including sink and drainer and cooking equipment. Grease dropping from the extractor hood. Blocked drainage system discharging into the rear yard. The catering equipment has not been inspected, as we are not expert in this area, you should seek expert advice. We have assumed that the catering equipment meets Local Authority approval and is appropriate for use.</p>		
<p>Services: See Services section</p>

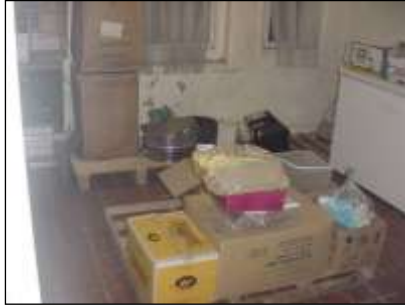
Rear store

DESCRIPTION	CONDITION	ACTION REQUIRED
<p>Ceilings:</p> <p>Gloss painted with central spin beam</p>	<p>Cracking and dated</p>	<p>Repair, prepare and redecorate.</p>

<p>Walls: Painted</p>	<p>Various cracks including to spin beam area and also to the rear window.</p>

<p>Visible dampness both rising and lateral dampness</p>

<p>Make watertight. Repair, prepare and redecorate.</p> <p>External drains need to be unblocked.</p>
<p>Floors: Quarry tile</p>	<p>Ingrained dirt. Lifted by water pressure. Skirting in danger of having wet rot.</p>	<p>Deep clean. Make area watertight. Repair/replace.</p>
<p>Detailing: Windows: Three sliding sash windows Doors: Flush painted</p>	<p>Average</p> <p>Marked</p>	<p>Ease and adjust. Repair, prepare and redecorate. Repair, prepare and redecorate.</p>
<p>Services: See Services section</p>

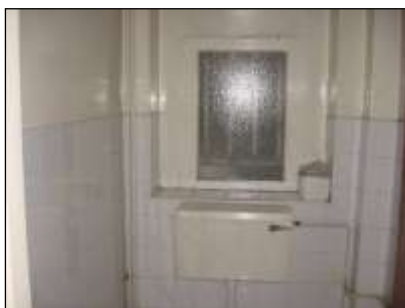
Staff toilets

DESCRIPTION	CONDITION	ACTION REQUIRED
Ceilings: Gloss painted	Dated	Repair, prepare and redecorate.
Walls: Gloss painted with tiles to approximately 1.5 metres	Marked. Ingrained dirt to tiles.	Deep clean. Repair, prepare and redecorate.
Floors: Quarry tiles	Ingrained dirt. Dampness coming up through the tiles.	Deep clean. Make area watertight.
Sanitary Ware Wash hand basin and WC with low level flusher		Deep clean
Detailing: Windows: Timber, barred Doors: Veneer	No ironmongery	Repair, prepare and redecorate. Replace ironmongery. Repair, prepare and redecorate.
Services: See Services section

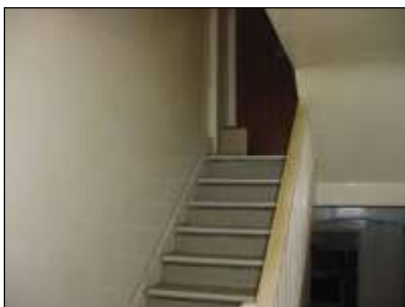
Staircase

DESCRIPTION	CONDITION	ACTION REQUIRED
Ceilings: Painted	Flaking	Repair, prepare and redecorate.
Walls: Painted	Heavily marked	Repair, prepare and redecorate.
Floors: Vinyl	Vinyl may contain asbestos. Dampness to base of staircase	Make watertight. Clean
Detailing: Balustrade: Painted timber	Marked	Repair, prepare and redecorate.
Services: See Services section
