SCHEDULE OF CONDITION

East Sheen,
SW14

FRONT EXTERNAL ELEVATION

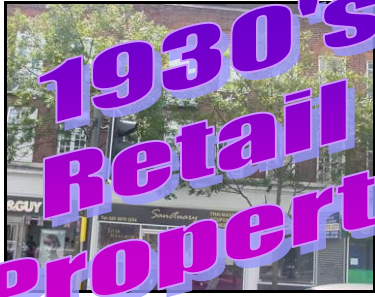
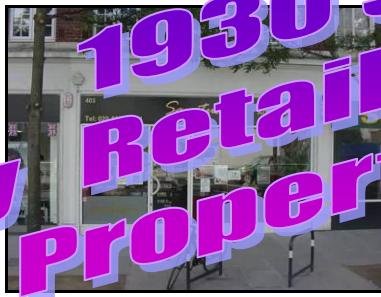
Shop Front

<p>Shop Front Window: Aluminium frame</p>   <p>Shop Entrance Door: Aluminium</p>   <p>Signage:</p> <p>Sign above the window</p> <p>Light Box</p>	  <p>Frames have in-grained dirt</p>   <p>Door frame is marked and dirty</p>   <p>Mastic is dis-coloured</p>   <p>Light box</p>	<p>Clean and remove marks. Touch up white frame as necessary.</p> <p>Clean tiles</p> <p>Clean and remove marks. Touch up white frame as necessary.</p> <p>Clean or replace mastic</p> <p>The signage will need to be removed</p> <p>Light box will need to be removed.</p>
---	---	--

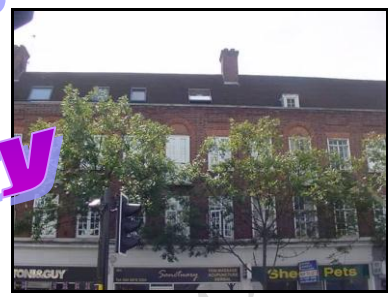
Upper flats

Repairs have been carried out to the brickwork on parapet wall. Also visible is some minor movement to the roof on the left hand side.

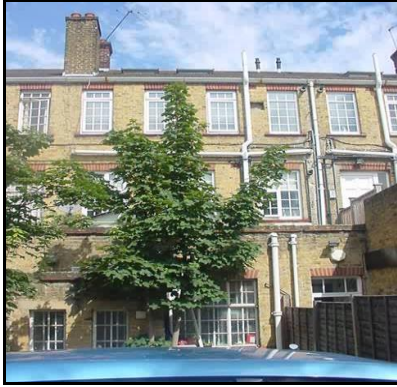
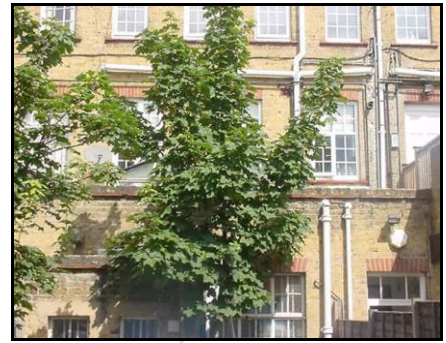
REAR ELEVATION

<p>Poor state of repair with cracking and crazing (all directions given as you face the front of the property). Also deterioration to the asphalt flashing</p>	<p>Exclude from the lease or new asphaltting required.</p> <p>Repairs to make watertight</p>

<p>These are rusting</p>	Clean Repair, prepare and redecorate

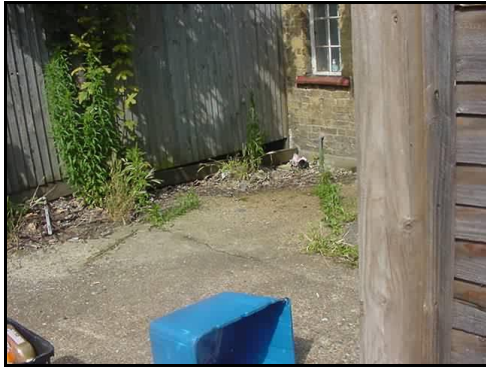
Rear Courtyard area

<p style="text-align: center;">Tree to front of shop</p>	<p>Your Legal Advisor to check and confirm.</p> <p>Your Legal Advisor to check and confirm responsibility, if any, for the tree to the front of the property.</p>
<p>Rear Courtyard area:</p> <p>Concreted over with a fall towards the property (we believe this is the main cause of the dampness).</p>	<p>This is overgrown</p> <p>The fence has been cut down</p> <p>We noted a motorbike had been parked by a resident in this area.</p>	<p>Clear area including plants and rubbish</p> <p>Reinstate the fence</p> <p>Advise the residents that they do not have rights to park in the area.</p>

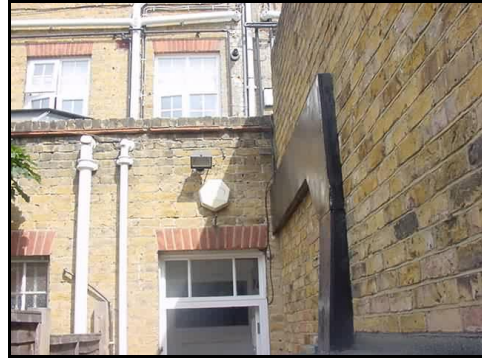
Shared entrance to rear of shop and flats

<p>Not checked</p>	<p>Service engineer to check and supply test certificate</p>
<p>Shared entrance to rear for shop and flats:</p> <p>Gravel base with timber fence leading to access door and shared lobby (shop to the side and residential straight ahead).</p> <p>We have not checked if this area is lit</p>	<p>Shared access</p>	<p>Your Legal Advisor to check and confirm if you have rights of access and your responsibilities with regard to redecoration and repair</p>

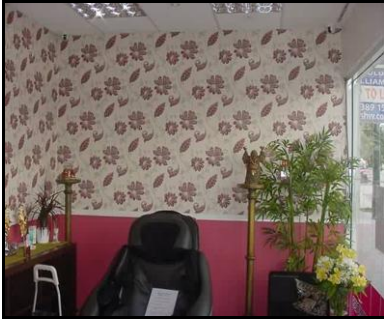
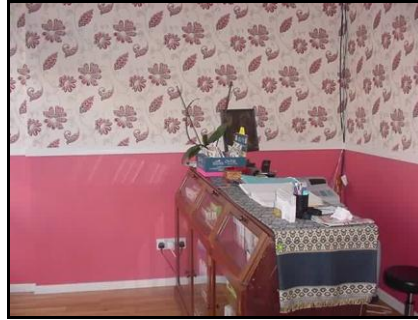
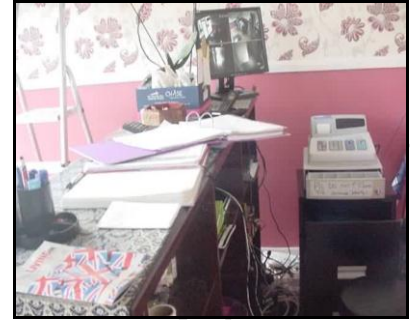
Front reception room

<p>Damaged tiles</p>	<p>Replace damaged tiles</p>

<p>Dry lining</p> <p>Painted at the bottom. Wallpaper to the top and a dado rail.</p>	<p>Could be hiding dampness in the property.</p> <p>Dated</p>

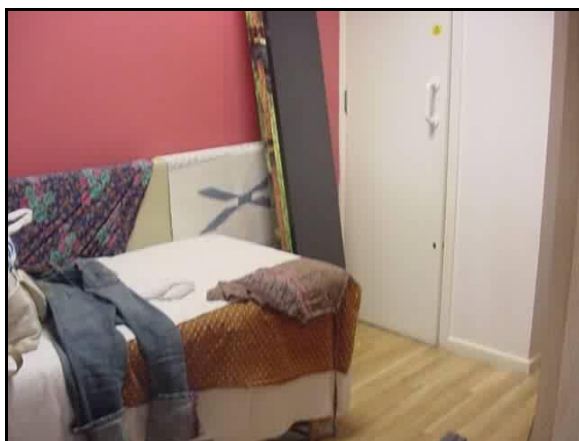
Treatment Room One (left)

Treatment room with under stairs cupboard

Partition does not reach the Ceiling General marks to walls	Prepare, repair, redecorate
Floors: Suspended timber floor Amtico wood style flooring		Check this is ventilated. We have not opened up the floor Deep clean and/or replace

Floorboards in cupboard	Stairs not lined. Asbestos lining removed under the stairs

Floorboards run from back to front of property	Stairs need relining

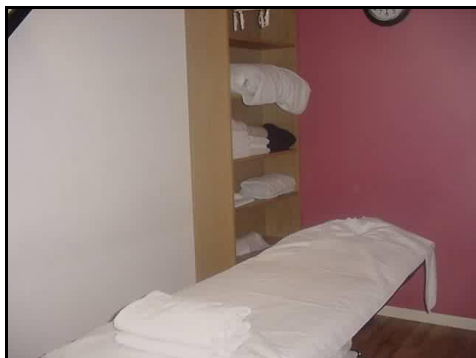
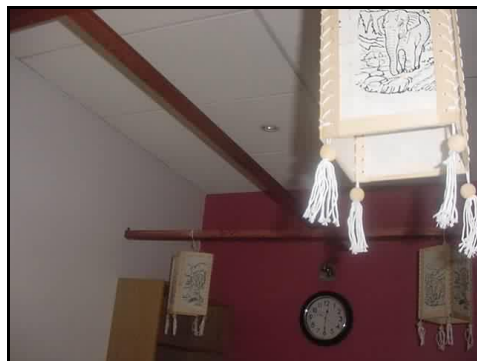
Treatment Room Two –right

DESCRIPTION	CONDITION	ACTION REQUIRED
Ceilings: Suspended Ceiling with exposed grid square tiles		
Walls: Dry-lined studwork walls Internal partition does not reach the ceiling, with a gap of half a metre Painted	General marks to the walls	Repair, prepare and redecorate
Floors: Amtico wood style flooring

Safe in the floor	Deep clean and/or replace
Detailing: Doors: Pressed hollow core door	Marked	Repair, prepare, redecorate

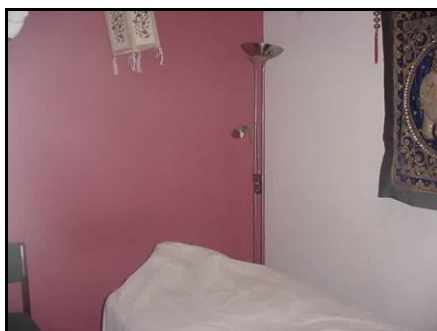
Treatment Room three (rear right)

DESCRIPTION	CONDITION	ACTION REQUIRED
Ceilings: Suspended Ceiling with exposed grid square tiles		
Walls: Dry lined studwork Painted	General marks to the walls	Repair, prepare and redecorate
Floors: Carpeted floor		Deep clean and / or replace
Detailing: Doors: Pressed hollow core door	Marked	Repair, prepare and redecorate
Services: Heating

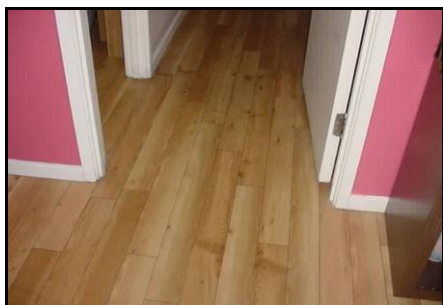
Amtico wood style flooring

DESCRIPTION	CONDITION	ACTION REQUIRED
Ceilings: First half: Square tiled suspended ceiling with exposed grid Second half: Older rectangular ceiling tile with an exposed grid	Some rainwater staining from a roof leak	Replace any damaged ceiling tiles
Walls: Studwork Painted walls	General marks to walls	Repair, prepare, redecorate
Floors: Amtico wood style flooring Polyvinyl floor to the end		Deep clean and/or replace Deep clean and/or replace

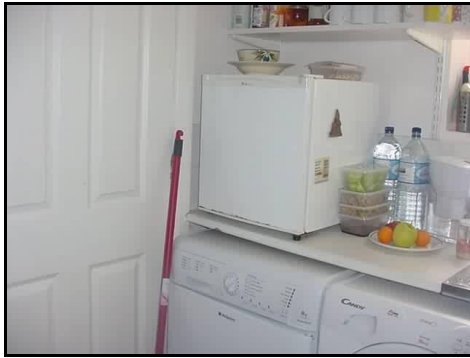
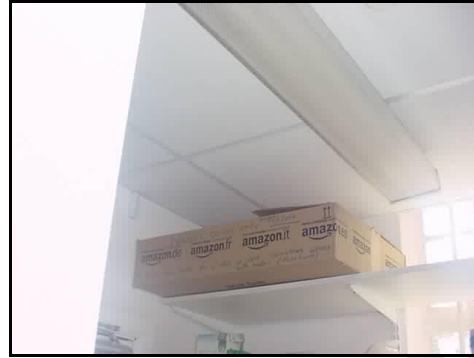
Kitchenette

<p>Flat roof with window light visible above the suspended ceiling</p>

<p>The wiring and plumbing needs organising above the ceiling</p>	<p>Make the flat roof above the ceiling watertight. The roof is cracked and has had previous repairs</p>
<p>Walls:</p> <p>Painted</p>	<p>General marks to walls</p>	<p>Repair, prepare, redecorate</p>
<p>Floors:</p> <p>Tiled Floor</p>		<p>Deep Clean</p>

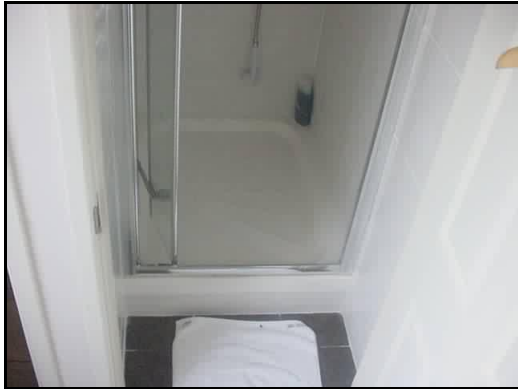
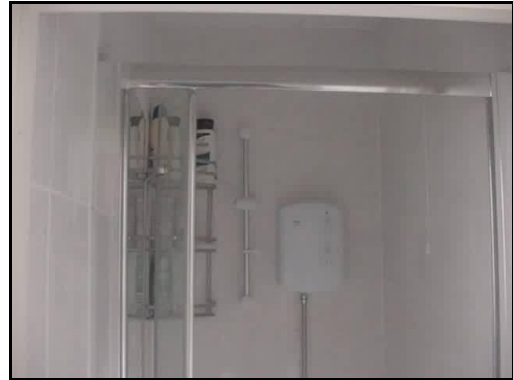
Shower Room

DESCRIPTION	CONDITION	ACTION REQUIRED
Ceilings:		
Tiled		Deep Clean
Extract fan		Service and leave in working order
Walls:		
Painted	General marks to walls	Repair, prepare, redecorate Re- mastic
Floors:		
Tiled		Deep Clean
Ceramic shower base		Deep clean
Detailing:		
Doors: Pressed hollow core	Marked	Repair, prepare and redecorate
Shower and Cubicle	Not tested	Deep clean Re-mastic

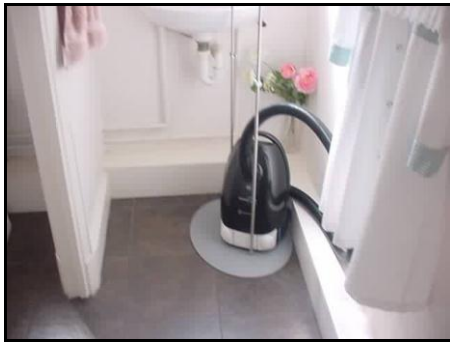
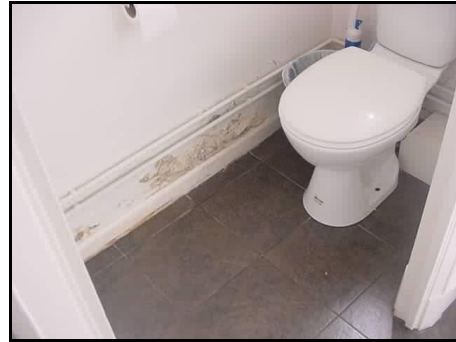
Wash area and W.C. - rear right

DESCRIPTION	CONDITION	ACTION REQUIRED
Ceiling: Plasterboard with a flat roof above	Staining to the wash hand basin area - indicating the flat roof above is leaking	See the rear external section
Walls: Solid Painted	These are damp

Testing for dampness reading of 93. Typically we would expect between 30 and 60 in this type of wall	Externally the ground level needs to be lowered. Add a French drain Add background heating to this area Redecoration once the work has been completed. There may also be a need to re-plaster.
Floors: Tiles		Deep clean

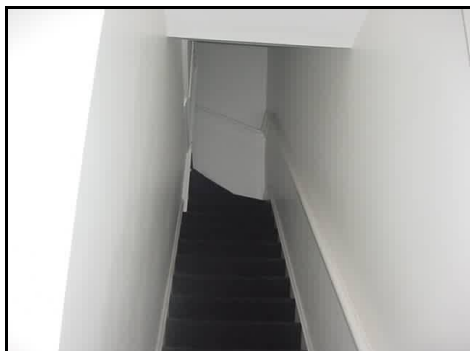
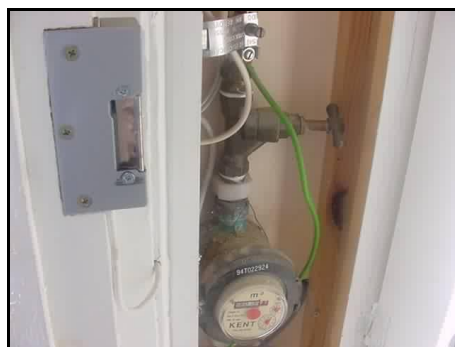
Rear shared access area

DESCRIPTION	CONDITION	ACTION REQUIRED
Ceilings: Painted		Your Legal Advisor to check your responsibility for this area
Walls: Painted		
Floors: Carpet
