# SCHEDULE OF CONDITION

Hall XXX

Welwyn Garden City,  
Hertfordshire.

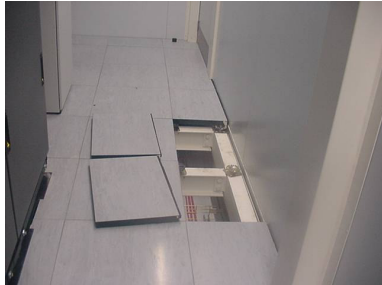
Two floor panels lifted

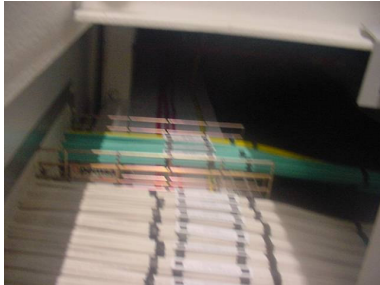
Firebreak

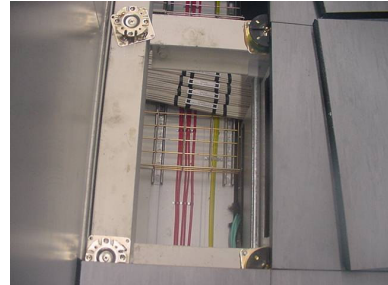
Firebreak

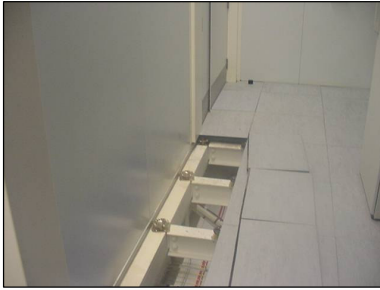
Three floor panels lifted

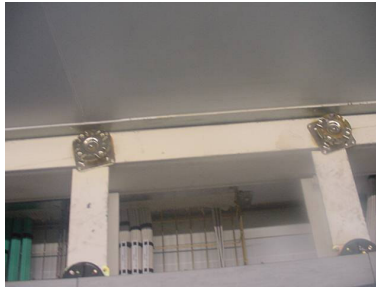
Firebreak

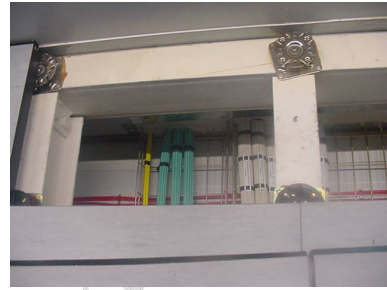
Firebreak

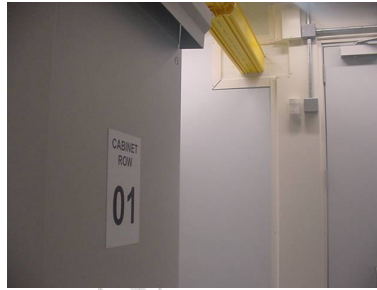
Conduit at high level

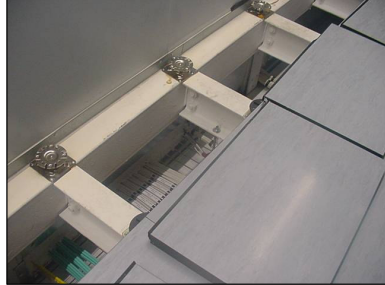
Floor panels lifted

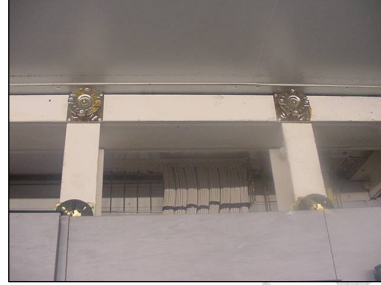
Firebreak

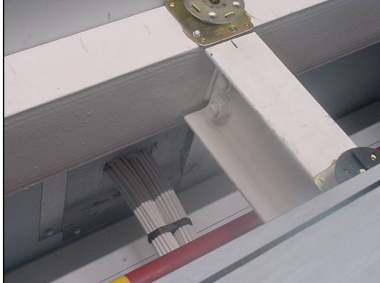
Firebreak

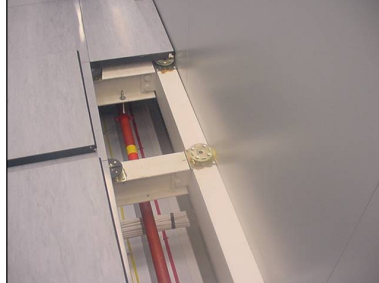
Two floor panels lifted

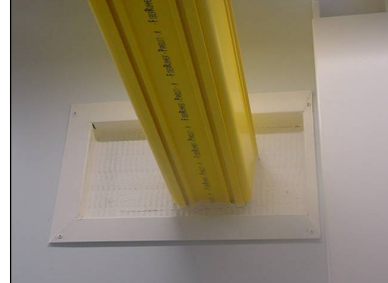
High Level trunking barrier

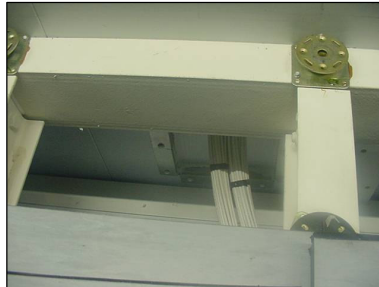
Low level firebreak
