SCHEDULE OF CONDITION

Hall XXX

Welwyn Garden City,
Hertfordshire.

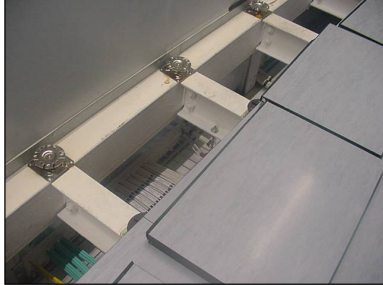
Floor panels lifted

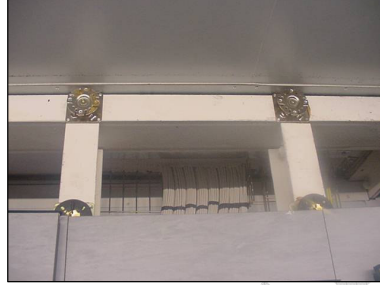
Firebreak
