SCHEDULE OF CONDITION

A Shop Unit In Woking Surrey

Address: A Shop
Woking
Surrey

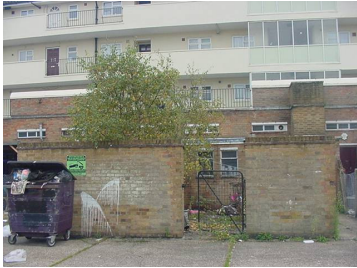
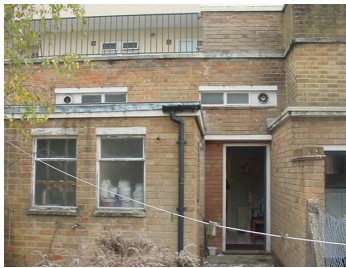
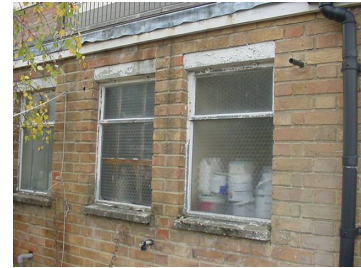
REAR ELEVATION

DESCRIPTION	CONDITION	ACTION REQUIRED
<p>Roofs:</p> <p>Balcony/walkway - asphalt covered</p> <p>Flat roof over rear toilets</p>	<p>Leaking/condensation – visible to ceiling tiles and ceiling internally. Partly damaged Some deterioration to asphalt and asphalt flashings</p> <p>Leaking/condensation</p>	<p>Repair and make watertight</p>
<p>Gutters and Downpipes:</p> <p>Plastic</p>	<p>Missing gutters</p> <div style="text-align: center;">

<p>Missing guttering</p> </div>	<p>Add gutters, repair and secure as necessary, ensure downpipes are clear. Ensure all gutters are watertight and falling towards the downpipe.</p>
<p>Walls:</p> <p>Stretcher Bond brickwork</p> <p>Concrete lintels</p>	<p>Weathered pointing</p> <p>Paint flaking</p>	<p>Some ad hoc repointing required particularly at base</p> <p>Repair, prepare and redecorate</p>

<p>Vegetation growing around walls</p>	<p>Vegetation growing on it and fly tipping</p> <p>Damage to boundary wall</p>

<p>Damage and sprayed paint to boundary wall</p>

<p>Rubbish from flats above</p>

<p>Broken fans</p> <p>Marked</p>	<p>Repair, prepare and redecorate</p> <p>Remove board and replace window</p> <p>Replace</p> <p>Repair, prepare and redecorate and associated ironmongery repairs</p>
<p>Outside Area:</p> <p>Concrete path and rear yard with access to separate WC/storage building</p>

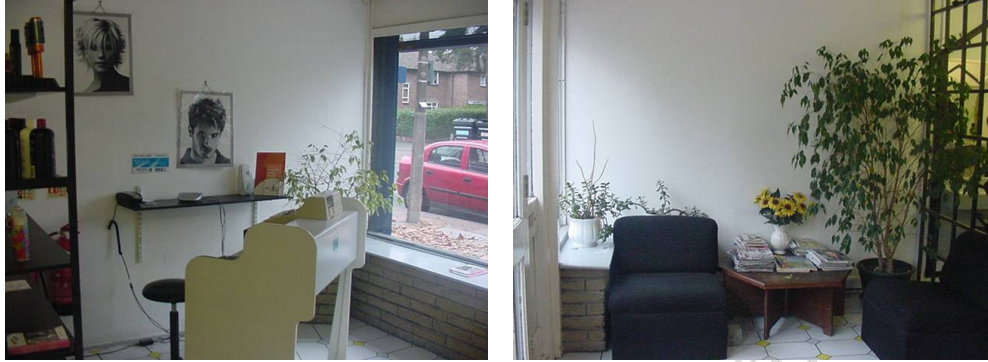
Reception and Waiting Area
(divided by open metal grid to Salon)

DESCRIPTION	CONDITION	ACTION REQUIRED
<p>Ceilings:</p> <p>Rectangular suspended ceiling tiles with exposed grid Fluorescent lights</p>	<p>Stained</p>

<p>Stained ceiling tiles</p>	<p>Repair, prepare and redecorate</p> <p>Most importantly, the cause of the leak needs to be found and resolved.</p>
<p>Walls:</p> <p>Painted</p>	<p>Average/dated</p>	<p>Repair, prepare and redecorate.</p>
<p>Floors:</p> <p>Patterned tiled</p>	<p>Ingrained dirt to joints</p>	<p>Clean</p>

<p>Condensation to front window</p>	<p>Repair, prepare and redecorate.</p>
---	--	--

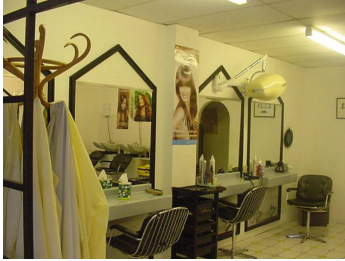
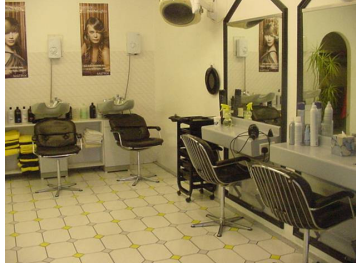
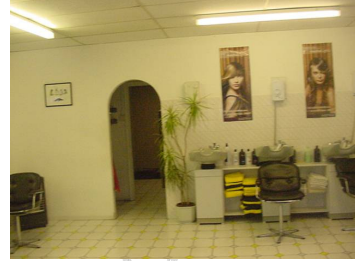
Salon

DESCRIPTION	CONDITION	ACTION REQUIRED
<p>Ceilings:</p> <p>Rectangular suspended ceiling tiles with exposed grid Fluorescent lights</p>	<p>Dampness and condensation problems</p> <div style="text-align: center;">

<p>Dampness and condensation problems in ceiling</p> </div>	<p>Make watertight and vent better to resolve dampness and condensation problems</p>
<p>Walls:</p> <p>Painted</p>	<p>Dated</p>	<p>Repair, prepare and redecorate</p>

<p>Floors:</p> <p>Patterned tiled</p>	<p>Ingrained dirt to joints, dated and worn under work area</p>

<p>Worn where tiles meet concrete</p>	<p>Clean and/or repair/replace</p>
<p>Services: See Services section</p>

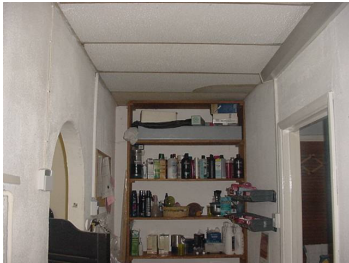
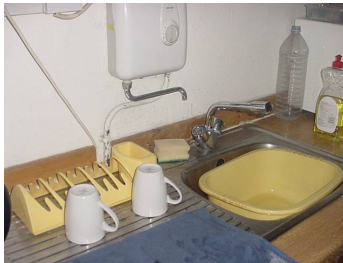
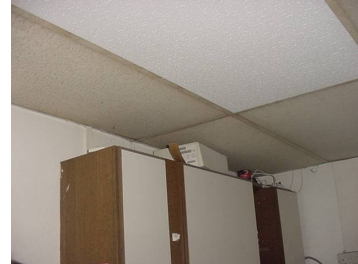
Corridor and kitchen to rear right hand side

<p>Dampness coming in through ceiling (left hand side of corridor)</p>	<p>Dampness and condensation causing problems. Fifty per cent of ceiling tiles have been replaced over the years, we assume relating to leaks etc.</p>

<p>Ceiling tile coming down due to dampness and leaking roof above</p>	<p>Stop leaks and condensation. We believe these are from the Landlord owned property above</p>

<p>Mould above ceiling</p>
<p>Walls:</p> <p>Painted textured Wall Unit Floor Unit</p>	<p>Marked Dated and marked Dated and marked</p>	<p>Repair, prepare and redecorate</p>

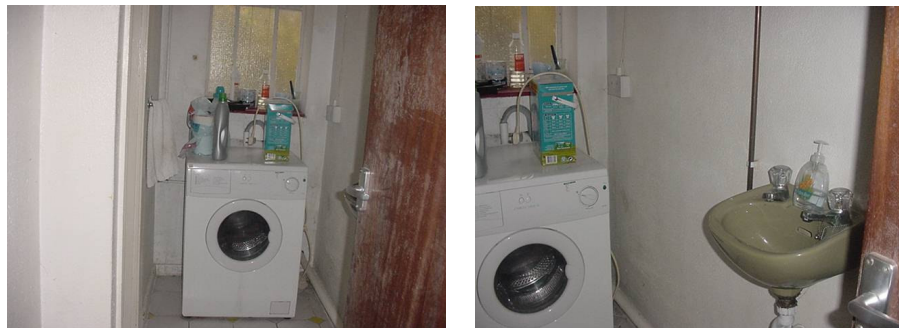
Wash Room Area
(at end of kitchen)

DESCRIPTION	CONDITION	ACTION REQUIRED
<p>Ceilings:</p> <p>Partly textured paint and partly an area which has been re-coated</p>	<p>Possible roof leaks Textured ceiling may have an element of asbestos</p>	<p>Repair, prepare and redecorate (make sure roof above is watertight)</p>
<p>Walls:</p> <p>Textured paint</p>	<p>Marked and dated</p>	<p>Repair, prepare and redecorate</p>
<p>Floors:</p> <p>Tiled</p>	<p>Ingrained dirt to joints</p>	<p>Clean</p>
<p>Sanitary Ware:</p> <p>Small hand basin</p>	<p>Dirty</p>	<p>Clean</p>
<p>Internal Joinery:</p> <p>Metal window with opaque glass</p>	<p>Metal corroding and window cill paintwork lifting due to condensation</p>	<p>Repair, prepare and redecorate, using a rust stop agent or equivalent</p>

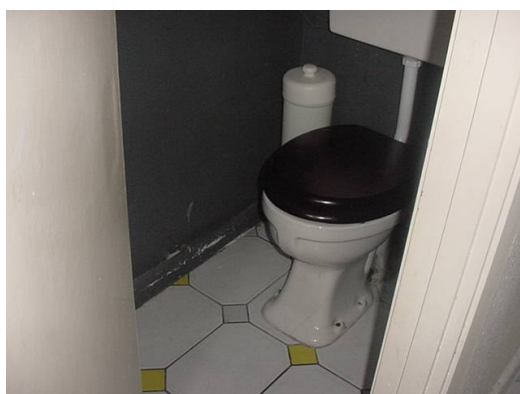
Internal Toilet (to right hand side)

DESCRIPTION	CONDITION	ACTION REQUIRED
Ceilings: Concrete	Marked – possible roof leaks

<p>Condensation to window cill</p> <p>Door</p>	<p>Metal corroding and window cill paintwork lifting due to condensation</p>

<p>Rusting to window cills</p> <p>Marked</p>	<p>Repair, prepare and redecorate, using a rust stop agent or equivalent</p> <p>Repair, prepare and redecorate</p>
<p>Services:</p> <p>Electrics</p>	<p>Light switch cable and light cable are exposed</p> <p>Electrics not up to Institute of Electrical Engineers (IEE) standards</p>

<p>Poor wiring – not to IEE standards</p>	<p>Added to conduit and make sure up to Institute of Electrical Engineers (IEE) standards</p>

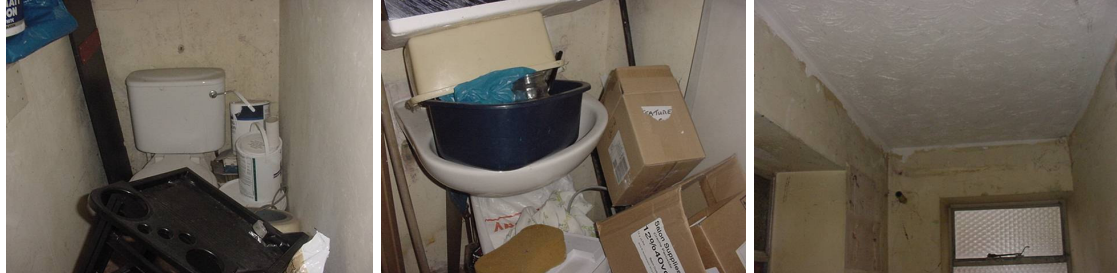
Outside WC
(used as a store room)

DESCRIPTION	CONDITION	ACTION REQUIRED
Ceilings: Artex	Marked	Repair, prepare and redecorate.
Walls: Painted	Dated and dampness coming in	Repair, prepare and redecorate.
Floors: Tiles	Cracked tiles and ingrained dirt	Deep clean
Sanitary Ware: WC and wash hand basin	Not checked due to items stored around it	Check in working order Clean
Joinery: Metal windows	Deteriorating	Repair, prepare and redecorate
Flush painted door	Marked	Repair, prepare and redecorate
Services: See Services section		
Bakelite finish electric fittings – dated – check to current Institute of Electrical Engineers (IEE) standards

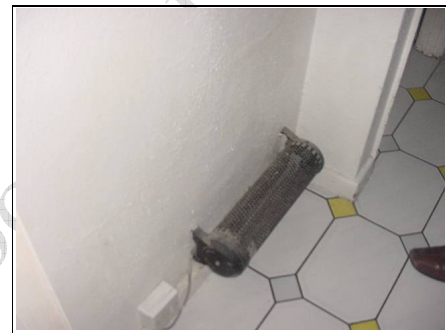
Background heater

We were advised that the background heaters were the only heaters that they were aware were working. These were located in the kitchen and the toilet.
