Example Pages taken from a Commercial Building Survey

A three storey mid-terraced property

COMMERCIAL BUILDING SURVEY OF Address of Property

FOR
Mr M

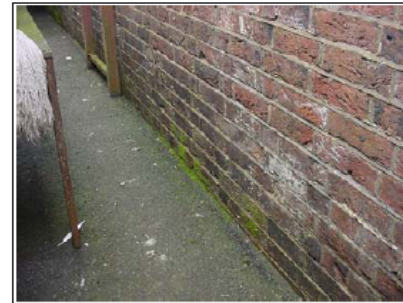
In addition to this, we have identified rising damp to the left hand rear of the property. This is due to the ground level variation of the adjoining properties.

High ground level to left hand side wall, which is damp with moss growing on it

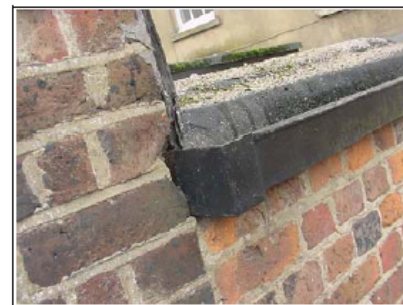
We would also highlight the flat roof above and the gutter that sits on the wall (left hand wall of the florist), where we can see various repairs have taken place to the roof over the years.

Gutter sitting on the wall

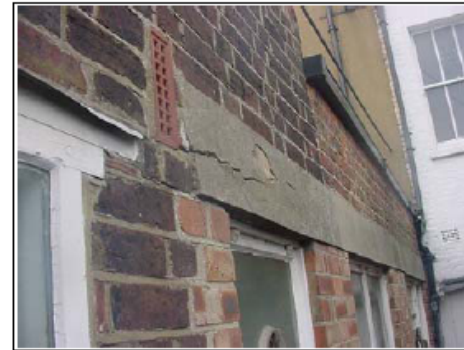
The amount of water discharging down the wall surface of the florist we feel has affected the lintel to the left hand side wall and repairs will be needed to be carried out to this.

Lintel to the left hand side wall

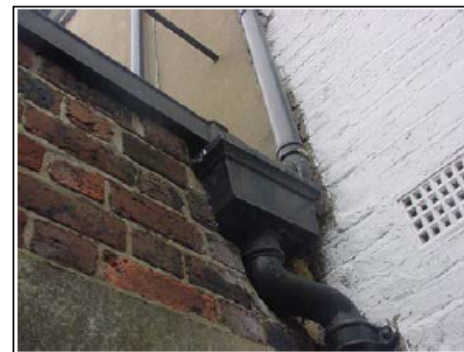
Gutter and hopper head sitting on the wall. These are prone to allowing dampness into the wall structure.

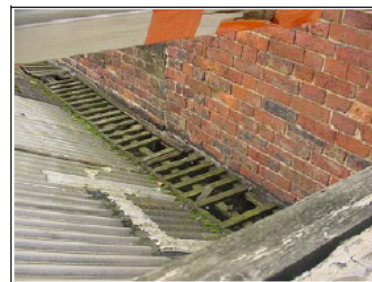
There is an awkward valley gutter detail to the right hand side of the property that we could see when we went in the CAB (Citizens Advice Bureau). We believe that damage and deterioration of this wall has been hidden by the wooden panelling.

This is a photo of the valley gutter.

ACTION REQUIRED: The lease needs to be inspected to establish your position and you need to take a business decision as to how you wish to proceed, as we are aware that you have had dealings with this company in the past, and indeed sold them a property recently.

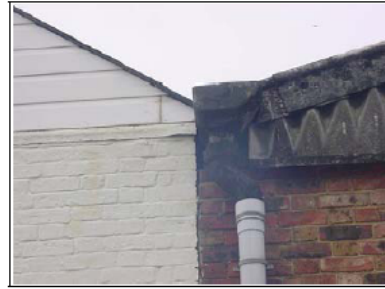
A considerable amount of water is getting into this storage facility and office area, particularly down the right hand back wall (all directions given as you face the property from the front). This is affecting both your property and the adjoining CAB (Citizens Advice Bureau).

The valley gutter and relatively small hopper head

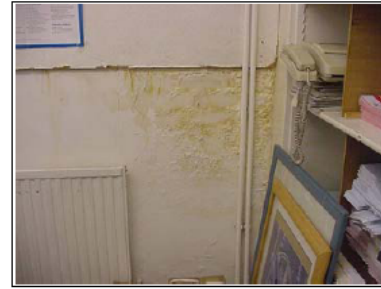
Water damage to the CAB office, which you will have liability for

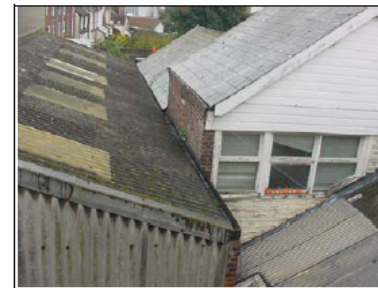
The only long term solution is to redesign the valley gutter. We would recommend a wider valley gutter. The roof problems could in turn, we believe, have affected the roof structure. Please note we have not gained access to the high level areas within the store.

The view of the right hand side valley gutter detail and your asbestos roof

ACTION REQUIRED: We would recommend the only long term solution to the valley gutter problems that you have is to change the design of them. We would recommend a wider valley gutter, which allows access, i.e. to be a width of approximately half a metre to one metre. This, unfortunately, would involve reconfiguring part of the roof. Also, the question is do you replace the asbestos now, or encapsulate it, which of course depends how long a term your long term plans are!

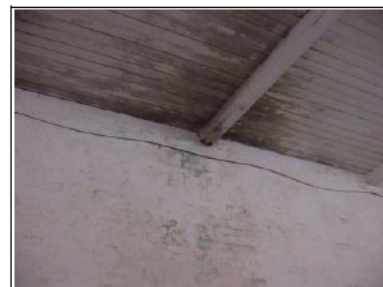
Leaking valley gutter within the store. Note the moss to the wall indicating this has been a long term issue

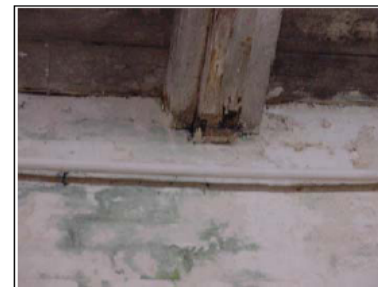
Rot to supporting beams

We would add that the timber beams need checking as there looks to be rot to some of them.

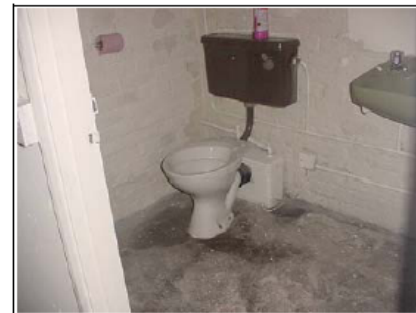
Finally, there is also a general upgrading requirement to the charity area/store if it is to be used.

Upgrading required!

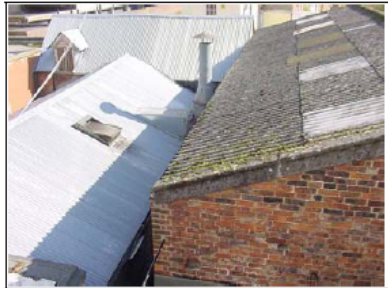
We would specifically draw your attention to the asbestos that has been used for the roofing, which in our opinion, the perception of asbestos problems do affect clients/future tenants.

Left hand view of asbestos sheet roof

ACTION REQUIRED: We believe that you should budget for repair/replacement of the asbestos roof, if you are looking at this as a long term investment, i.e. ten years plus.

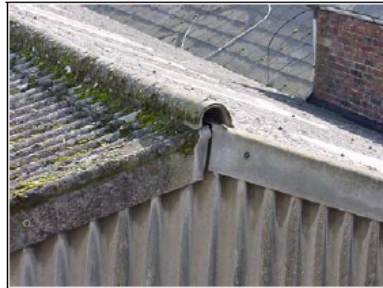
Cracked asbestos on roof

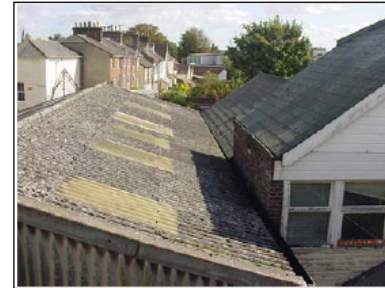
Right hand view of asbestos sheet roof
