RESIDENTIAL BUILDING SURVEY
OF
Kempston Near Bedford Bedfordshire

Mr & Mrs I Brown

1st Associated

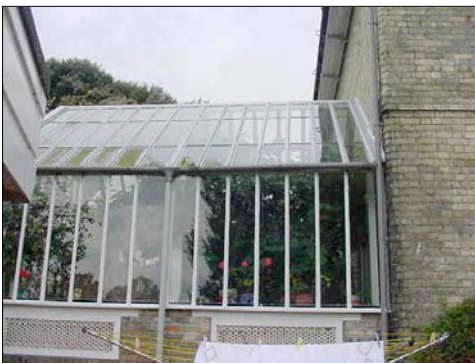
The timber conservatory has been heavily filled over the years and looks to have recently been repaired. We found several areas of rotten timber, particularly around the rainwater hopperheads and downpipes.

A general view of the side of the conservatory

ACTION REQUIRED: The property is in need of proper repair to the joints and valley gutters, which currently have been filled or covered with a product known as Flashband which is a temporary repair material.

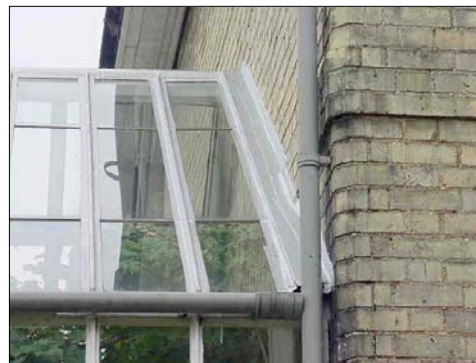
Flashband is a sticky backed felt which is best used for temporary repairs only.

If you look more closely you can see flashband has been stuck over the timber frame.

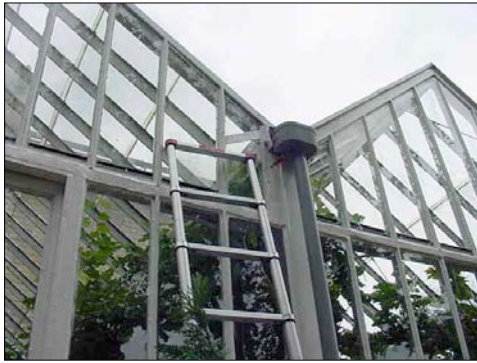
This is one of your valley gutters with the hopperhead in black

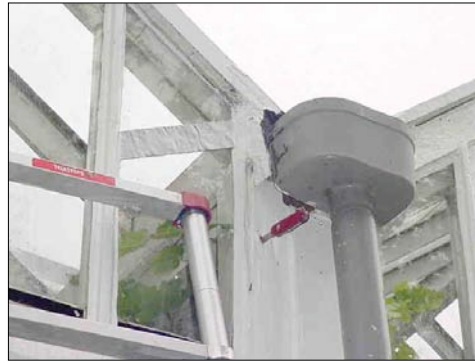
This is a close up of the valley gutter and you see our pen kni sticking into the timber. The present owner is well aware of these problems as they have been filled many times.

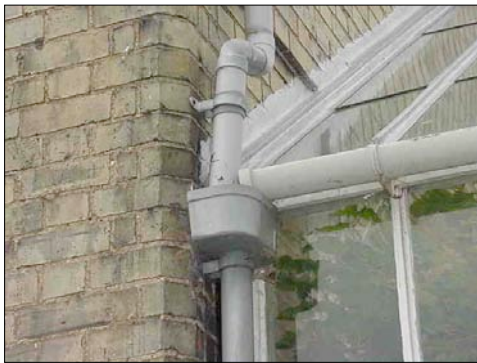
This is another view of the conservatory. Here is the hopperhead against the main building, the hopperhead will be overloaded during any rainfall. In our opinion it simply isn't big enough to take the surface area.

ACTION REQUIRED: In the long term you really need to look at replacing the hopperheads, at the very least to larger sizes, although we are not certain they do these in plastic. Ideally we would recommend that the entirety of the gutters and downpipes are replaced in cast iron, but this is expensive. A half way measure may well be to replace them in aluminium which has more strength. We would always recommend that the gutters and downpipes are cleaned out, the joints are checked and the alignment checked to ensure that the gutters fall towards the downpipes. Please refer to the photos in the Executive Summary.

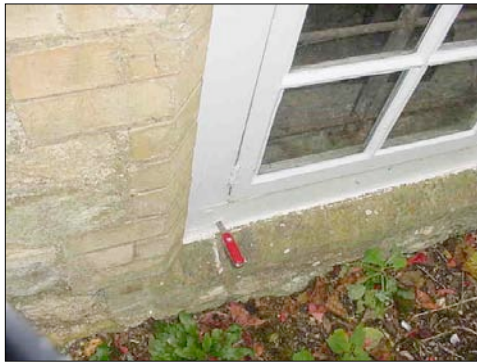
We also tested a random sample of the sliding sash windows to the ground floor and found them to mostly have rot and are in need of work before they become fully operational. We generally tend to find that the lower level windows are in a better condition than the first floor windows, as they are easier to reach and repair and no scaffolding is needed!

Our knife going into the base of the window.

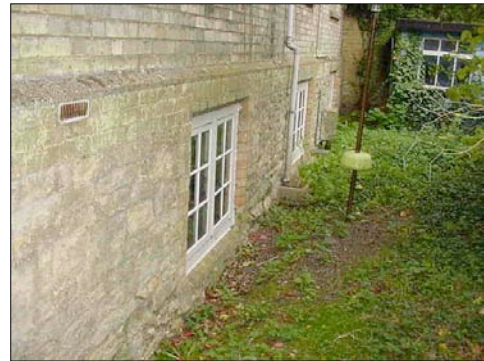
The windows on the left hand side of the property (some at the front of the property being the riverside)

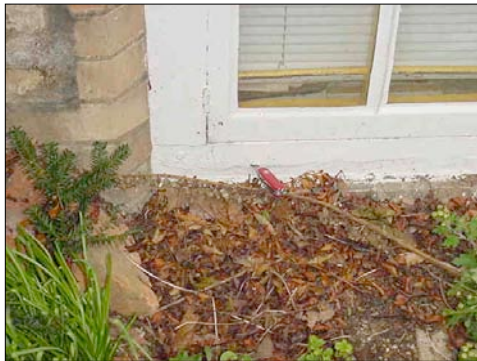
Our knife going into one of these windows.

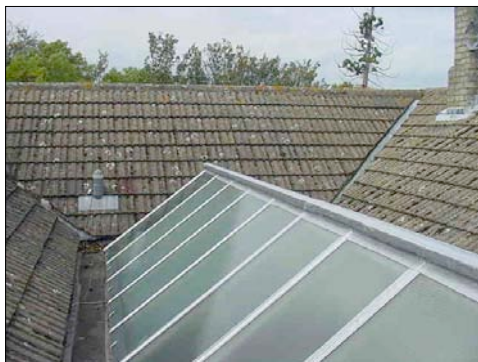
This is looking to the roof along the roof light

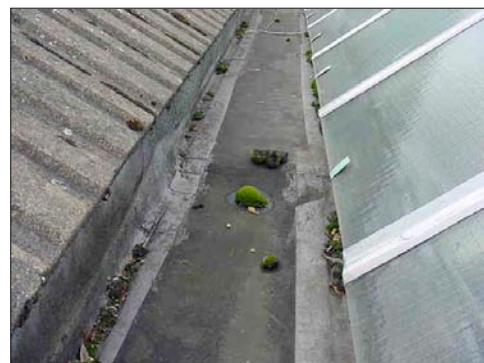
There is a box gutter to the property around the light well over the stair areas which will benefit from being repaired properly. It has over the years had many patch repairs, although there were no obvious visible signs of leaks internally i.e. staining to the ceiling. We do feel that leaks are probably getting into the structure but simply not coming out as far as the ceiling.

This is the box gutter. You can see on both the right and left hand side flashband has been used.

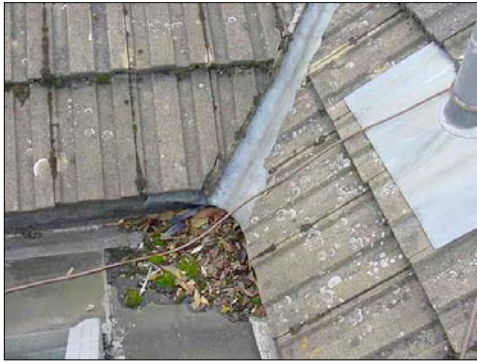
This is a typical example of how debris starts to build up.

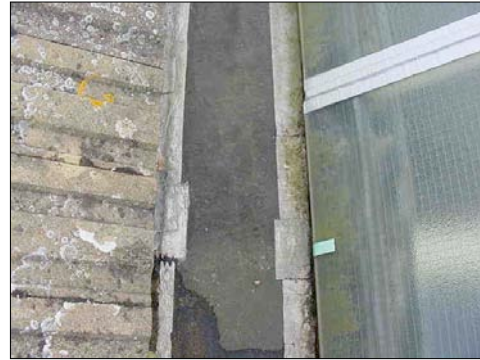
Here you can see repairs to more flashband.

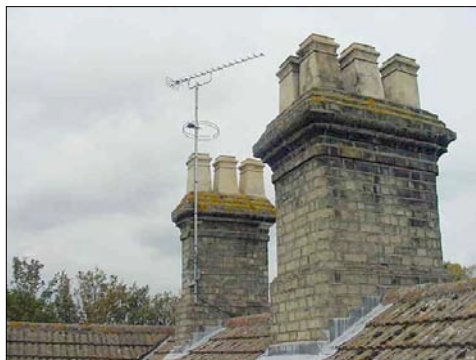
Left hand chimney

This is brick built with a lead flashing and three chimney pots. There is some slight deterioration to the mortar, but is generally in reasonable condition. There has been some deterioration resulting in some small or minor cracking, this is nothing to be overly concerned about. Unfortunately we were unable to see most of the flaunching therefore we cannot comment on its condition.

ANTICIPATED COST: We would expect the cost to be in the hundreds of pounds as the chimney is accessible from the flat inner roof/light well over the stairs.

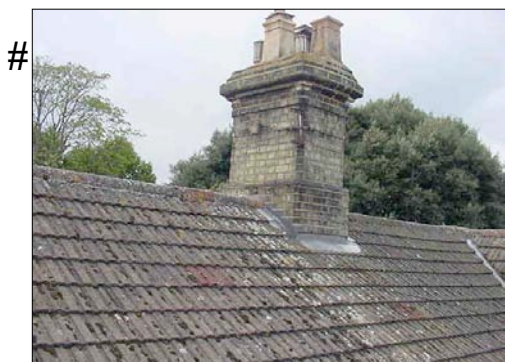
Right hand side chimney

This is also brick built with a lead flashing, two chimney pots and two flues. It looked in reasonable condition, however we found internally dampness coming through on this particular chimney into the master bedroom area.

ANTICIPATED COST: We would estimate costs to be in the region of £500 to £1,000 (five hundred to one thousand pounds).

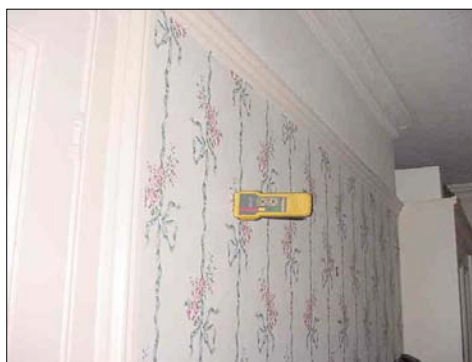
This is our damp meter stuck in the chimney getting damp readings.

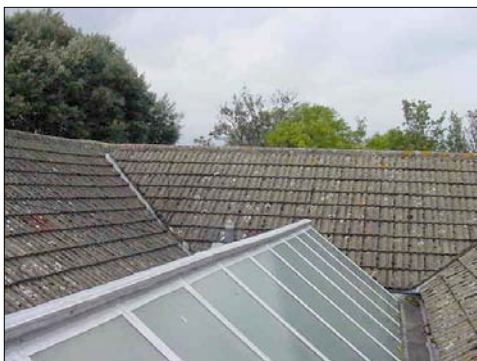
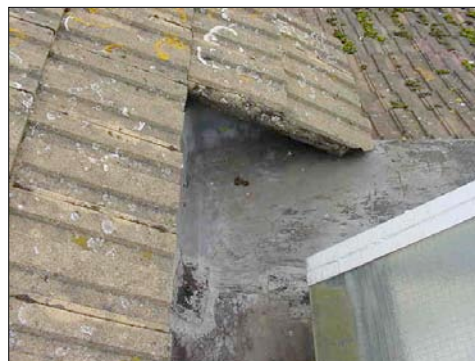
us most concern, as this has been repaired and repaired again. We could see to the joints flashband has been used in most cases, this is probably an adequate repair in this instance, although we would very rarely recommend flashband without complete renewal of the light well it would appear the only option.

Here is a close up of the box gutter and also the corner of the light well complete with the flashband repair; you can see the silver.

A view of the light well.

ACTION REQUIRED: The entirety of the box valley gutter we feel would benefit from being renewed in the next few years. Ideally with lead although further advice would be needed on this. Bearing in mind our comments with regard to the light well and the flashband repairs; not an ideal situation, so the entirety of the light well will need renewing at some point in time. This is very much something we find owners put off and off.

We would suggest in the region of £10,000 to £20,000 (ten thousand to twenty thousand pounds) to renew the light well. We are not in any way suggesting that this needs doing immediately. Indeed in the near future, providing you are prepared to carry on repairing it.

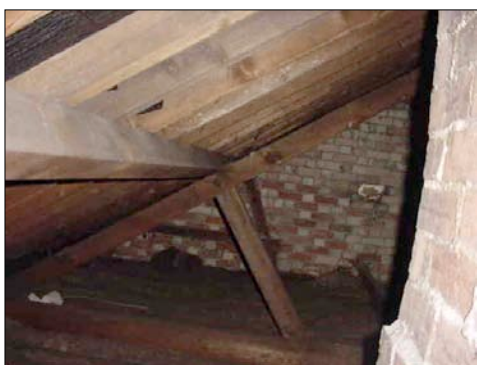
There is some moss growth present on the roof slopes. This can, in extreme cases, impede the run-off of rainwater, lead to gutter blockages and cause water penetration, which in turn may lead to rot or other defects in nearby timbers. You need to clear the roof moss periodically; the present owner advised that he does this on a yearly basis.

A general view of the roof. To the left hand side you can see the purlin

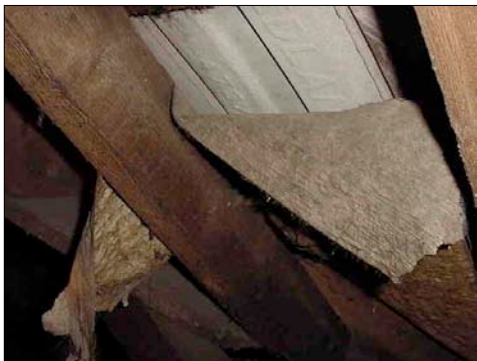
There are several different underlayers in the roof, indicating that it had been re-roofed several times. The newer areas were to the rear of the roof on the light well side. In parts there were some of the earliest type of underlayer which is almost paper like.

The paper like underlayer.

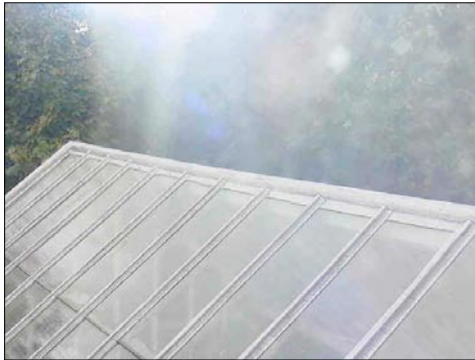
You have a glazed roof with box gutters set within a timber frame and this poses a problem if they are not well maintained. We believe the conservatory has been recently painted, we assume to help sell the property and in doing so many of the repair issues have been painted over. This makes it very difficult for us to see them! However we would comment the box gutters pose a problem. From what we could see internally there has been considerable making good. To some extent we would expect this due to what we have seen

A general view of the conservatory roofs.

ANTICIPATED COST: It is very difficult to calculate without further investigation and obtaining quotations. In the region of £10,000 to £20,000 (ten thousand to twenty thousand pounds). If you are serious about taking this property on, we suggest that quotations need to be obtained.

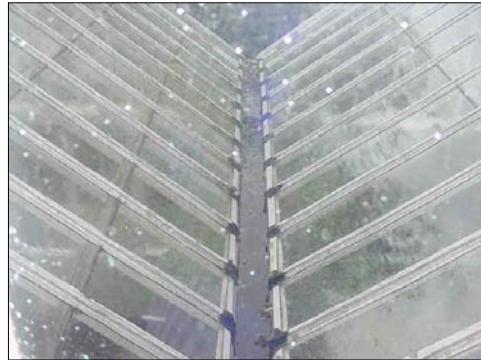
A view of the valley gutter.

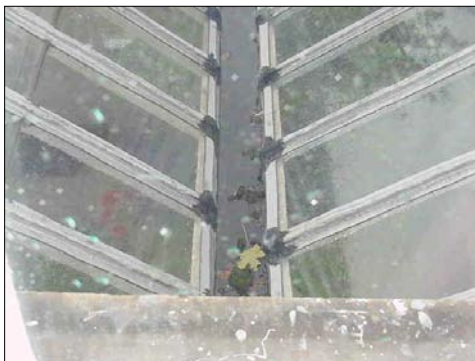
A close up of the box gutter. You can see there is moss and leaves etc. accumulating here and you can also see it is full of water. If you look closely you can also see that bitumen has been added to the end of the conservatory, indicating that dampness is getting through in these areas. Also what you cant see is that there is flashband over most of the join.

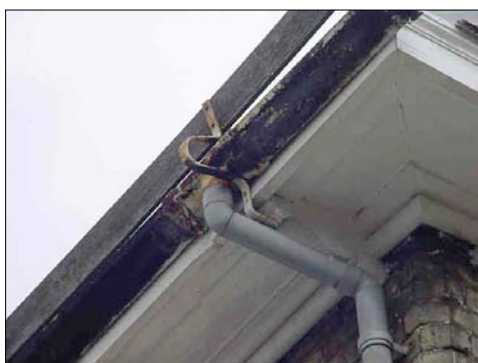
This is an interesting photo. This looks to be a mixture of the original cast iron and a plastic downpipe; the two never marry up well as one is imperial measurements and the other is metric, not to mention that they are different materials and we would expect leaks in this area.

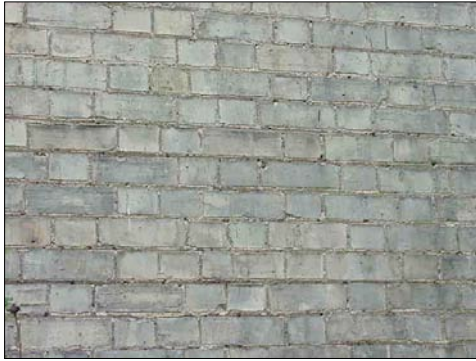
A close up of the brickwork. As you can see the pointing is in good condition.

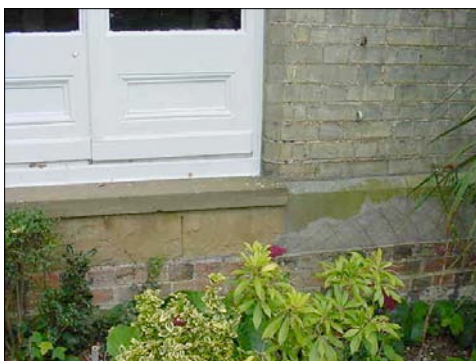
To the base of the property at the front there has been a soft red brick used and to the left hand side is limestone. This may be from an older construction, we simply do not know. We spoke to the owner during the question and answer session and they didn't know either.

An example of the base of the property with the softer red bricks.

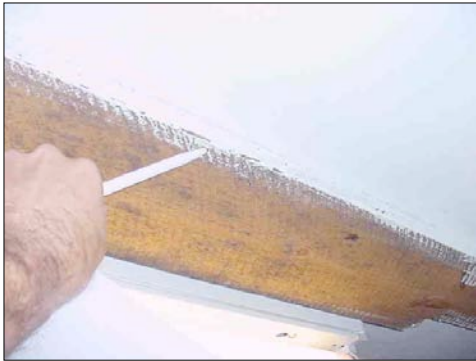
A minor outbreak of woodworm was found, but don't panic!

ACTION REQUIRED: What we suggest you do is when the property is empty of furniture you keep an eye open for frass which is a chewed up sawdust and the woodworm flight holes (the flight holes mean that they have flown, it doesn't mean that they are active regardless of what the woodworm companies say). The only time that you can really tell if woodworm is active is during the breeding season in Spring. If you find them we would be happy to advise you of various ways of establishing if the woodworm is active. Even if it is we feel its still relatively small.

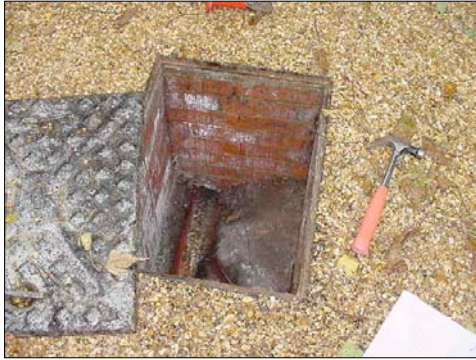
This manhole was located in the driveway. This has got a lightweight manhole cover which is not really appropriate for this location as it deforms when driven over. The manhole itself was free flowing at the time of our inspection.

Note the lightweight cover

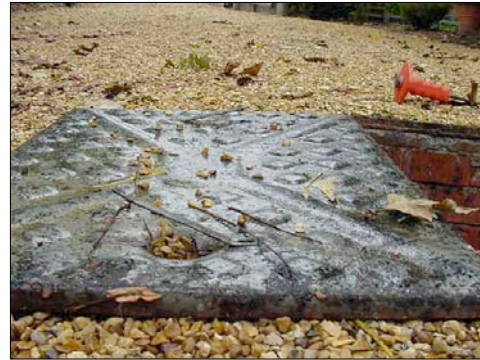
If you look carefully at this you can see how the handles on the manhole cover have been broken. These should be replaced at some point in time.

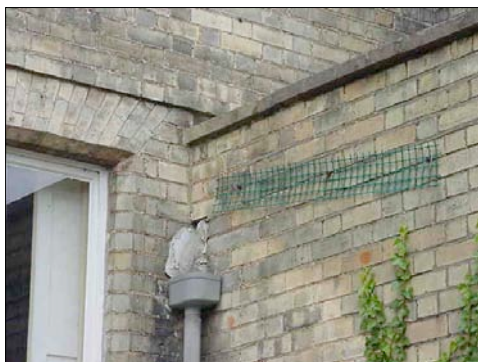
This is a good example of a poorly detailed hopperhead; there should be leadwork around it. We are sure there will be dampness in this area.

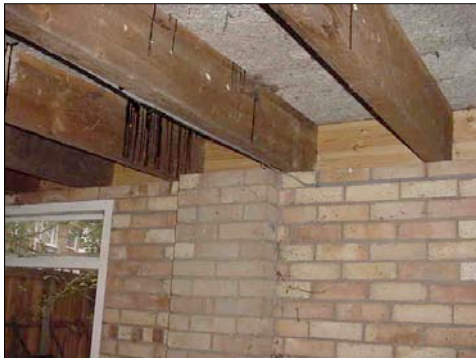
The only thing we would warn you about with regard to the garage is that the decking i.e. the bit under the roof is formed in strannett board; this is basically glued together straw. Any dampness that gets into this type of roof it will deteriorate very rapidly.
