RESIDENTIAL BUILDING SURVEY
OF
An Edwardian Mid-Terrace Property

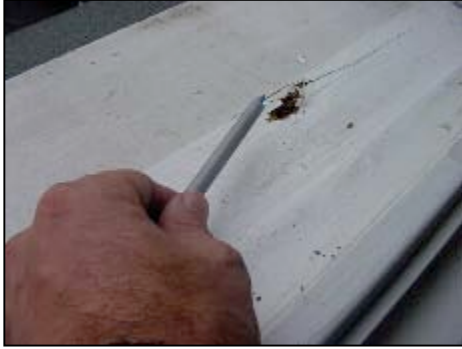
We found, during the course of our random inspection of the windows and doors wet rot to one of the front sliding sash windows and wet rot to the rear sliding patio door.

Wet rot in the sliding sash window

ACTION REQUIRED: Repair in due course. Preferably during the next few years, the longer it is left the worse it will be. Repair and redecorate.

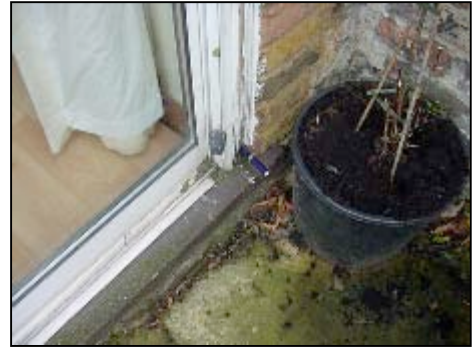
This is the base of the rear doors

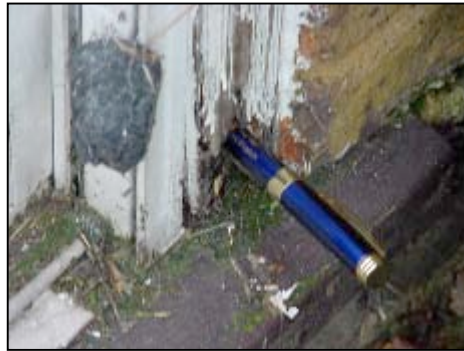
This is a close up of my pen pushed into the rotten timber

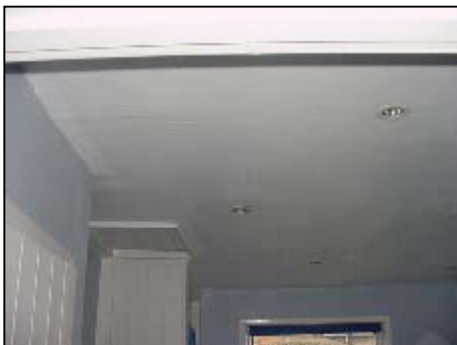
For example, within the bathroom you have ceiling lights, this can be a fire hazard due to heat given off to the rear of them. You should ensure that they are not covered from within the loft space.

Ceiling lights in the bathroom

ACTION REQUIRED: Check the back of the lights are not covered.

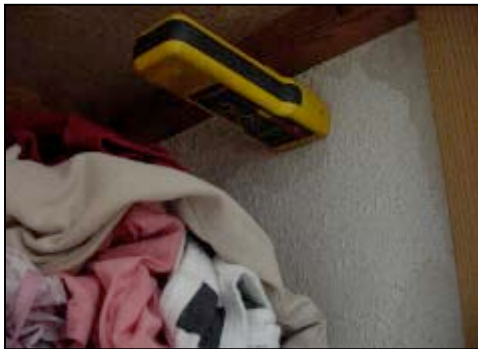
The dampness found within the cupboard

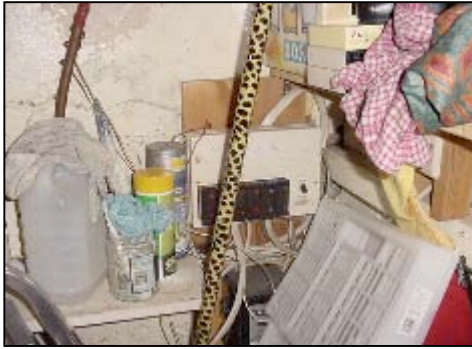
The electric fuse board is dated. This to may apply to the rest of the electric system. Ideally we would recommend that a new fuse board be added, as this would be safer.

Dated fuse board

ANTICIPATED COST: £250 plus recommended repairs.

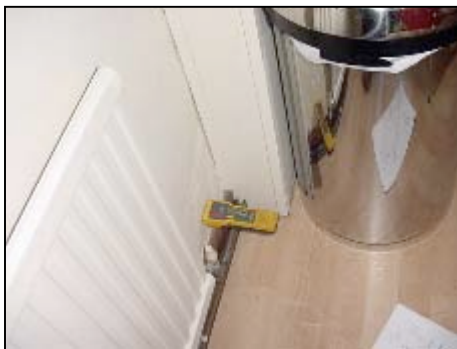
Within the kitchen area we found rising damp.

Dampness found in the kitchen area

There is damp to the property but not excessive to the main area but in the kitchen it is higher than normal and we would recommend a damp company to look at this. However, because it is a kitchen and not a room you live in and you will have to remove the kitchen units we suggest that you try and live with it as it is for the moment. But you do need to obtain a quotation from the damp proof company.

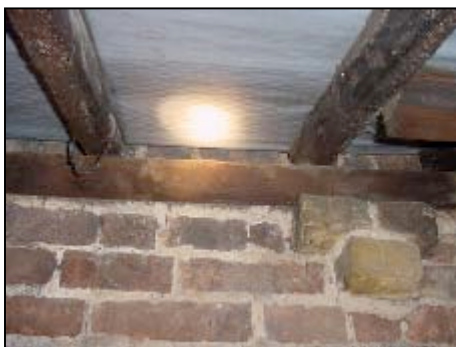
Within the roof we can see condensation is occurring, this is due to the lack of ventilation. Ventilation can be added into the pitch of the roof tiles, you should ask the roofer to quote for doing this at the same time as he is generally inspecting the roof.

If you look where the torchlight is in the centre of the photo this is where the plastic underlayer is. To either side you can see the staining to the timbers.

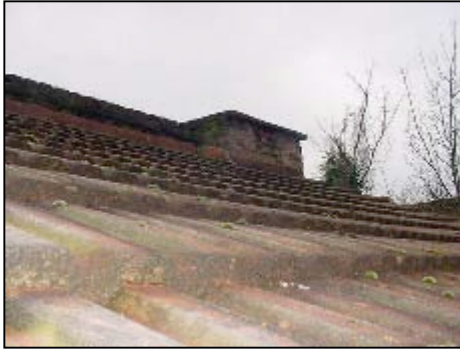
Rather than a lead flashing a tile on edge has been used to the roof. This type of flashing usually leads to water getting in sooner or later. The reason it is used is because it is cheaper than lead flashing.

Photo taken out of the rear window perched on the windowsill with a digital camera above our head!

ACTION REQUIRED: We recommend that all of the flashings be replaced in due course with a lead flashing.

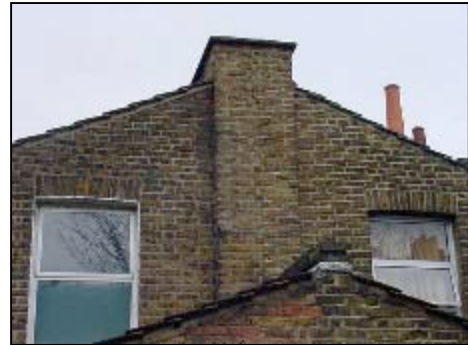
This is the rear view of the chimney where you can see some re-pointing has taken place.

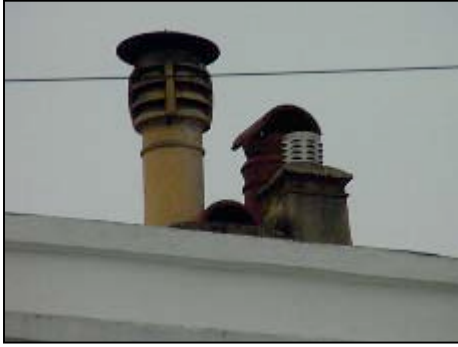
This is all we could see of the chimneys

ACTION REQUIRED: Several roofers are asked to inspect and quote on the roof as a whole, flashings and the chimneys. You need to ensure that they have a long ladder to gain access to the roof and you need to insist that they take photos of what they see. Please forward these on to us for further comment.

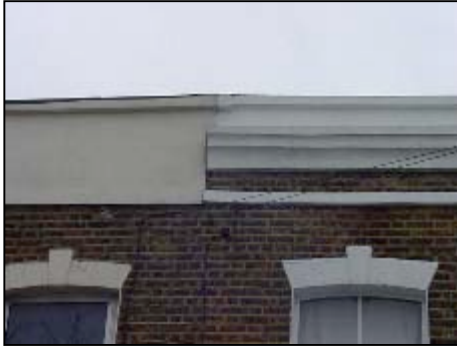
A close up of the front parapet wall, left hand side

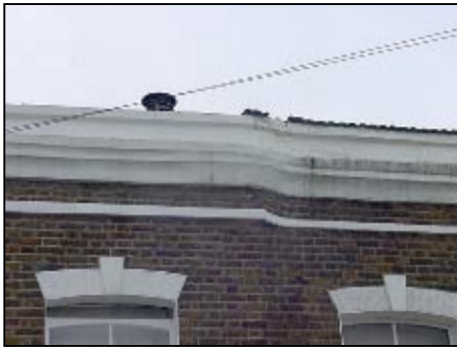
To the front they are in reasonable condition, from the side that we can see although this area to the front right hand side is where dampness is getting into the main roof, which is why it is essential to have a roofer check the property.

A close up of the front parapet wall, right hand side

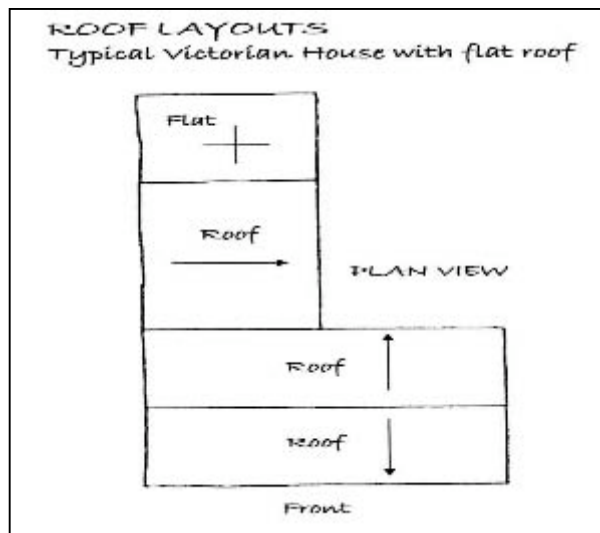
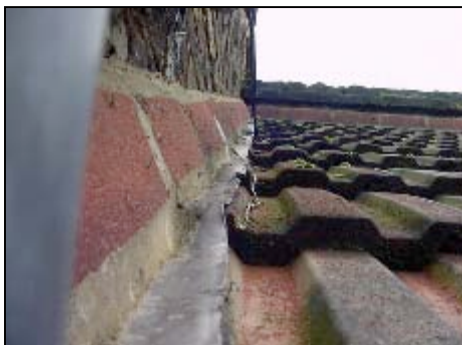
This is often a weak area. In this instance we believe it is the flashings formed in a tile on edge, which is not ideal as we mentioned earlier and should be replaced with lead.

This is the best photo we managed to get with the junction of the two roofs. This is a very strange detail, there is a tile on edge but there looks to be lead underneath it. Bearing this in mind it may well be worth leaving the tile on edge until such time as water is getting in via this roof.

ACTION REQUIRED: Ideally this should be replaced with a lead flashing although it is a relatively common problem in this age, type and style of property.

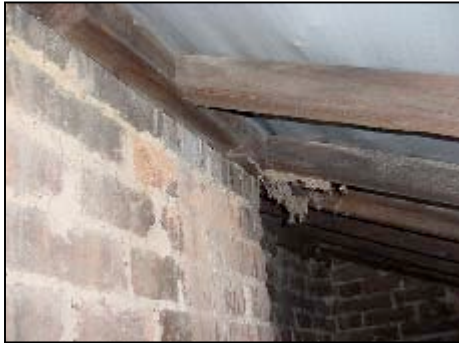
When we inspected the roof space we found a reinforced plastic sarking felt. This type of sarking felt was used in the 1970s/1980s and its use was generally stopped because it was susceptible to causing condensation unless the roofs are adequately vented, which they are usually not. In this case it was in reasonable condition.

The underlayer, which is a plastic sheet.

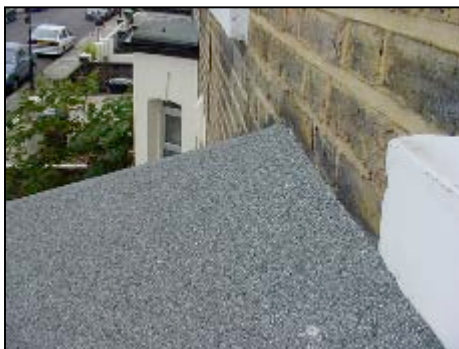
This has a mineral felt roof, which looks in reasonable condition. Although we could not see a flashing to it.

This is where the bay roof meets the main property and there really should a flashing here.

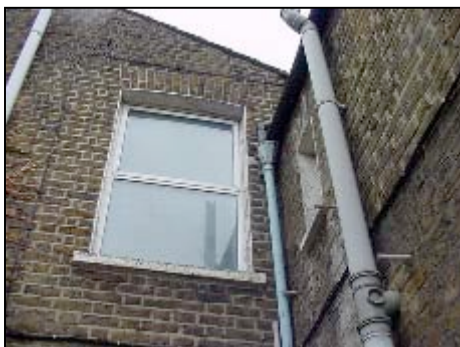
You can just about see the staining below the windows.

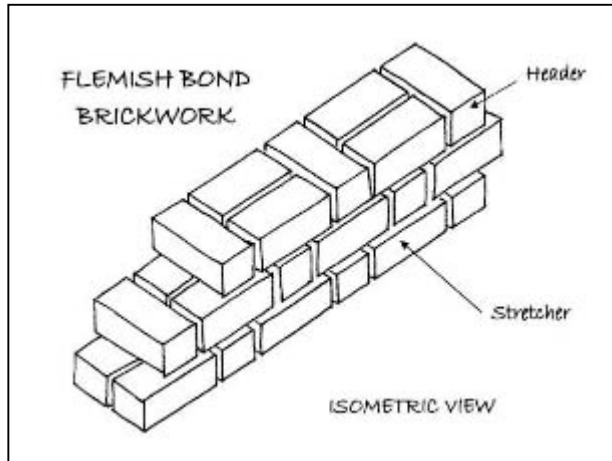
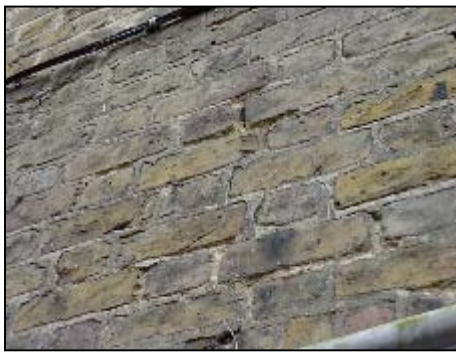
Unfortunately the re-pointing, whilst well meaning, is not appropriate for this type of construction. A cement mortar has been used rather than a lime based mortar. We recommend you use lime mortar in any future repairs regardless of what the builders say! Using lime mortar will limit further damage to the brickwork, which is almost impossible to repair successfully. However, we would add that many if not most properties have been re-pointed in this way.

Here is a typical example of how the pointing on the property, as you can see, in some areas is worn away. It is necessary to re-point these areas to stop dampness getting into the structure.

ACTION REQUIRED: When re-pointing is carried out we recommend a lime mortar be used, although there is a fair bit of life left in the existing pointing.

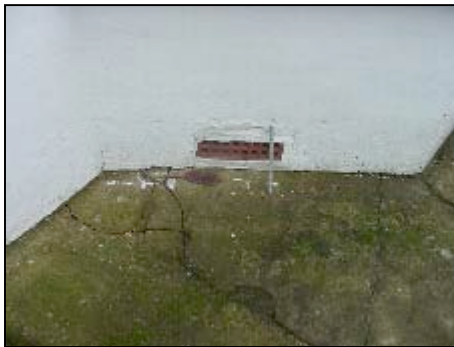
If you look very closely just above the airbrick there is a pen indicating where one of the holes for the damp proof course is.

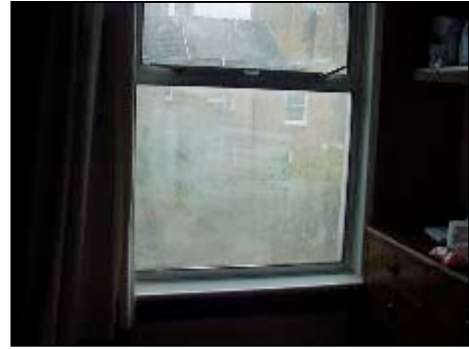
One of the rear aluminium windows, you can see how it is misting over with condensation.

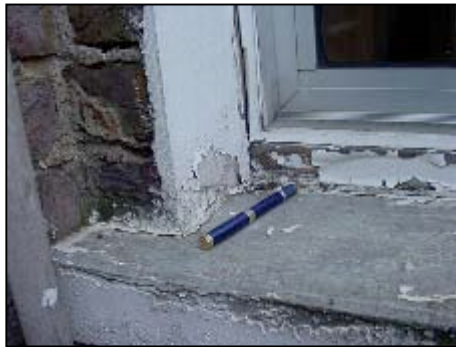
Decoration required

In this case, external decoration will be needed to the windows, the doors, the bay area and the rendered area in due course. Probably within the next three to four years. Do not underestimate the time this takes and the cost if you get someone else to do it.

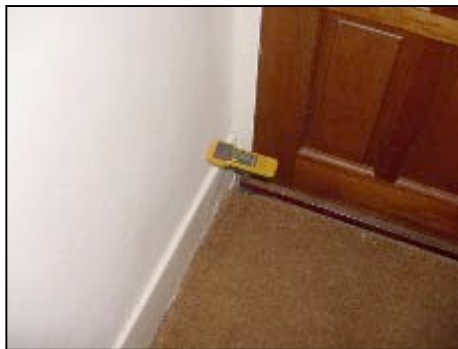
Minor dampness to the front door area, we feel within an acceptable limit.

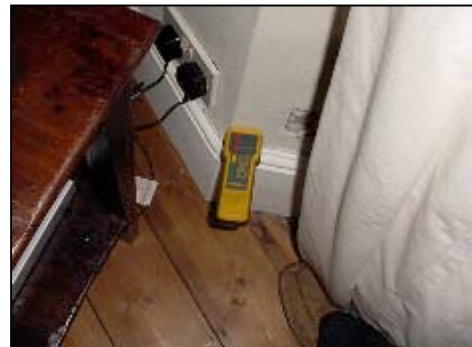
This is to the front bay where dampness again we feel is within acceptable limits

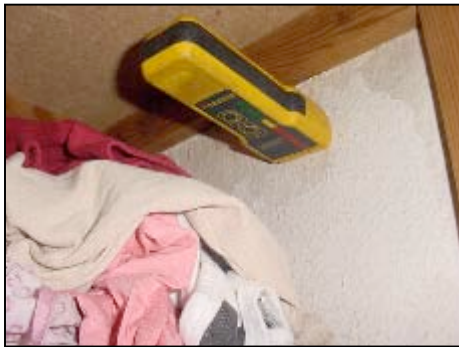
Dampness coming in through the walls

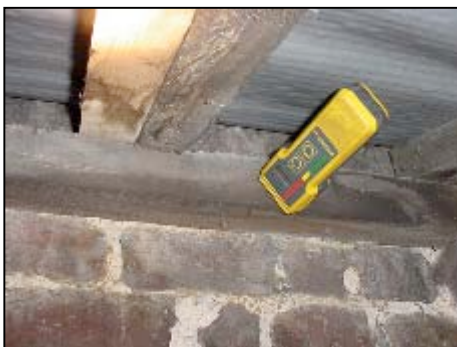
Some dampness is getting in to the roof space; this is probably due to the quality of flashings (although we have not been able to see them). Left Long term this would lead to wet rot and possibly dry rot. This is where we recommended that the flashings are replaced.

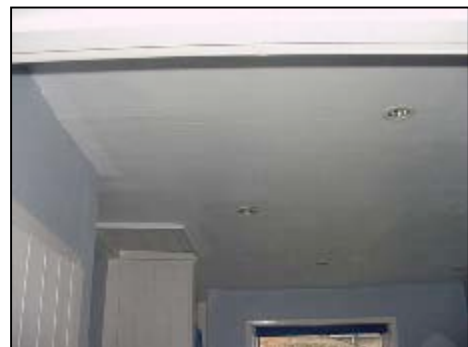
Ceiling Lights set within the bathroom
