**RESIDENTIAL BUILDING SURVEY
OF
A GEORGIAN CONVERTED FLAT**

FOR

Mr Flat

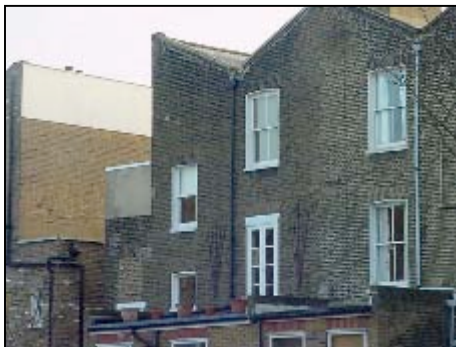
Butterfly roofs are renowned for their problems, particularly with a central valley gutter. To this one there looks to have been problems to the parapet wall surrounding it, which is also fairly common. Despite our best efforts we were unable to contact the people on the top floor.

Apologies for using the same photo again but it does demonstrate the butterfly roof. You can see the "V" shape in the roof to the rear of the property.

ACTION REQUIRED: Your Legal Advisor to specifically request information on the main roof and whether it is a shared responsibility and if so, what are the costs associated with repairing it when it is anticipated it will need to be repaired.

We are more than happy to return to inspect the roof if access can be gained via the top apartment.

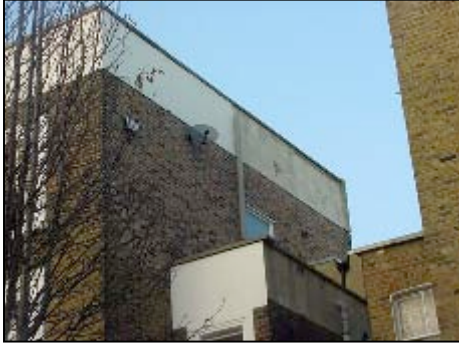
Here you can see the different finishes to the parapet walls, if you look at the white render to the top of the wall.

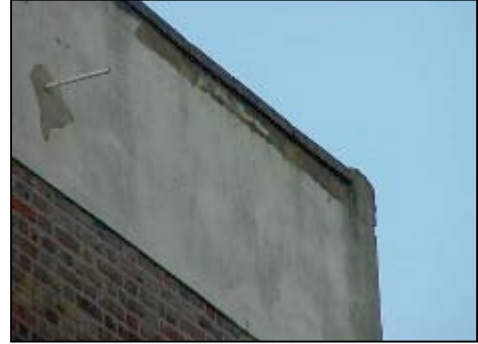
Here is a closer look at the parapet wall. You can see some repair work and/or some deterioration has occurred.

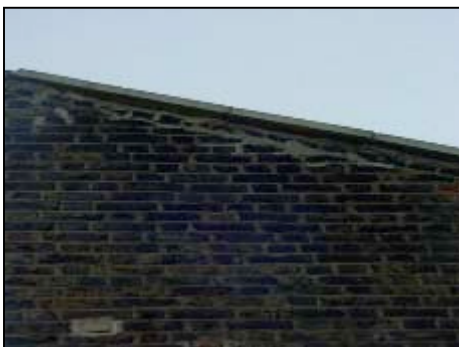
Although difficult to photograph, we believe there has been repair work to the butterfly roof.

ANTICIPATED COST: With regard to the roof work in general both in the first section and the second hairline cracking section, as this work is likely to need scaffolding it would be expensive to carry out and also the property is relatively high does limit the builders that are prepared to do the work. We would anticipate the costs for the repair works to be £10,000 (ten thousand pounds) plus depending of course on what is found. We assume this will be shared between the three parties but a quotation is needed due to the specialist nature of this work.

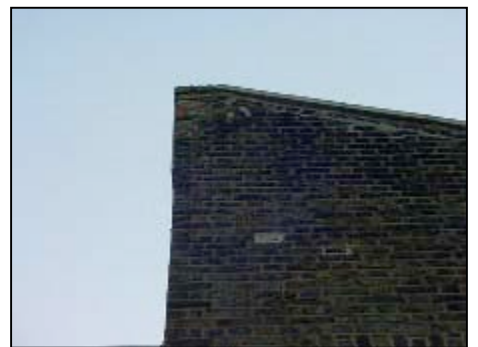
This is looking at the top of the parapet wall; you can see that some of the bricks have been repaired.

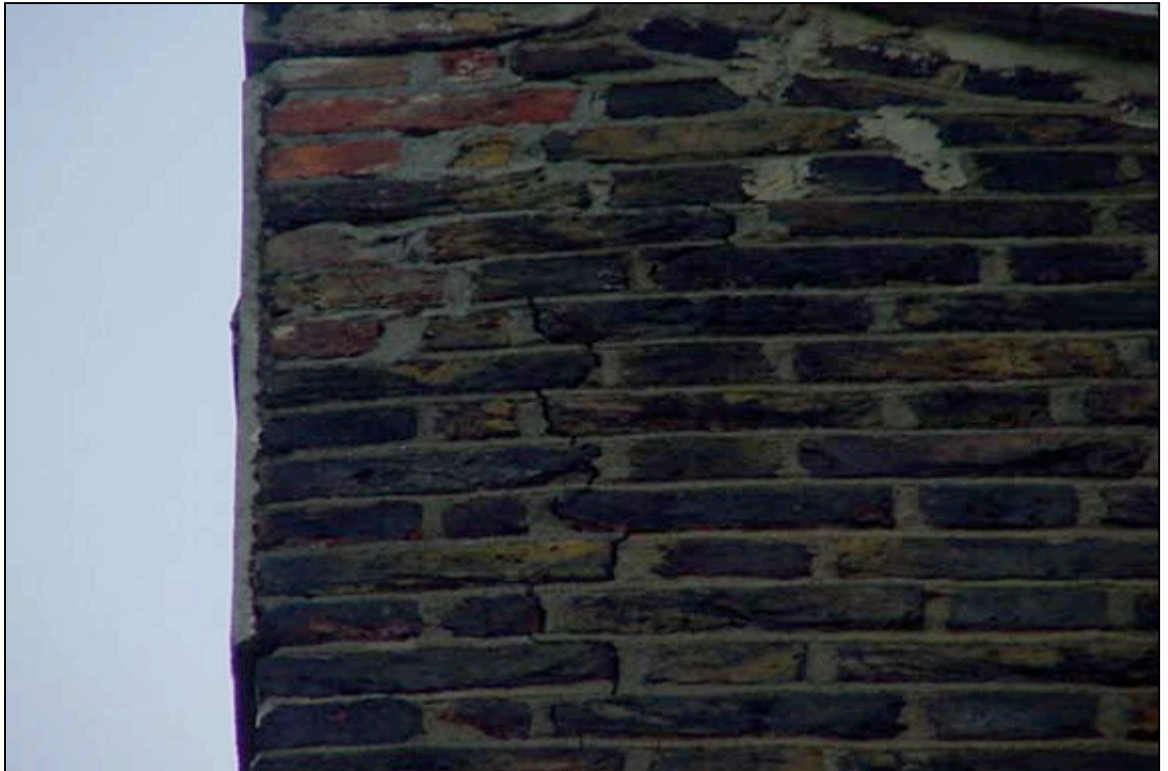
This photo is perhaps more revealing, you can see cracking in the brickwork that still has not been repaired.

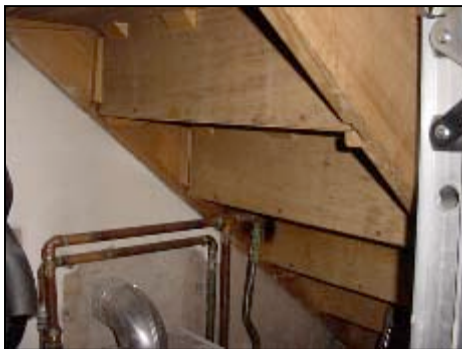
Rather unusually we can see the underside of the staircase within the boiler room. We do not feel that this is ideal as should there be any problems with the boiler or the electrics and there was a fire it would burn the staircase which is the main form of access for the top floor. We would expect this area to be lined with plasterboard within the “high risk” items that are in it. We assume that the boiler has been repositioned to this area at a later date, as have the electrics.

The underside of the stairs, you can see the boiler directly below it and the exposed underside of the stairs.

ACTION REQUIRED: Lining under the side of the stairs.

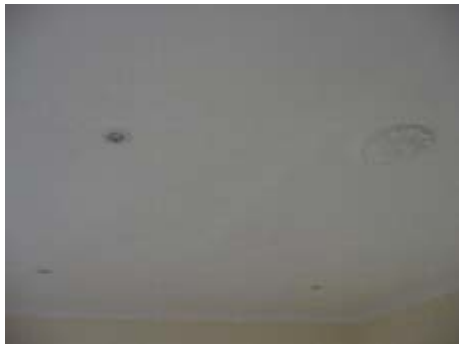
There are some ceiling lights. Older lights such as these give off heat to the rear and can be a fire hazard. You also may wish to add new or additional socket points added as minimal.

Ceiling lights to your property

ACTION REQUIRED: Have the lights checked by an NIC EIC electrician and also possibly extra electrical sockets added.

ANTICIPATED COST: A few hundred pounds.

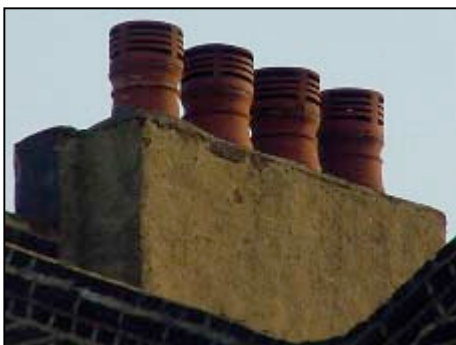
A photo of the chimney taken with a x16 zoom camera lens.

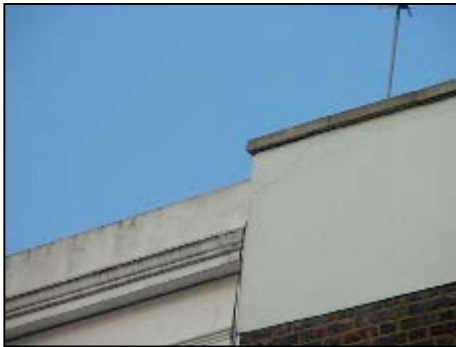
The different render finishes to the parapet walls. This may have been the original design or it may be that repairs have taken place.

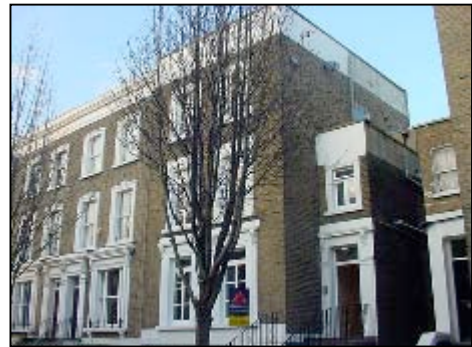
Here, if you look to the parapet wall to the top you can see the different colours indicating problems

In our educated guess as to what we would find rests upon the hairline cracking to the rear of the property we feel there could be dampness getting into the structure via the parapet walls possibly due to defective flashing, as this is a common problem. We simply do not know without getting into the roof or better still getting onto the roof.

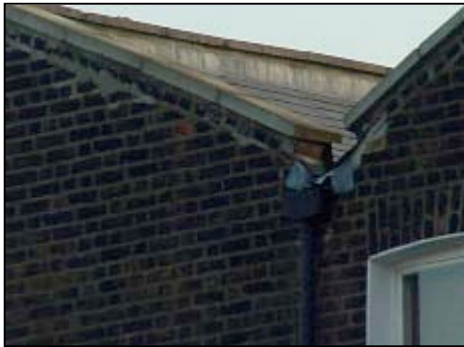
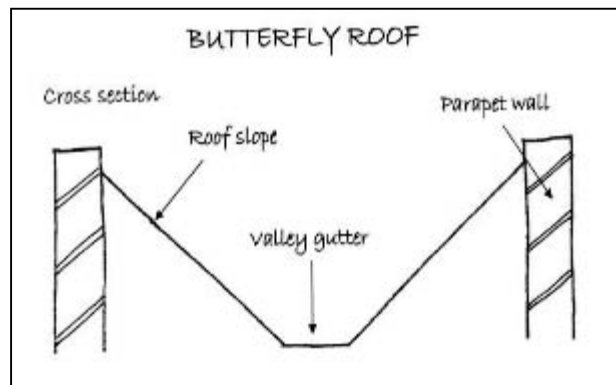
This is the very best view we have of the roof! Again, this was taken by a x16 zoom camera from the rear of the property. The roof finish looks to be in slate but we believe these are probably manmade slates.

This type of roof is renowned for problems with the central valley gutter and also to the outer parapet wall.

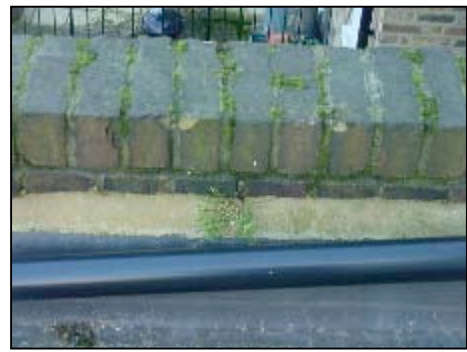
A close up of the parapet wall reveals that there may be some dampness getting in but this is likely to be minor (the correct detail for this is to have a capping stone on top of the brickwork to stop rain getting in from the top).

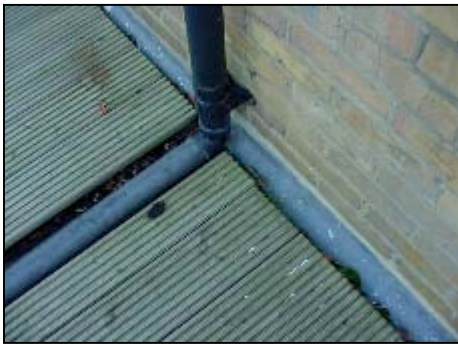
Our view of the asphalt was actually quite limited by the wood decking. We would comment that the wood decking has been added obviously at a latter date. It may start to get damp in the base of the property. This is because there should be two bricks between the ground level and the flashing. You can see it is almost level.

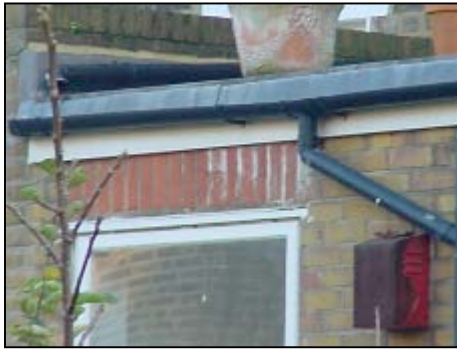
The main concern we have with this kitchen roof is the detail at the front of the property, which appears to allow the water to drain underneath the guttering and staining, and dampness is therefore getting into the kitchen area.

Here you can see the efflorescence on the brickwork where dampness is getting in. The easiest way to resolve this, apart from ensuring the gutters are kept clear is to add extra brackets to the gutters to make sure that it does catch the water or alternatively replace it with a deep flow guttering system.

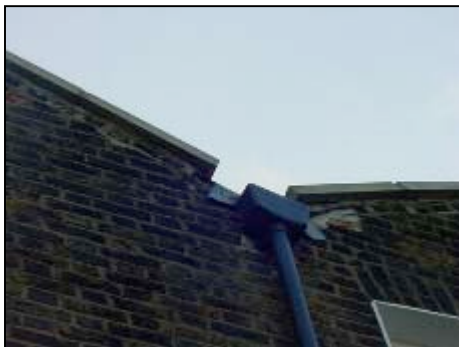
Typically what happens with this age of property is the hopper head is not large enough to contain the water from the roof during large downpours and therefore dampness can occur around the hopper head and downpipes particularly at roof level.

This is the hopper head to the rear of the property. You can see the lead around it; it should be dressed into the hopper head.

ACTION REQUIRED: Access needs to be gained to the top apartment. We would however take the educated guess that some dampness is getting. This may be your joint responsibility depending upon the Lease. We usually recommend that either a larger hopper head is used or as a more temporary measure additional lead is added and formed into the box gutter.

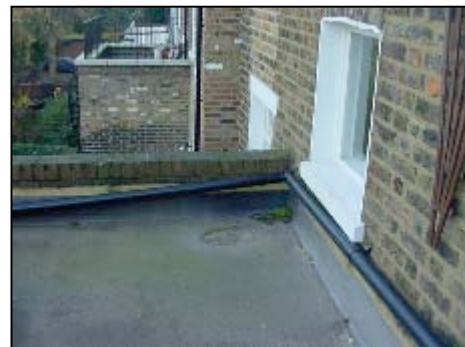
Some of the bends in the main downpipes at the rear of your property are very sharp. We are sure they leak when it rains. Rainwater drainage simply is not being filtered out very well.

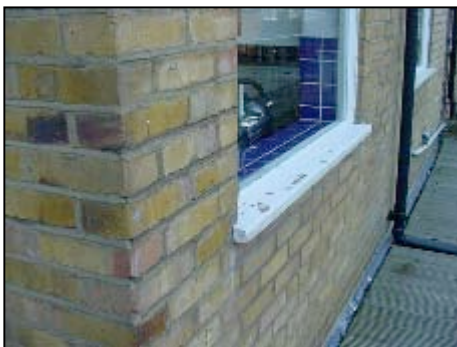
If you look closely in this photo you can see paint is peeling to the windows, we would class this as a DIY job. If you look in the gutters and downpipe section you will see part of the reason for this is that the water is discharging from the roof onto this area rather than into the gutters.

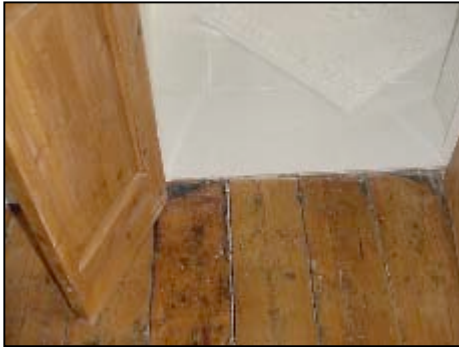
As is the fashion, the doors have been dipped and stripped of their paint, often unfortunately the process also effects the glue that has been used and ironically the timber used in these doors would not have been considered good enough to be exposed in the way it is today. We would term these doors to be in average condition for their age, type and style. Please see our comments within the Executive Summary with regard to the first floor doors, which should be fire doors.

You can see the bathroom door and also the timber flooring.

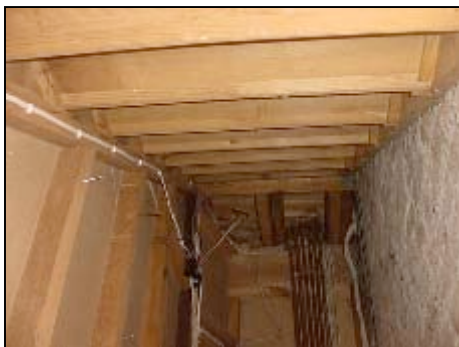
We noted that the underside of the staircase was exposed; please see our comments in the Executive Summary.

A view of the underside of the stairs.

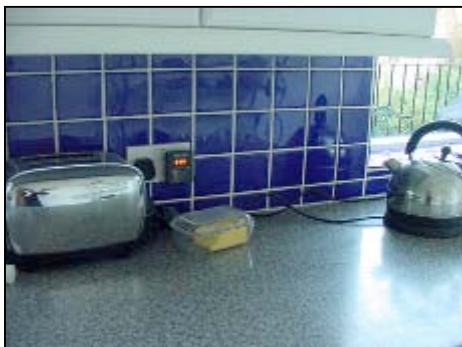
We carried out an earth test in the kitchen area to the socket point that is normally used for the kettle, this proved satisfactory.

Here we have carried out an earth check on the electrics. Here you can see the meter on the socket point.
