RESIDENTIAL BUILDING SURVEY OF Post War Semi Detached Property

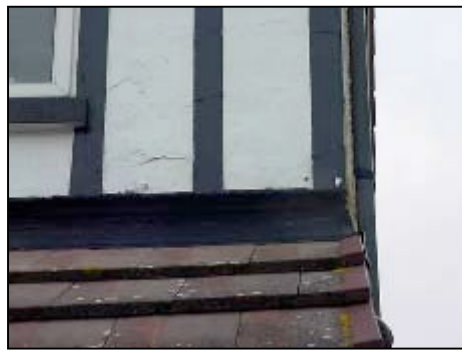
The render to the front of the property looks to be original, it looks to have been fairly recently painted over which we feel are hiding defective areas; we can see some areas where the paint is starting to flake.

If you look closely you can see the flaking paint to the white rendered areas.

ACTION REQUIRED: We feel that you will need to carry out some re-rendering within the next five years. Keeping the paintwork in good decorative order can prolong the life of the existing render.

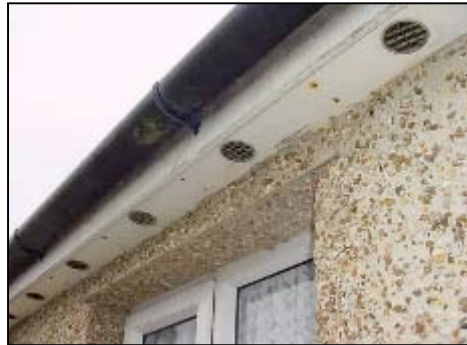
We are unsure whether the plastic cladding to the fascia and soffit boards is over-cladding; this is where plastic sheets are put over the original timber. This can cause the fascia and soffits timbers to rot and in extreme cases the rafter end. Please see our comments in the External Joinery Section.

A close up of the fascia and soffits. You can see also that the nails are rusting. The photo also gives a good view of the render and you can see the drip detail above the window indicating that it is a reasonable quality render to the back of the property.

ACTION REQUIRED: With a long ladder you need to closely examine the fascia and soffit boards. Some times the only way to find out for certain is to actually drill into the plastic sheeting to see if there is timber beneath.

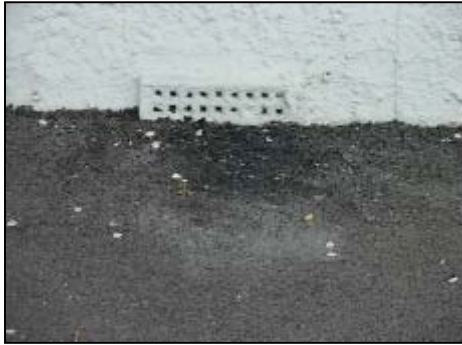
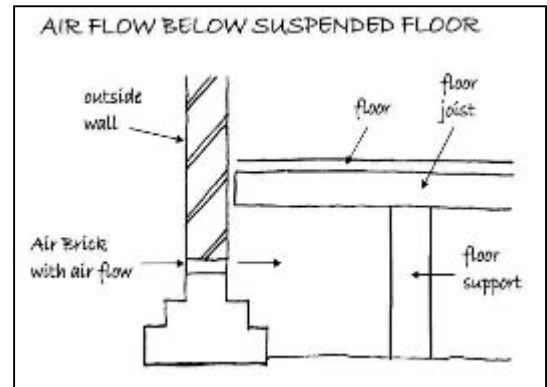
The Airbrick

Due to the way the tarmac at the front of the property has been lowered the ground level is now level with the airbricks (which are needed to vent the suspended timber floor), which are too low and are therefore susceptible to rainwater getting into them when it rains.

ACTION REQUIRED: We suggest a brick barrier is added around them, although this may stop next door from gaining access to the garage area.

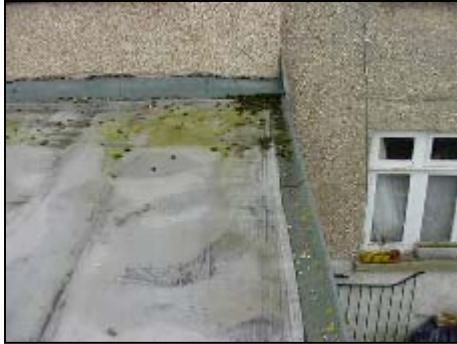
Flat roofs are renowned for there problems. This one does not look to have a suitable fall on it and it also looks to have been re-tarred indicating that it leaked in the past.

A general view of the roof. You can see where the moss is sitting; this means that there is minimal falls to the roof.

ACTION REQUIRED: We would recommend the entirety of the roof have a high performance felt added to it and that a lead flashing is used at the junction where the roof meets the house. The present owner advises us that insulation has been put into the roof voids but unfortunately we do not have any way of knowing this without opening the roof up. Insulation can be cut to falls “to allow the water to drain away.”

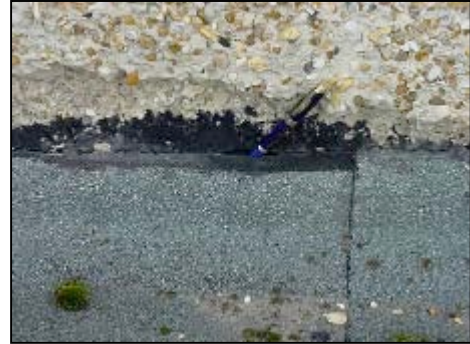
There are areas where the felt flashing is coming away from the wall, as can be seen here where I can get my pen literally behind the felt.

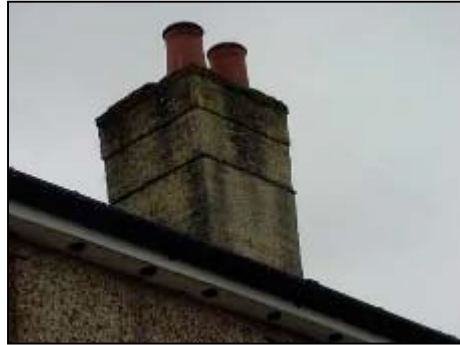
This again is a pea shingle render finished chimney with a lead flashing but is in below average condition particularly with regard to the top areas. Please see the photos and please see our comments in the Executive Summary.

Rear Chimney. You can see the darker areas which often indicate that deterioration/dampness is occurring to the render.

ACTION REQUIRED: We would recommend that this chimney is inspected within the next few years (you may as well look at the other chimney at the same time). You will need crawler boards and a ladder to access the chimneys.

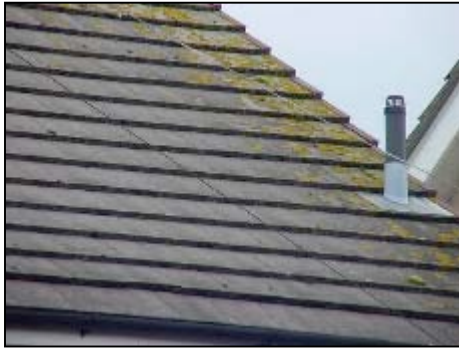
This photo shows a general view of the roof, some moss to the perimeter and also the flue that we mentioned earlier.

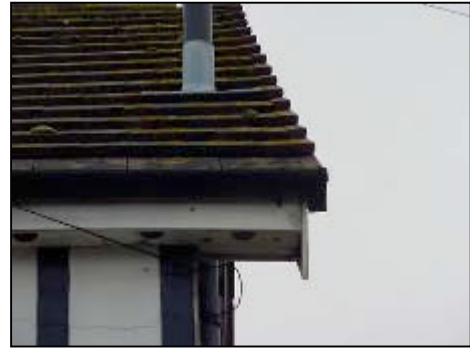
If you look closely at the tiles at the bottom of this photo you can see how they tip down rather than up.

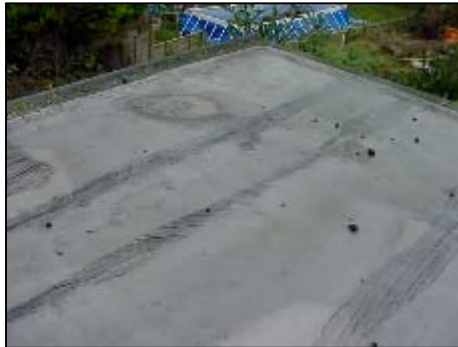
We believe this roof has an older style Bitumen. Brushed on tar looks to have been used, which bonds the various layers together. This requires skill, together with the right conditions. Where the bonding was not completed properly, this ultimately led to deterioration. In this case we believe the roof will need ad hoc repair in the near future which is why we have recommended the following works.

A general view of the flat roof. The picture shows where the roof has been repaired or badly bonded together which are the darker areas.

We would add that this felt sits on a timber decking. It does give and flex more than we would normally expect, therefore there might have been some deterioration to the decking or it may simply be too thin.

ACTION REQUIRED: Please see our comments in the Executive Summary.

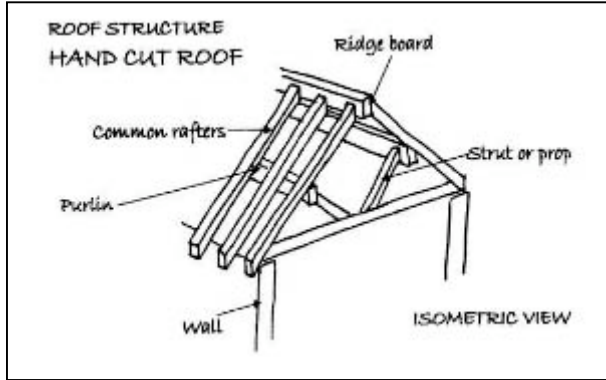
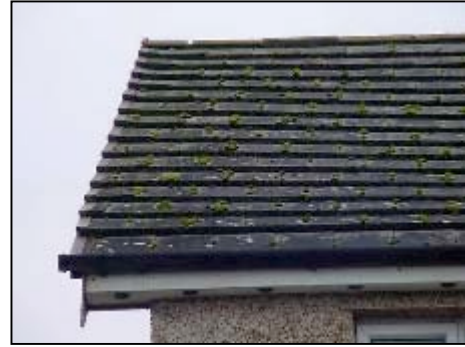
A general view of the roof, you can see the moss and you can also see some slight displacement to the ridge tiles, which will need re-bedding in due course.

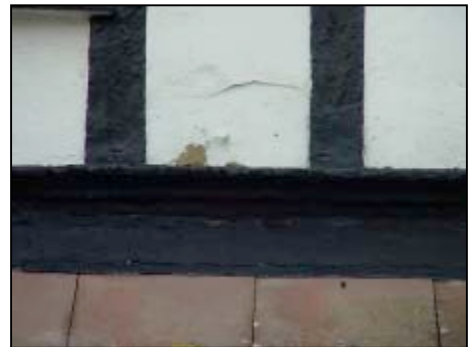
A close up of the flashing. You can also see some deteriorating render above it.

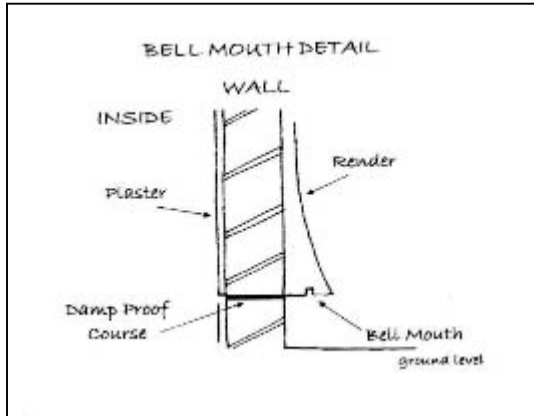
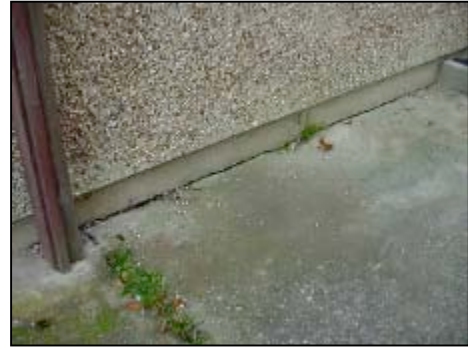
We noted a gap to the right hand side of the property. We suggest a mastic seal is run along the gap to stop water getting underneath it.

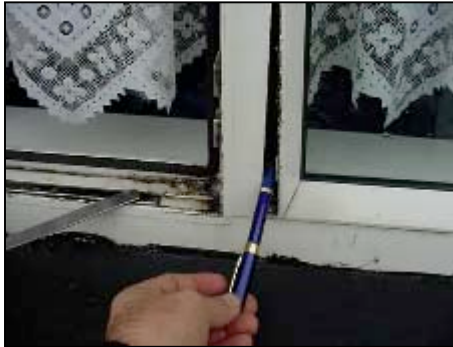
Some of the window beads are loose.

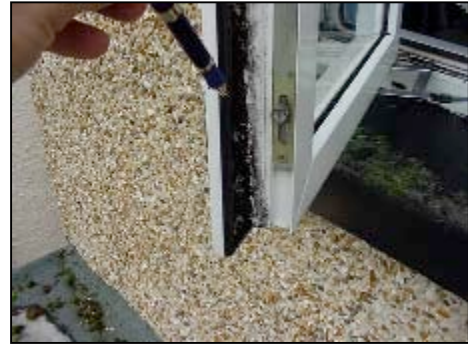
This for example is to the rear right hand bedroom window.

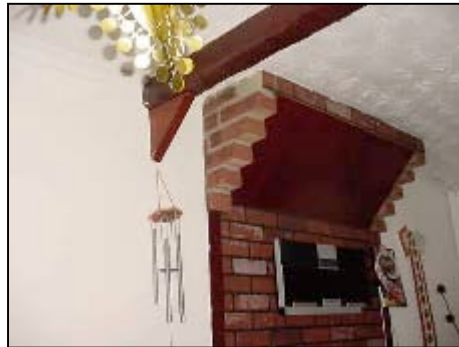
The chimneybreasts are located on the left hand party wall, the rear chimneybreast has been removed, the front chimneybreast follows through from the roof level to the ground floor (all directions given as you face the front of the property). Where the left chimney has been removed the chimney now needs venting to stop dampness from occurring in it (we did check it and there was no dampness occurring) but nevertheless it should have vents in.

You can see where the chimney has been removed. You generally find that where the brickwork is stuck back gives reasonable support.

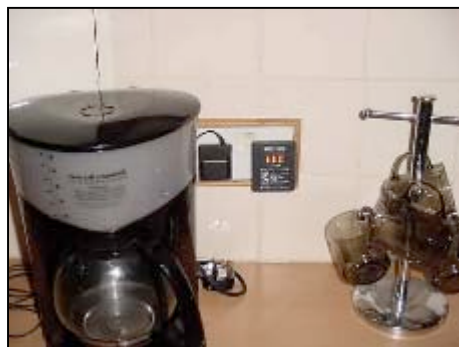
We carried out an earth test in the kitchen area to the socket point that is normally used for the kettle, this proved satisfactory.

Here we have carried out an earth check on the electrics. Here you can see the meter on the socket point.

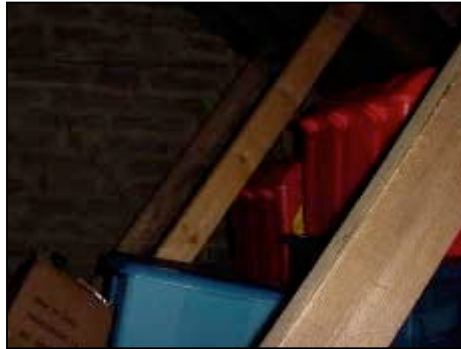
Unfortunately in this instance our inspection has been very limited due to poor light and access to the roof and due to the sheer amount of stored items in the property sometimes limited us to what areas we could inspection. For example the testing for dampness was fairly limited.

On the right hand side, you can see that the storage within the roof was stacked several boxes high.
