# PROPERTY REPORT

## Industrial Unit in Berkshire

We have been asked to inspect and prepare a Report and Schedule of Condition for an industrial unit in Berkshire.

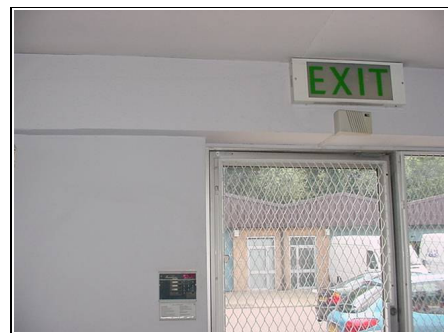
### 1) **Fire Regulations**

Currently the property is not to Fire Regulation standards, for example the fire signage needs to be changed.

**ACTION REQUIRED:** We would recommend that a specialist fire protection company is asked to visit the premises and advise. The rules and regulations relating to fire safety have recently changed and they will be in the best position to give you guidance on how to comply.

**ANTICIPATED COST:** In the region of a few thousand pounds. We would recommend that a quotation is obtained.

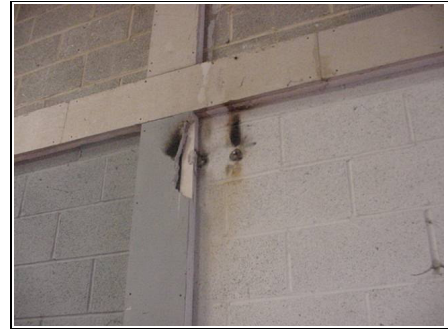
Throughout the property there is some impact damage, particularly, for example, in the warehouse areas to the columns, and general damage. All of this needs to be made good.

Impact damage

**ACTION REQUIRED:** Repair impact damage.

**ANTICIPATED COST:** This should be carried out as part of the redecoration work at the existing Lessee's cost / the Landlord's cost.

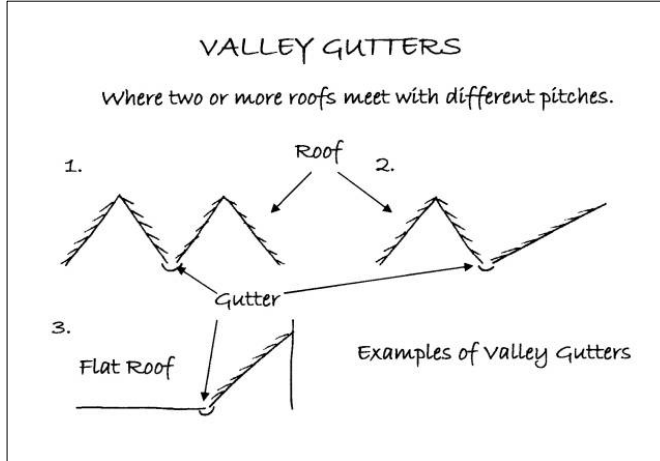
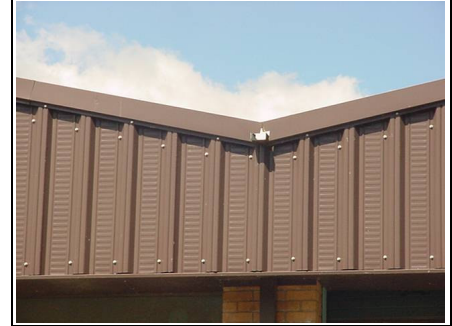
#### 4) Roof

We have experienced problems in the past with this type of valley gutter roof. This is a valley gutter roof with a hidden drainage.

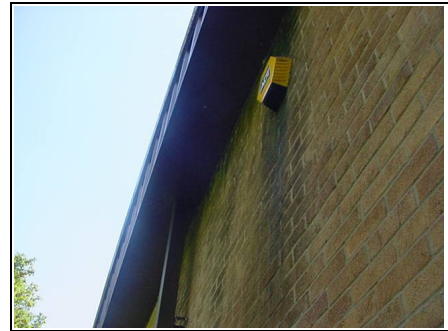
To the rear of the property green mould can be seen to the brickwork, indicating to us that there are leaks in the area of the roof.

**ACTION REQUIRED:** The roof needs inspecting prior to legally committing to purchase the Lease.

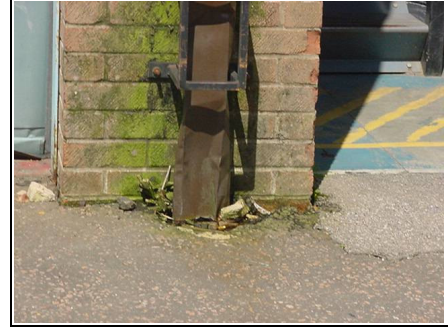
Whilst some of the downpipes are internal the downpipe to the front right hand side is visible externally and green mould could be seen around to the brickwork, indicating that the pipe is blocked or is partially leaking.

**ACTION REQUIRED:** You need to inspect this next time it is raining. You may need to add a rodding eye and rod into the drains.

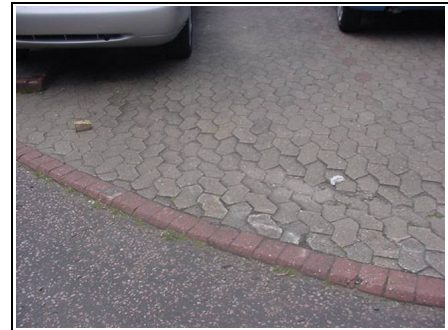
The block paving to the parking area has settled unevenly. This usually occurs due to the bed that it has been laid on not being prepared correctly.

**ACTION REQUIRED:** To resolve the matter would normally require the digging up of the block paving, forming a new bed, and re-bedding.

**ANTICIPATED COST:** In the region of a few thousand pounds.

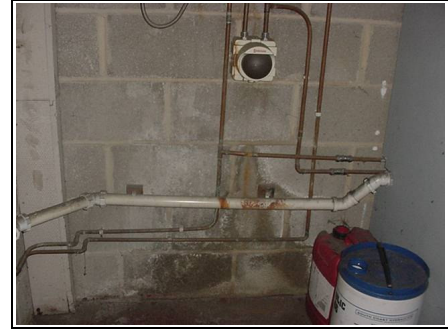
Within the warehouse area there is various wiring and piping that is exposed that really needs either boxing in or placing into conduit.

Pipework from kitchen (obviously if expect to remove the kitchen there is no need to do this).

**ACTION REQUIRED:** Box in pipework and wiring.

**ANTICIPATED COST:** A few hundred pounds.

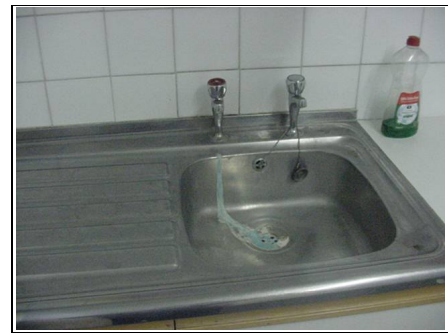
Generally the sanitaryware would benefit from a good clean. Also, there looks to have been a build up of scale in some areas.

**ACTION REQUIRED:** General good clean.

**ANTICIPATED COST:** A few hundred pounds.

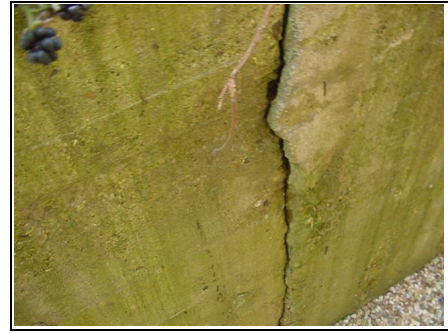
To the rear of the property there is a retaining wall in which we noted some movement cracks. We are uncertain whether this wall is the boundary wall as we have not seen a copy of the Deeds. You need to establish who has responsibility for this wall.

**ACTION REQUIRED:** Your solicitor to establish that the rear retaining wall is not the responsibility of the Lessee.
