# COMMERCIAL BUILDING SURVEY

**A Two Storey Hotel situated in Southport**

**GEM Associates Limited**

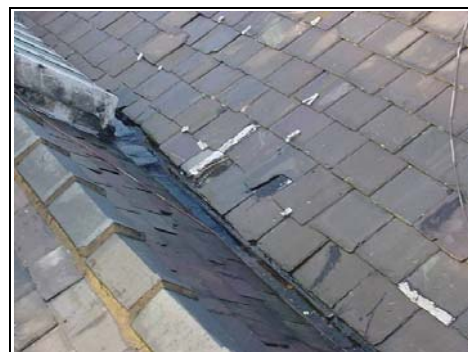
The pitched roofs have been considerably repaired due, we believe, to nail sickness and dampness getting into the roof valleys; water was literally sitting in the valleys at the time of our inspection.

Nail sickness is the rusting of the nail fixing points. These have been secured in place by lead tingles.

Lead tingles to the valley gutter

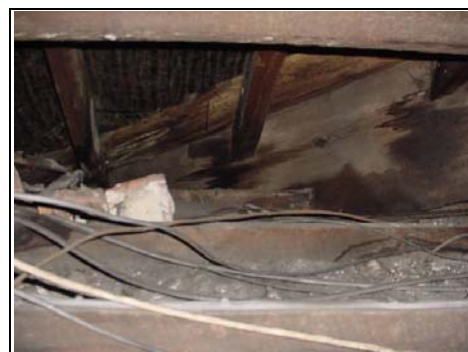
Dampness visible to the base of the roof timbers adjacent to the valley gutter.

We recommend that each of the roofs are not only made watertight but have ventilation added to them.

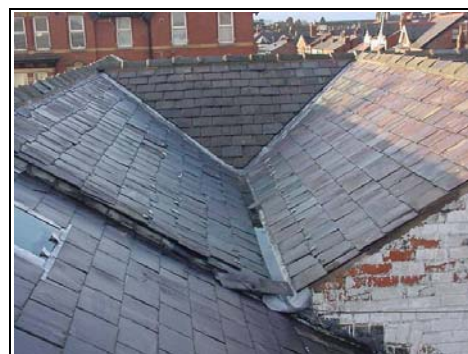
Valley Gutter

We believe a special mention should be given to the valley gutters. These are very problematic areas and are generally prone to leaking. In this case we could see from within that the valley gutters have leaked in the past.

**ACTION REQUIRED:** Repairs are needed to the pitched roof. They don't need to be carried out instantly but they certainly need to be carried out within the next three years, possibly sooner. We were quite surprised that we did not see much more dampness inside.

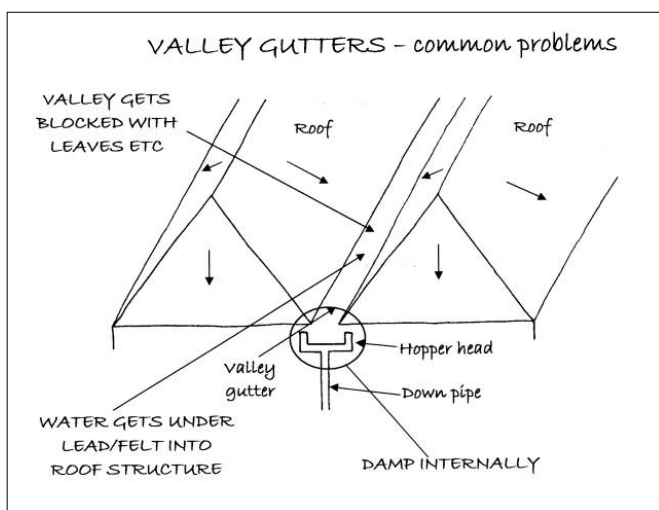
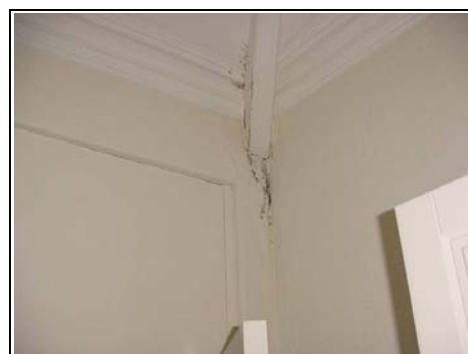
Dampness coming in via the valley gutter

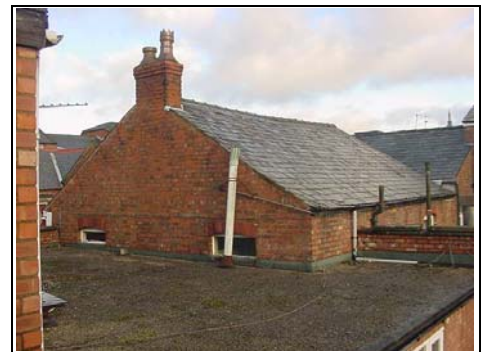
Flat roof adjacent to shop

Whilst we haven't had direct access to this roof we were able to view it from the rear of the property. We noted moss sitting on this roof, which indicates that it is a 'flat' flat roof without the rainwater being able to discharge from it.

**ACTION REQUIRED:** We believe that patch repairs are required to this roof at present and ultimately we would recommend again that insulation cut to falls is added and a high performance felt is used.

We would also recommend for this roof and the previous roof that lead flashings are used rather than the present felt flashings. Estimates should be obtained.

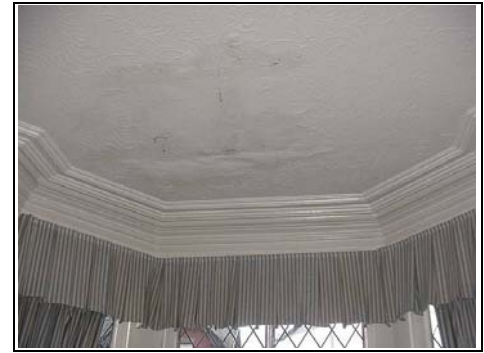
We could see that some water has been getting in via these smaller flat roofs, for example to the front left hand bay there are repairs indicating that there has been dampness coming in through this roof for some time.

**ACTION REQUIRED:** We often find with bay window roofs that it is a simple case of the downpipes needing repairing and patch repairing. Unfortunately we have not been able to see into these bay window roofs.

**ANTICIPATED COST:** We would suggest you set aside a sum of £3,000 for patch repairs. Estimates to be obtained.

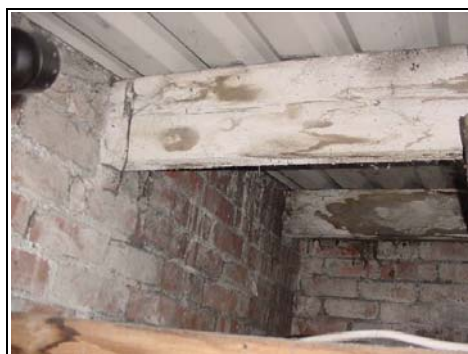
We inspected within the roof space and noted that there is dampness getting in caused either by rain getting in or condensation. This is causing rot into the timber members and also rusting of the structural steels.

Dampness

**ACTION REQUIRED:** Typically dampness gets in on this type of roof via the bolt fixing points and the usual way of resolving this is to mastic around these bolt points, but great care needs to be taken as more damage than good can be caused in some instances.

We would also add that we would suspect that there would be condensation in this roof space when the property is occupied and we would therefore recommend that ventilation is added to the roof.

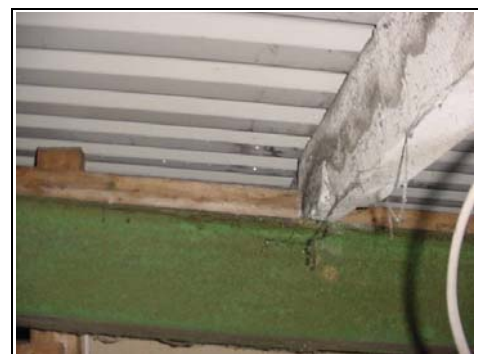
Corrosion to the metal 'I' beam

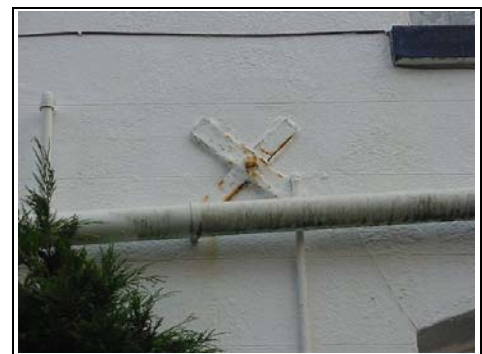
We could see that there has been some movement in the property from many years ago which has had tie bars / bracing added.

Tie bar / bracing

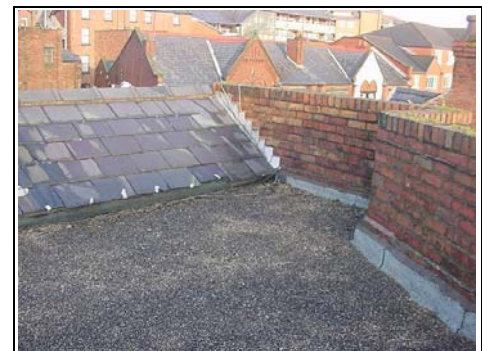
Parapet wall above the deteriorating gable.

**ACTION REQUIRED:** We recommend a coping stone is added to the parapet wall in the first instance to stop water from penetrating from the top of the wall. We also recommend that lead flashings are added.

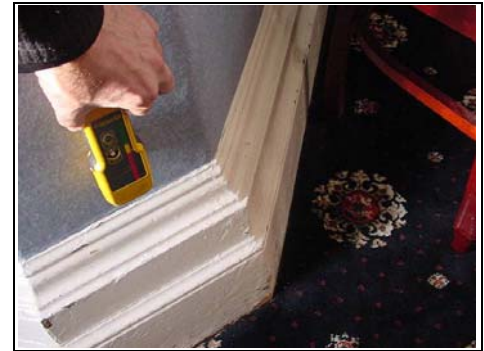
Finding rising damp to the front of the property

**ACTION REQUIRED:** We would recommend that a French drain is added, however is difficult to identify where the French drain would drain to. Ideally a soak-away should be added.

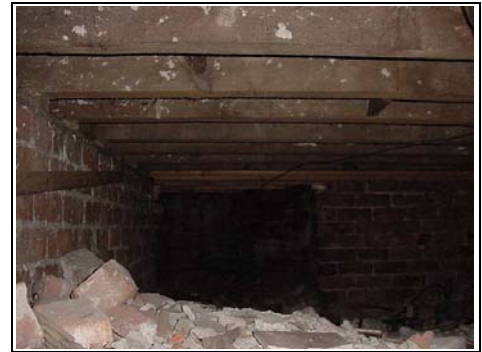
We feel that there is a good chance that further work will be required to the timbers. Within the cellar we took the adjoining photo. If you look carefully you can just see the lighter timbers; these are timbers to the bay window area which have been replaced. This is fairly common in properties of this age; it nevertheless does not stop it from being expensive!

**ACTION REQUIRED:** This is why it is essential to carry out the French gulley work we have mentioned and once this has been carried out we would recommend that the floor joists are checked carefully.

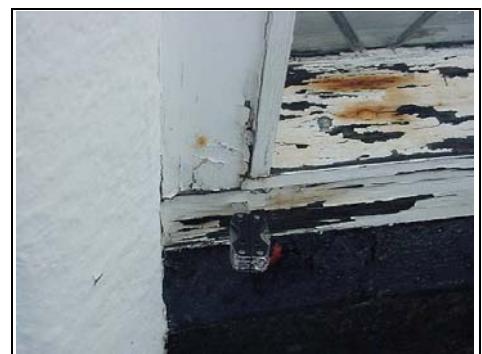
We have tested a selection of the timber windows (at ground floor level) with a knife, by literally pushing it into them, and we found there to be 30% - 50% rot within them. We do believe these windows are 'saveable' and believe this is probably the most economic way to carry out repairs, although ultimately you may wish to replace some of the timber casement windows with a modern plastic equivalent or more appropriate period window.

Our knife going completely into one of the windows

**ACTION REQUIRED:** You will need to carry out a proper repair and redecoration of the windows and render.

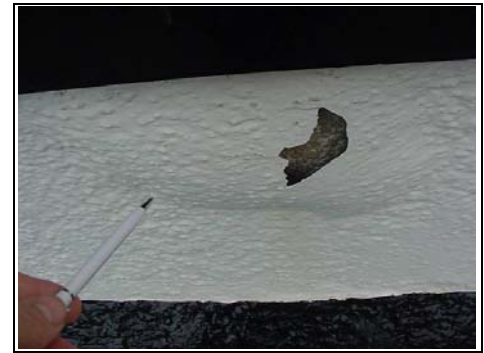
The render looks to have been painted to sell. There was a paint blister in one area that we popped to reveal degraded paint beneath.

Popped paint blister

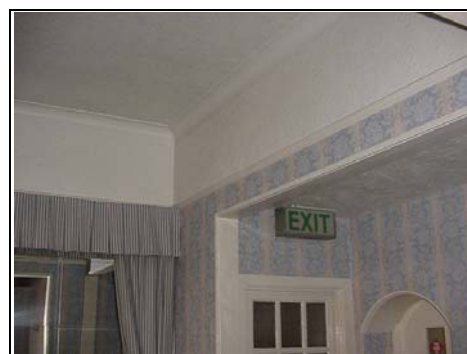
Old style fire exit signs are still in place.

We noted that some illuminated fire exit signs still had the wording rather than the pictorial fire exit definition that is now used. The aim of an illuminated sign is to give a safe egress should there be a fire or an emergency.

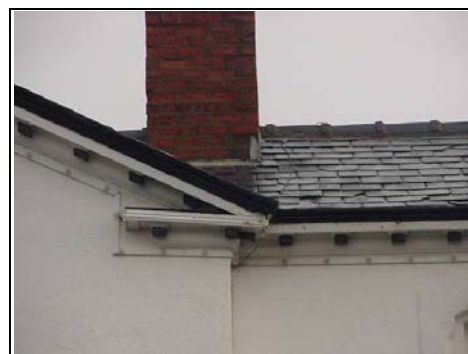
This is a substantial brick chimney finished with two metal cowls. We also noted a vent pipe part of the way up the brick chimney, indicating possibly that one section has been capped. There is a lead flashing to the base.

**ACTION REQUIRED:** The chimney looks to have been repointed. We suggest that a close inspection is carried out when the valley gutters are attended to in a year or so. There is nothing immediately urgent.

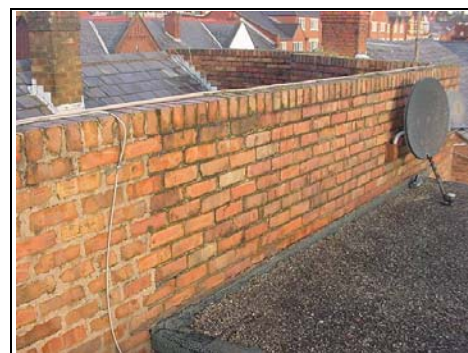
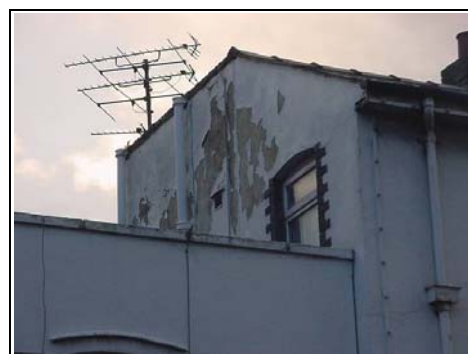
The sort of damage this dampness causes is particularly visible to the gable end on the left hand side where the paint and the render is being affected by it. The wall is literally saturated by dampness coming in via the parapet wall and possibly now via the deteriorating render.

**ACTION REQUIRED:** Initially we would suggest you put coping stones across the entirety of the parapet walls, ideally removing two courses of brick and adding a damp proof course. Also all the flashings should be replaced with lead.

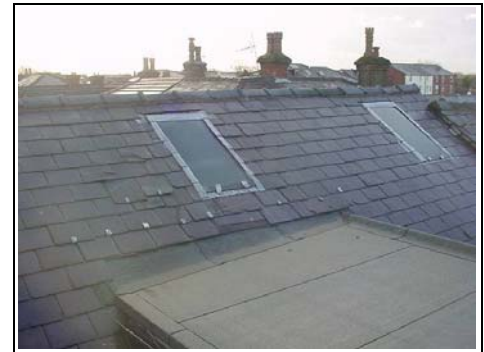
Older style roof windows

It seems inevitable with this type of roof window that leaks will occur sooner or later. If this doesn't occur then they seem prone to condensation. Keep a cloth handy!

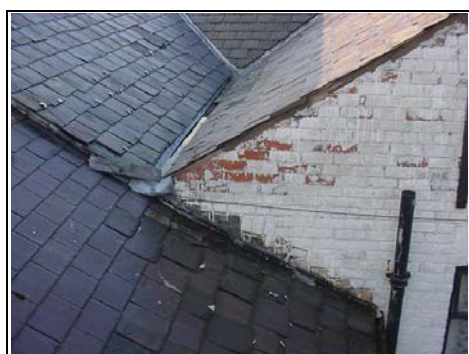
Here we're looking at the base of the pitched roof where it meets the valley gutter and you can see the dampness.

We would comment that valley gutters will leak unless regularly maintained. Please see our further comments in the Executive Summary.

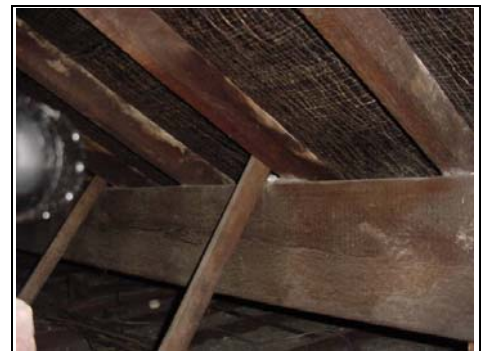
In the front left hand roof when we inspected the loft space we found a Hessian based Bitumen membrane. This type of membrane has been used since the 1960s. We generally found it to be in average condition, it's damaged in a few more places than we normally find.

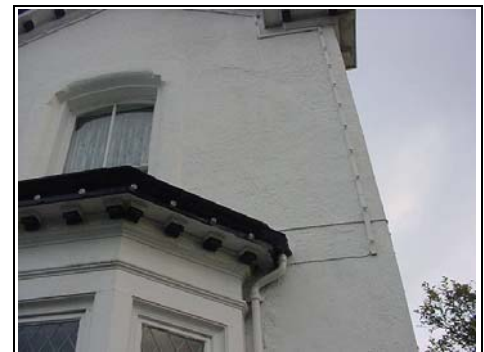
Bay Window Flat Roof

There are various smaller flat roofs that are around the property, for example over the bay windows. There look to have been leaks coming through in these areas in the past which are usually due leakages in the downpipes. We note that the bay window has a smaller downpipe than would commonly be used today, it looks to be two inches (50mm) and typically four inches (100mm) is used today.

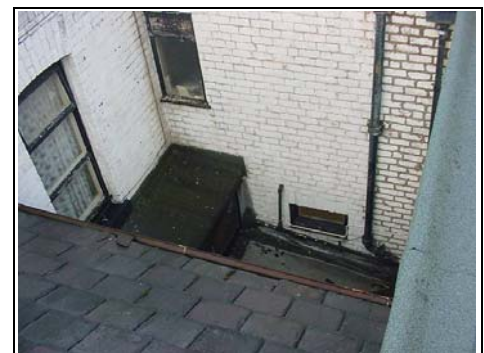
Central vaulted area

When we were on the main roof we noted that there is a central open area that has various roofs in. It looks to have suffered in the past from leaking gutters.

**ACTION REQUIRED:** We would recommend that a wide gutter is added (often known as a deep flow gutter) as this area really does need a permanent solution as any problems will be unseen until major problems occur. It would also be worth repairing or replacing the cast iron downpipe.

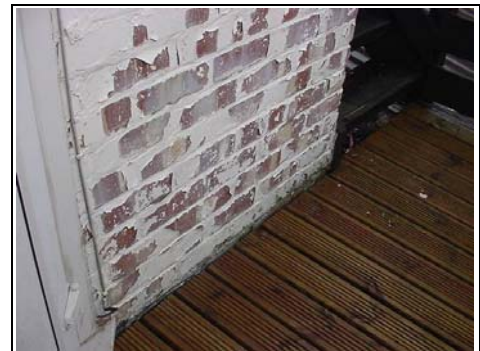
Likely to have been caused by leaking  
gutters and downpipes

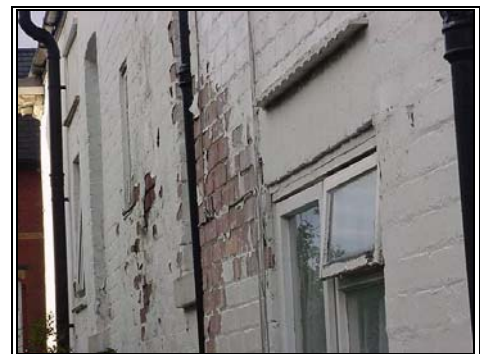
We also noted areas where the brickwork has been painted and the paint has flaked off; we believe this relates to leaks from the gutters and downpipes. It is slightly unusual to paint modern brickwork as brickwork is normally painted to stop dampness getting through, which doesn't generally occur on modern brickwork.

Paint coming off the wall due to leaking gutters and downpipes

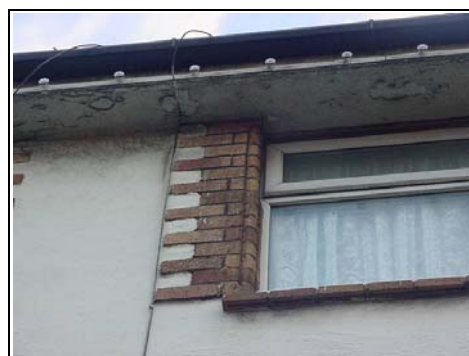
Fascias and soffits in below average condition with peeling paint

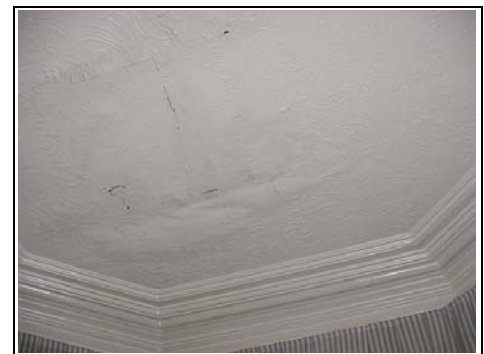
Leaking ceiling underneath  
the bay window

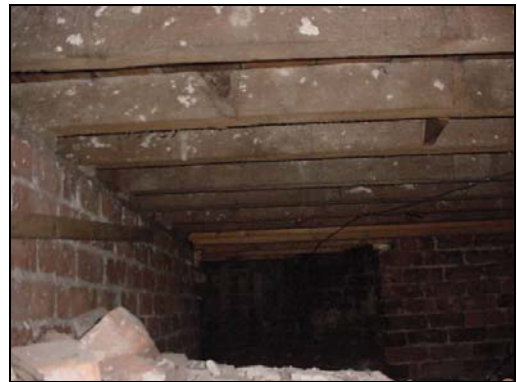
We noted new timbers under the bay window area. The owner when questioned confirmed that they had been replaced.

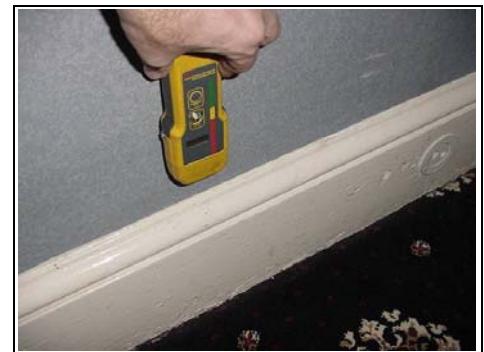
We found rising damp to the front and side of the property

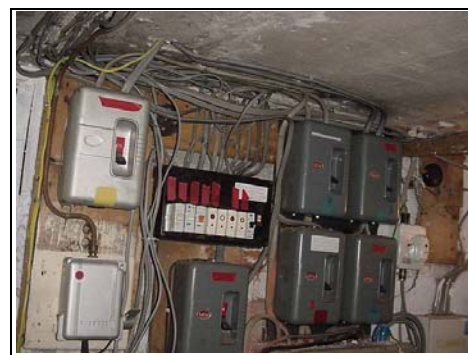
Dated fuse board in the cellar

We recommend that the dated fuse board in the cellar be replaced.
