# COMMERCIAL BUILDING SURVEY

## Industrial Unit, Warwickshire

***GEM Associates Limited***

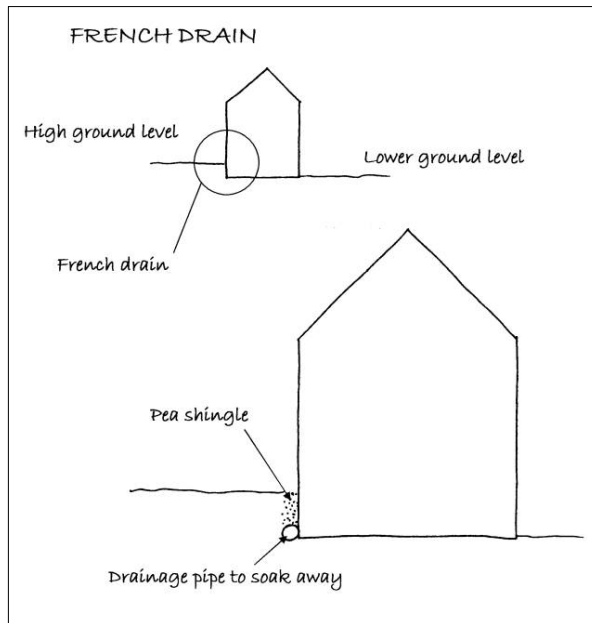
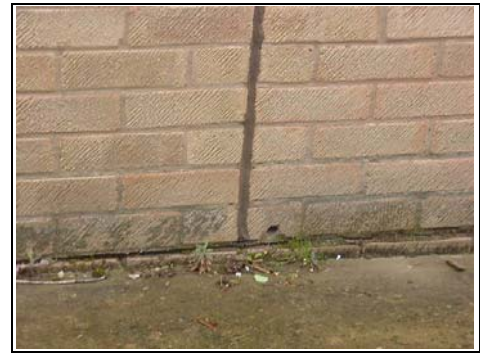
Currently on the left hand side of the property the level of the external concrete roadway is above the damp proof course and will cause rising damp and also deterioration in the area in general.

**ACTION REQUIRED:** We would recommend a French gully is added, approximately 100mm to 150mm wide and filled with pea shingle. You need to ensure that the French gully is suitable for the traffic that you will have passing over it, such as the fork lift trucks you advised us about.

**ANTICIPATED COST:** A proper French gully which drains into nearby drains using a perforated pipe; should cost in the region of £3,000 - £5,000. Quotations should be obtained.

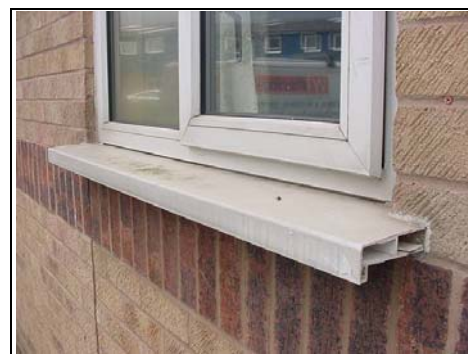
It would be fair to say the double glazed windows are from the cheaper end of the market. We make this comment based on lack of trickle vents, the thickness of the profile of the units and the misting over of some windows which are typical of cheaper quality double glazed windows.

End caps missing

**ACTION REQUIRED:** The dilapidation work should cover the fitting of end caps, the windows and also need a general clean and any windows that are misting should be replaced. You may wish to consider renewal as part of the presentation of the front of the property.

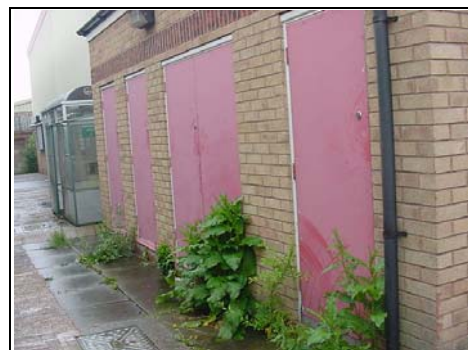
All doors require redecoration and repair.

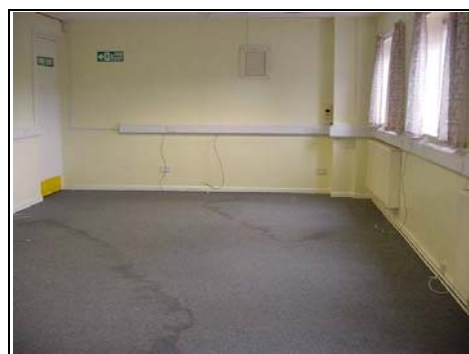
There is damp staining to the front right hand office and the floor is lifting. Further investigations needed are required. The best case scenario is that this is a poorly laid screed; the worst case scenario is that there are some problems with the foundations in this area.

**ACTION REQUIRED:** Existing owner to allow for the floor to be opened up so that we can have access to comment further.

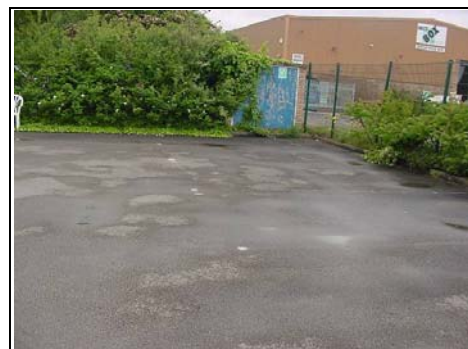
The car park entrance requires resurfacing; however this may be the Local Authority's responsibility. However, you may wish to carry out this work as obviously the entrance area gets far more traffic than the remaining part of the car park. We also suggest that the redundant planter is brought back to life or removed.

We were unable to find a drain from the car park, this does mean that it will tend to deteriorate quicker

Car park to front of the property. White lines and disclaimer notices are needed.

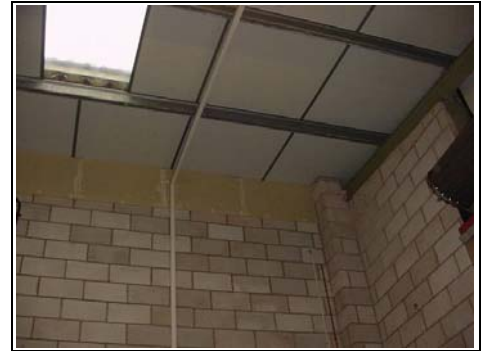
If you look closely at the adjacent photo at the skylight and you look carefully just above the steel beam you can see the curve of what looks to be Big Six asbestos sheets.

**ACTION REQUIRED:** Your solicitor needs to specifically request information relating to the existing roof and to obtain certificates showing the asbestos has been removed; if it has not been removed then you need to obtain certificates showing the condition it is in. We are not asbestos surveyors but we would recommend that the roof is opened to confirm that there is no asbestos in it. It is a legal requirement to have an Asbestos Register.

**ANTICIPATED COST:** If this is a worst case scenario and the asbestos roof is still in place you need to establish its condition; if there are no records available then the roof needs to be opened up.

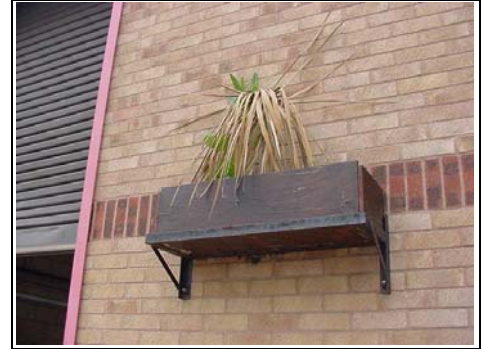
The last remaining planter!

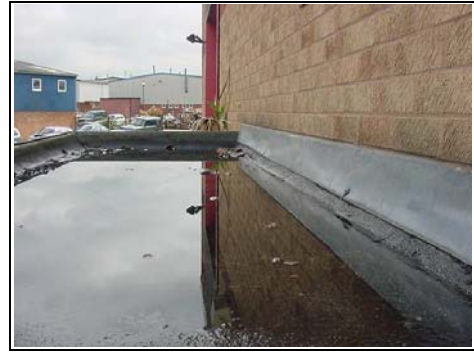
Ponding to Roof

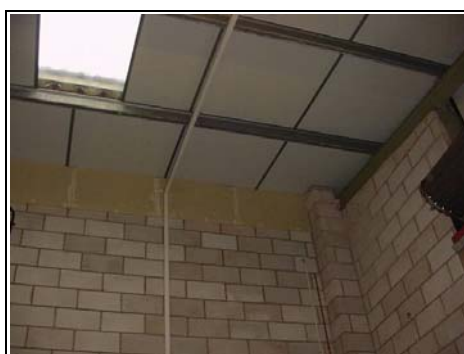
Looking at the Ceiling from the mezzanine floor. If you  
look very closely at the roof light we can see what looks  
to be a curved edge of an asbestos sheet. This is known  
as Big Six

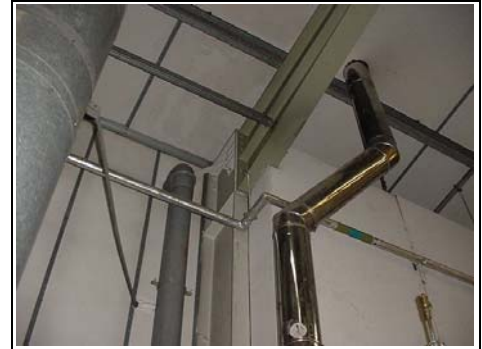
The internal downpipe is to the centre of the photo

**ACTION REQUIRED:** We would always recommend that the gutters and downpipes are cleaned out, the joints are checked and the alignment checked to ensure that the gutters fall towards the downpipes.

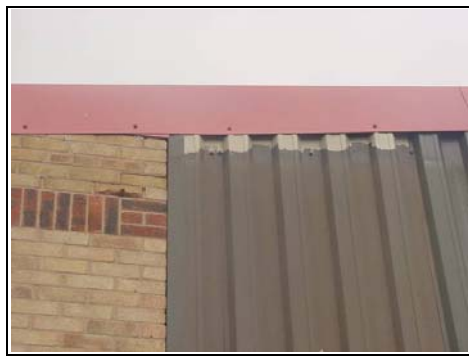
Cladding unfinished

**ACTION REQUIRED:** We would recommend that a section of the cladding is opened up, this can be carried out internally to see if there is asbestos beneath.

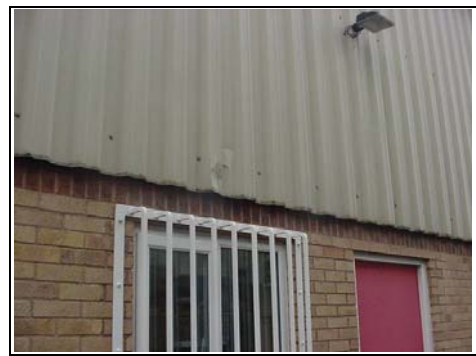
There was various damage and deterioration to the cladding. This should be dealt with under the dilapidation works. However our main concern is if there is any asbestos underneath this cladding, we think there maybe to the roof structure.

Typical damage to cladding

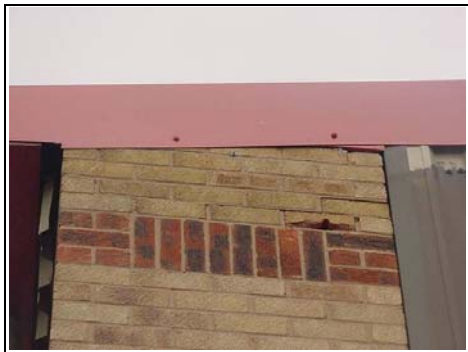
Front left hand side Brickwork – Minor movement probably due to the brickwork not being tied in properly and / or impact damage.

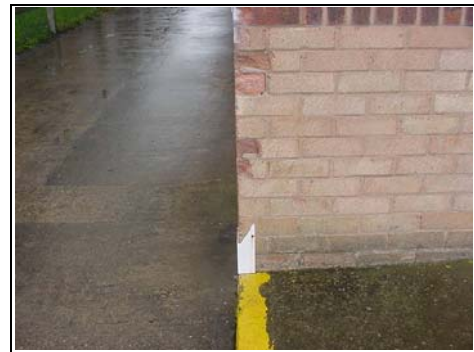
Impact damage to Front left hand corner

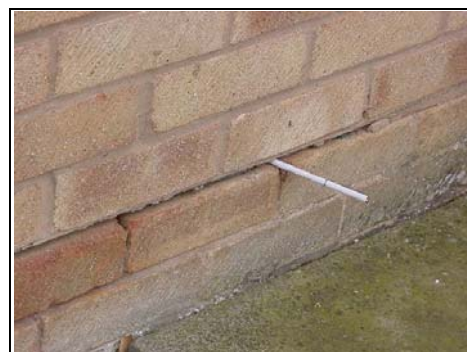
Damp proof course at correct level.  
Note re-pointing required.

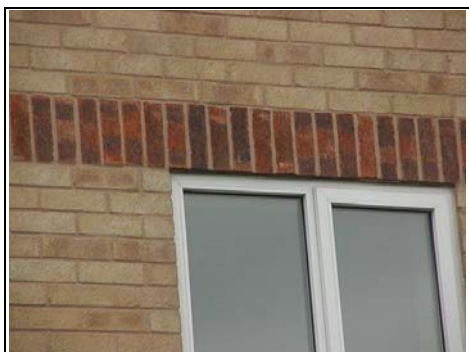
Plastic windows – from the cheaper end of the market

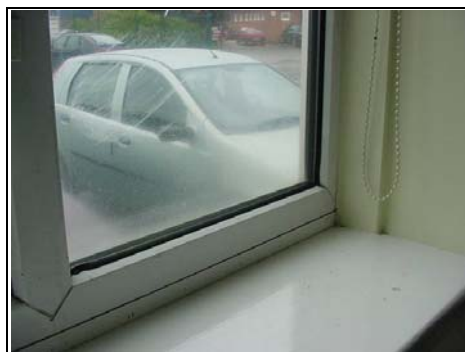
Some of the windows are misting over

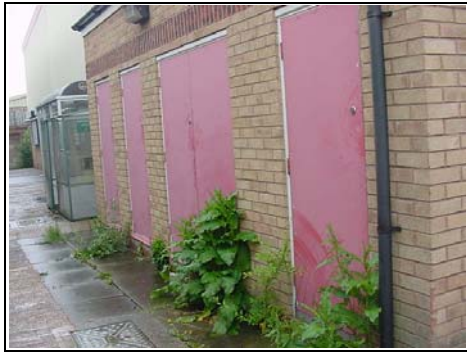
All the doors need repair and redecoration

They should all be replaced/repared as part of the dilapidations of the property.

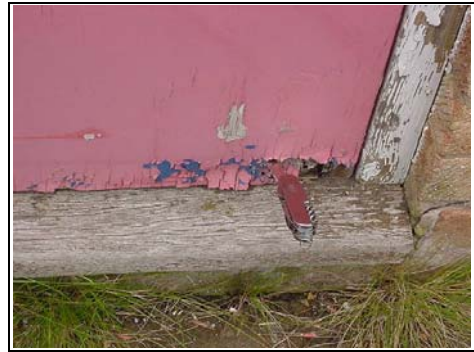
Deterioration to base of door

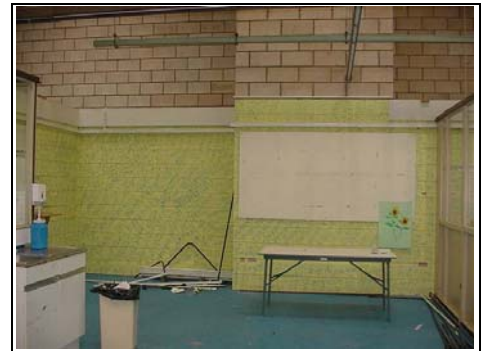
Walls to right hand side offices and toilets to be redecorated

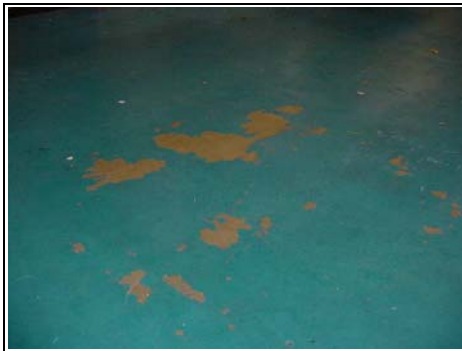
Minor damage to floor within Services Room.

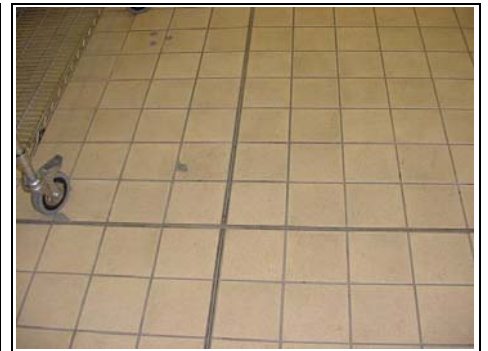
Tiles to kitchen floor to be removed and made good

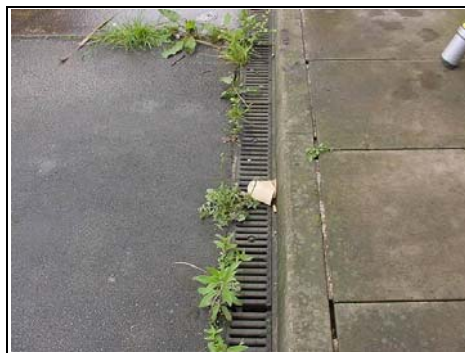
General maintenance required
