SCHEDULE OF CONDITION

PREPARED IN XXXXX
OF
A Good Food Country Pub

The Schedule of Condition has been prepared by GEM Associates Ltd in xxxxx. The inspection was carried out on Tuesday xxxx and xxxxx. This report does not constitute a Structural Survey (now known as a Building Survey).

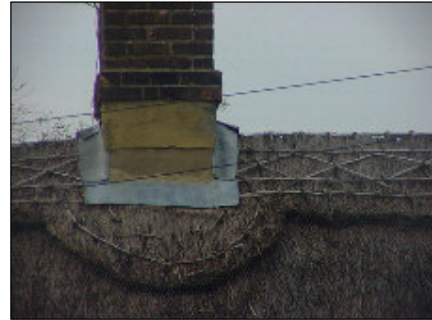
Brick built with two large clay chimney pots. It was not possible to view haunchings fully, although from what we could see there was a covering of moss, which would indicate water is settling on the haunchings. We also noted that the flashing, due to the thatch dropping, would be unlikely to be giving a watertight bond.

Thatching has dropped away from the lead. Also note the exposed deteriorating render

Action required: Re-form lead and give a watertight bond and check and repair haunching.

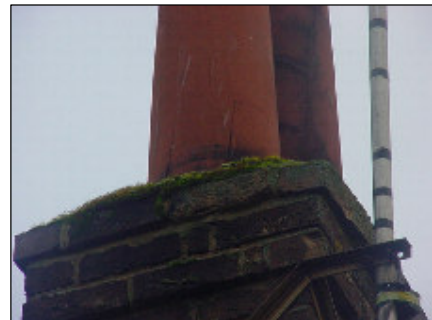
Close up of base of chimney, haunching can be seen to have lost covering and also hairline cracks are visible within the chimney pots

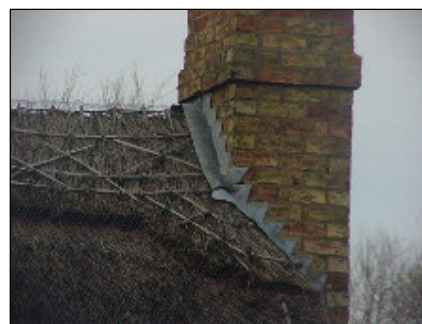
Note how the thatch has dropped away from the lead flashing

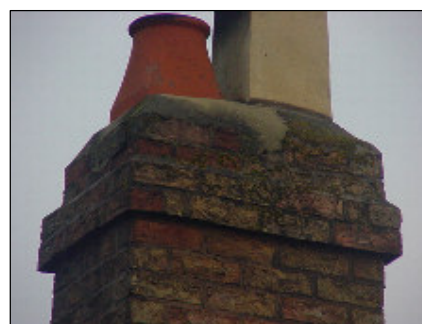
Repair to haunching can just be seen

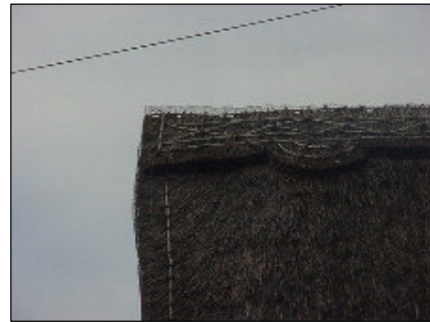
Chicken wire indicates where thatch was prior to its settling

Action required: Intermediary repair work is necessary with all thatch, and in this instance we feel that it should now be carried out and close checks should be made of the flashings.

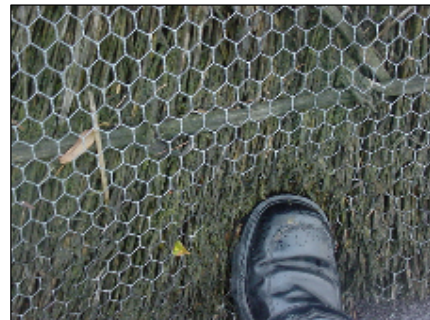
Mulching of straw thatch on the rear elevation

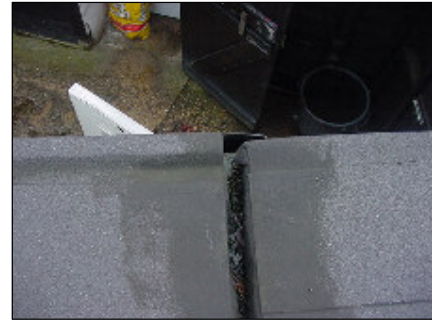
Close up of valley gutter – terrible detail as it is likely to get blocked very easily, there have also been leaks in the area

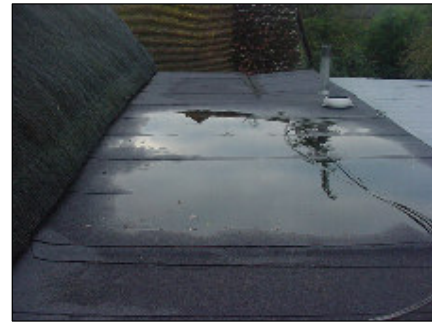
This area consists of many roofs that have been added over the years as the property has been enlarged. We would comment that the main issue with this roof is that it is flat as opposed to the twelve and a half degrees that good practise would dictate it is laid to. This has caused extensive ponding in the centre of the roof that can only get worse. There is also a very poor shallow valley gutter detail. These are renowned for blocking, and at the time of our survey it was full of leaves.

Ponding

Action required: We would recommend that the entire roof be re-felted using an insulation cut to falls system to generate falls on the roof and also provide suitable thermal insulation (presently you will be losing a lot of heat through the roof) or alternatively a pitched roof should be added.

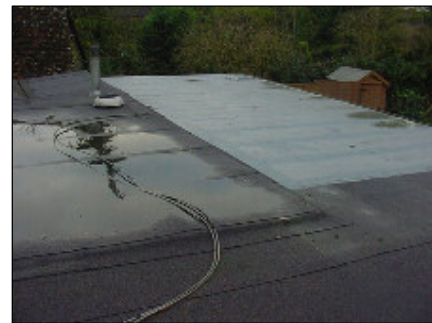
Further ponding and overview of the fragile roof

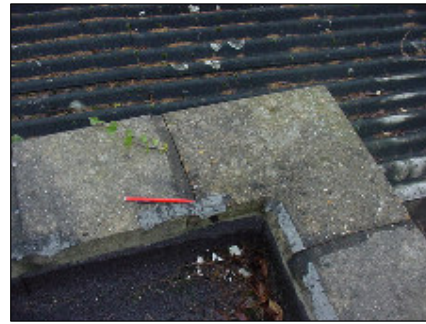
Red pencil indicates where the
defective parapet wall has been
repaired

We also noted that in some areas flashings were not lead and we would recommend that they all be replaced in lead. We also noted that the parapet wall to the right hand side of the property had been repaired, which no doubt is due to water penetration. We would suggest that the entire parapet is reconstructed with a damp proof membrane.

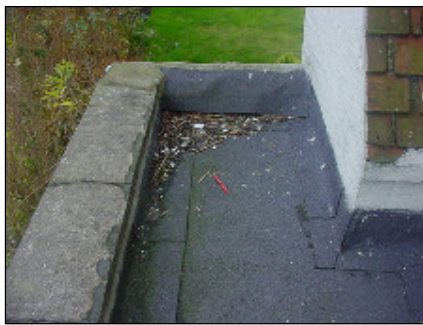
Lack of fall and outlet to the
front right hand side of Roof
Two

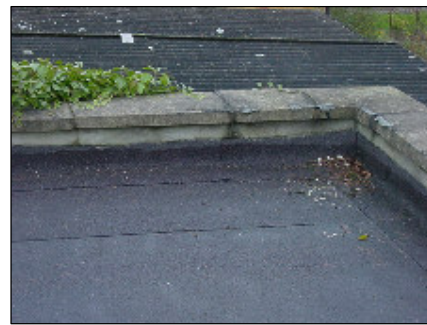
We would recommend the felt
flashing be replaced with lead as
it is starting to drop. Note also
the various and many repairs to
the parapet wall

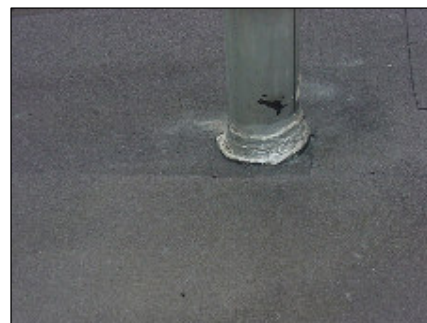
Poor flash band repair.
Flash band is a
temporary product

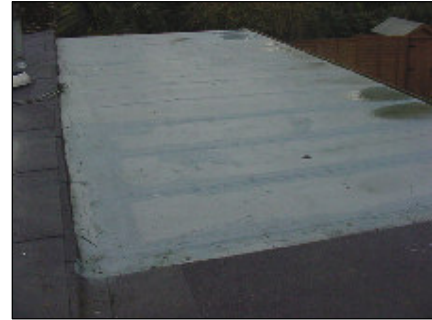
Fragile roof

Action required: The entirety of the roof needs to be replaced with a roof that meets current building regulations and good practise.

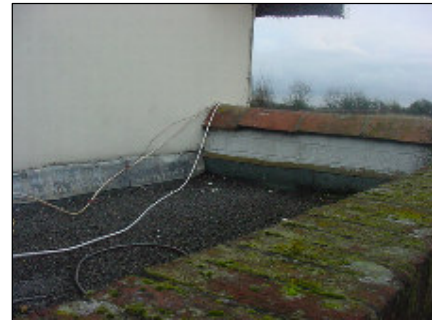
This is a small roof in reasonable condition, although it was noted that the lead flashing is starting to split.

General view. Electrical cables should be placed in conduit

Action required: Replace lead flashing and carry out ad hoc repairs.

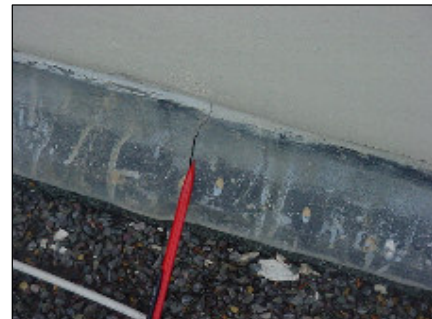
Hairline cracking to lead flashing

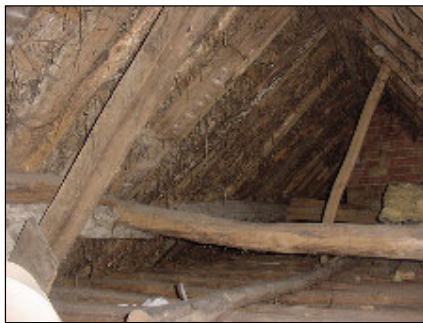
The vast majority of the timber is not original and indeed the old steeper, more appropriate, pitch can be seen within the roof space. This is part of the reason why the thatch is deteriorating fairly quickly.

General view of roof showing collar running horizontally and on left hand side the old pitch of the roof

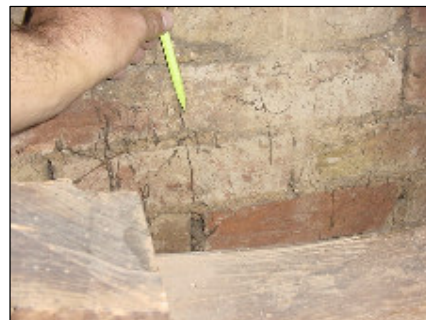
There is one chimney visible within the room; this is the central chimney which has a flue system running through it. We noted that there is a vertical crack within the chimney; this is probably caused by condensation within the chimneystack, which is a problem with the older flue systems.

View of central chimney. Pencil indicates crack within it. This chimney is flued, therefore it is likely to be condensation

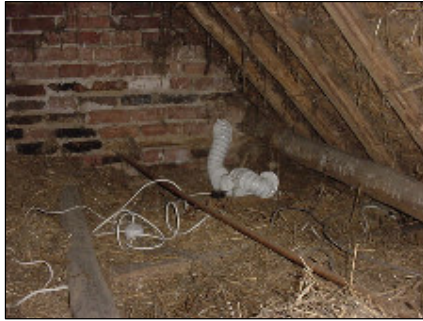
Far left hand side of roof. We would recommend electric cables be put in conduit due to high fire risk in this area. See comments on next photo.

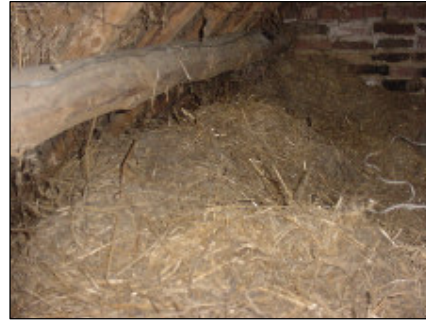
Straw in the roof represents a fire hazard greater than it is necessary to take. We suggest the straw is removed and a fire detector is added.

Action required: Remove all straw from roof space (fire hazard) and replace with a quilted insulation.

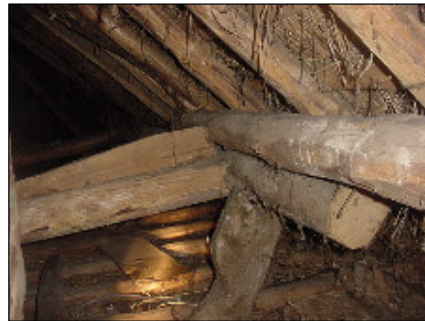
New timbers have replaced the old. In my discussions with you, we believe the brewery would have carried this out when they re-roofed the property. You should get written confirmation from them that the timber was suitably treated.

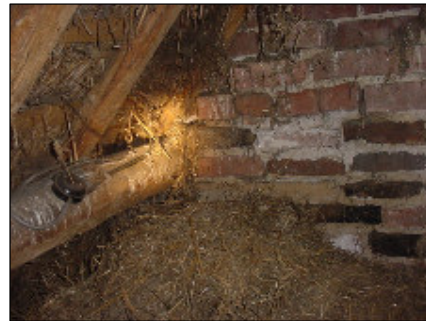
Bird excrement indicates that vermin has accessed the roof. The fascias and soffits should be therefore checked and netted to stop this from occurring.

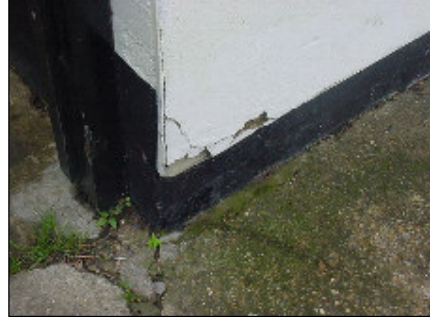
Seasonal movement within the property has lead to hairline cracking within the render. We suspect this will get worse over the years. We also noted that on the far left hand of the property there is some impact damage.

Impact damage to incorrectly used cement render

Action required: Seal all hairline cracks immediately with mastic. Carry out ad hoc repairs to blown render as part of an overall repair and redecoration program.

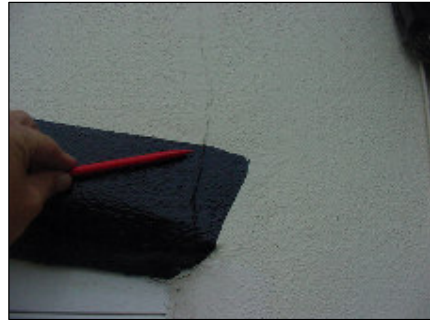
Hairline cracking to incorrectly used cement render

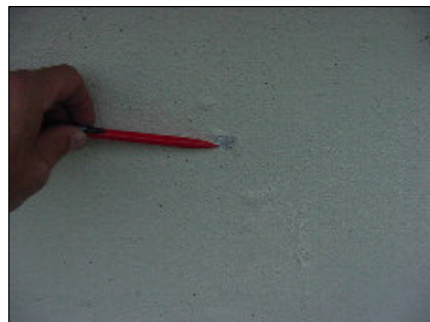
The wall has a painted render finish. The render is cement mortar, which is not ideal and indeed not in keeping with a listed property. We noted some of the paintwork was starting to blister, which would indicate that it has been painted in damp or humid weather. The paint acts as a protective coat and therefore needs to be redecorated as soon as possible.

Paintwork render starting to blister

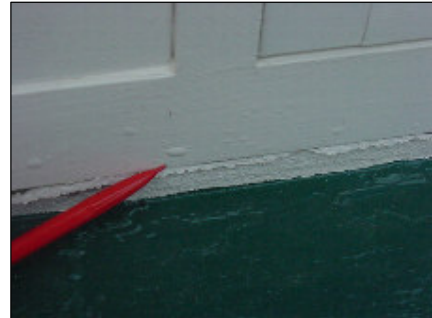
Ground Floor: The three ground floor windows are as new. We noted that blistering was starting to occur in the paintwork in some areas.

Blistering starting to occur to new window

Action Required: Redecorate windows.

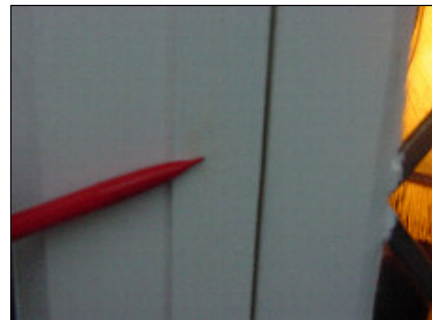
Staining indicates that the timber was not knotted or prepared correctly

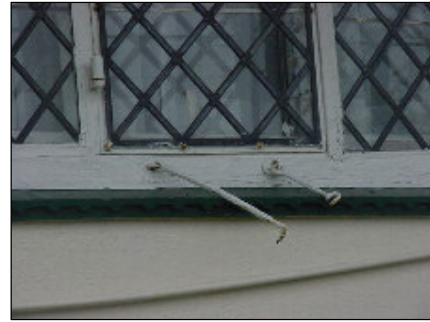
Note rusting to ironmongery, indicating that a rust stop agent has not been used

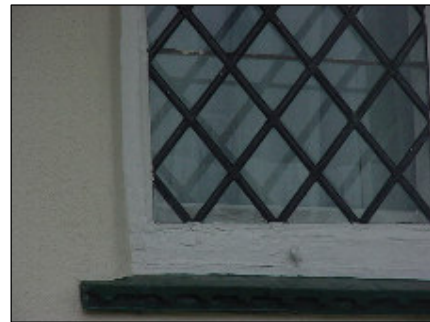
Note cracking starting to occur to base of window, even though it was only painted recently

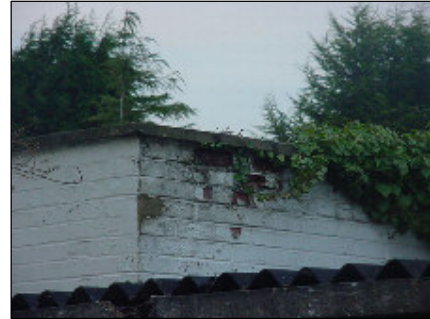
This elevation has painted brickwork. There is an area that needs re-pointing to the centre of the chimney. We also noted spalling to the right hand side, close to the adjoining garages. A mixture of the vegetation that is attached to the wall and leaking through the top and side of the parapet probably causes this. Generally we would comment that the paint has lost its key and this is due to the brickwork being damp beneath.

Deteriorating parapet wall.
Vegetation should be cut back

Action required: Hack off loose areas of paintwork, repair brickwork and redecorate. Cut back vegetation and supply and fit new flashing and re-build parapet wall as previously mentioned.

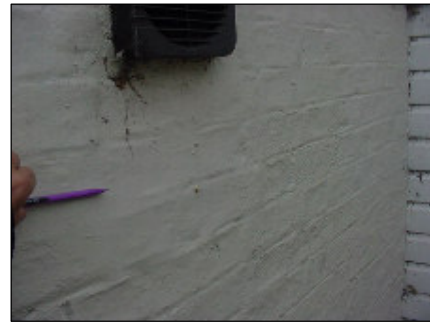
Paintwork has lost its key

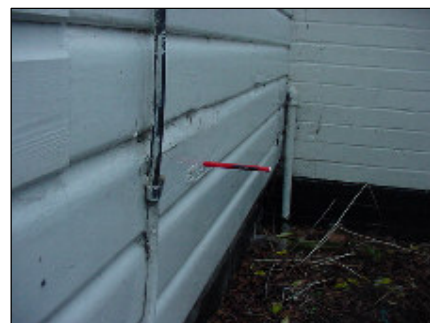
Painted timber shiplap boarding is rotten in various areas, particularly to the base.

Rotten shiplap boarding. Red pencil is pushed through the timber

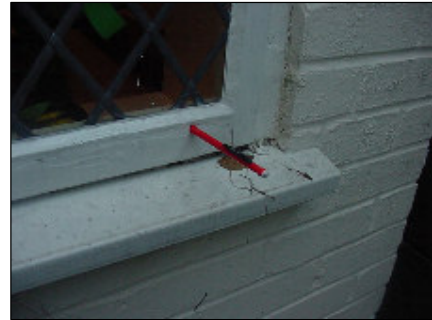
The toilet window has wet rot and it is probably more economic to replace the entire window.

Rotten timber window. Pencil is pushed through the timber window

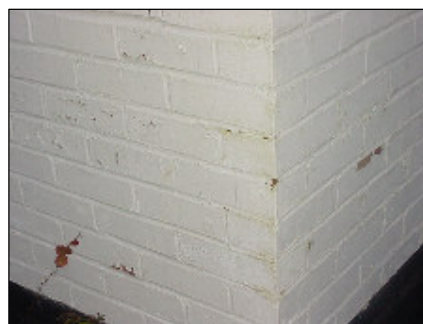
Predominantly double-glazed with a painted brickwork area to the left hand side. On part of this the paint is flaking, we believe due to water being discharged from the roof/gutter above.

Paint blistering with walls starting to spall due to a combination of the leaking gutter above and poor roof detailing

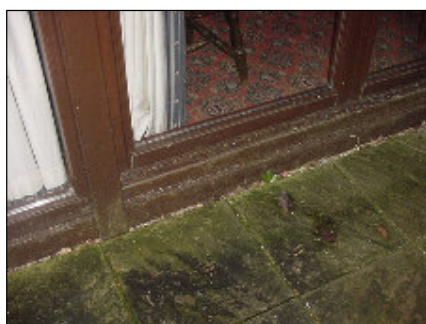
Close up of the front of the conservatory, this is at ground level, therefore it will allow dampness into the suspended timber floor on the other side

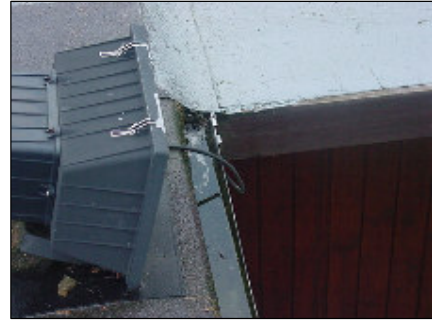
The plastic rainwater goods are almost ineffective on this elevation, as they are not falling towards the down pipe. The down pipe itself discharges onto the wall, which is not satisfactory and should be taken to a soak away.

Water sitting in gutter with nowhere to discharge to other than through the structure

Action required: As previously mentioned, renew all rainwater goods utilising a deep flow gutter system and discharging into a soak away.

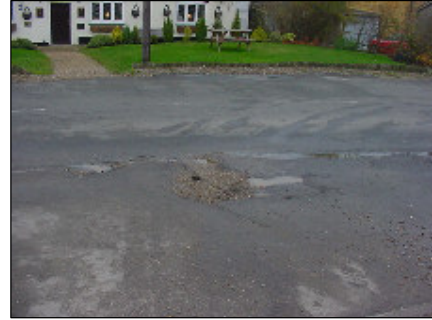
The entrance to the car park is in tarmac and the topcoat has worn through to the base coats.

Pothole to entrance of car park

Action required: This requires filling, compacting, a new topcoat and levelling.

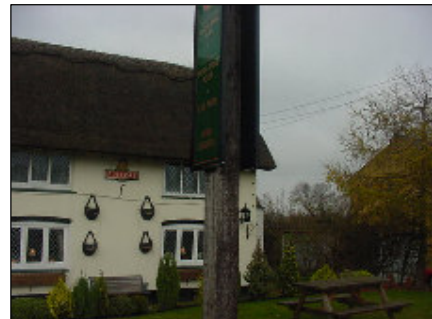
The timber framework and posts supporting the signage generally require re-decoration.

Swing signpost, paint flaking and general deterioration

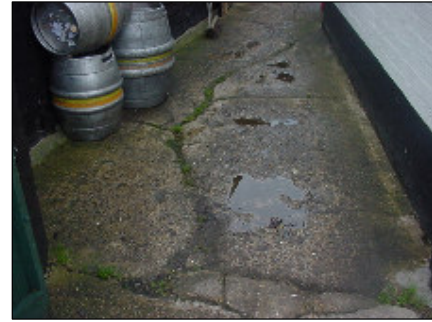
Areas of concrete surrounding the property are generally damaged and have become broken up over the years.

Damage to surrounding concrete paved area

Action required: A new topcoat.

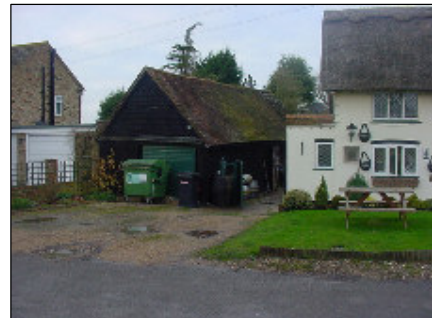
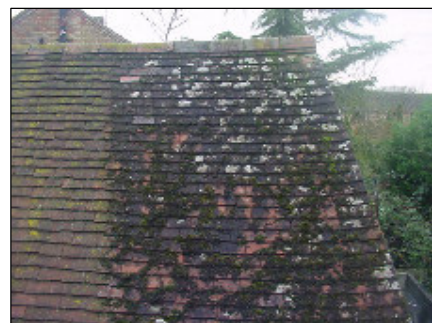
Pitched concrete tile roof covering (with some clay tiles). Many of the original tiles still remaining to the rear elevation, which is not visible as it adjoins neighbouring properties, are the old peg tiles, although the majority of the pegs have been replaced with nails, which we could see were corroding. The elevation closest to the public house has concrete tiles; these have a heavy moss coating, which will, no doubt, be blocking the guttering beneath.

Tiled pitched roof with moss covering

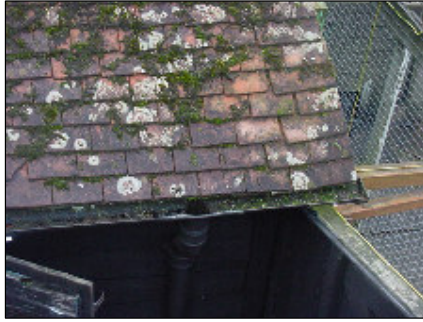
Spalling starting to occur

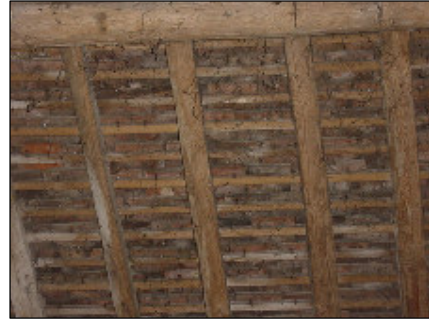
Old peg tile roofs susceptible to nail sickness (corrosion of the nails that are used to fix it into position), originally these would have been timber pegs

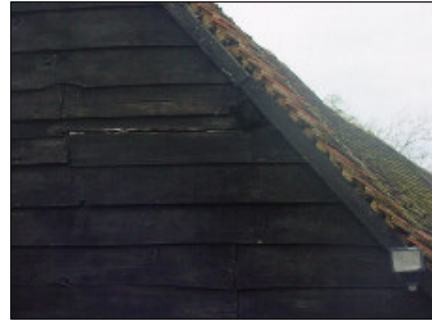
Close up of the shiplap boarding to the barn, which is starting to deteriorate

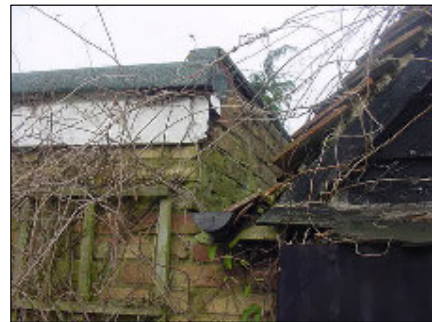
It has a mixture of plastic and cast iron goods. We noted that the end cap was missing on the right hand side, and that the gutter did not fall evenly. The left hand gutter would appear to be trespassing on the adjoining properties land, causing a valley gutter, which we believe is likely to be causing dampness into the adjoining property.

General view of gutter trespassing on adjoining property

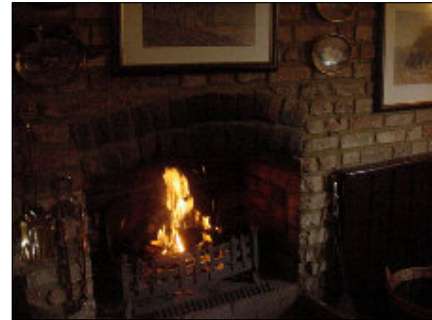
Brickwork around the two fireplaces is smoke stained.

Open fire on the right hand side
with smoke staining above

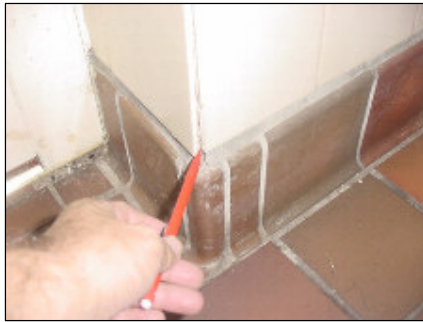
Damaged tiles

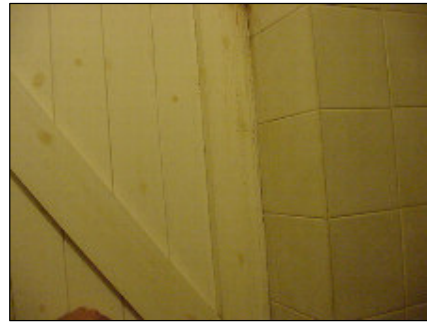
Door has not been knot stopped or primed correctly

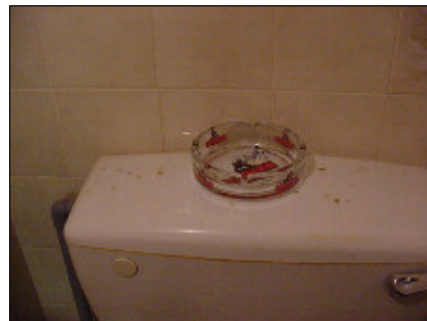
Generally in need of an overhaul. WC cistern with cigarette burns.

Cigarette burns to WC cistern

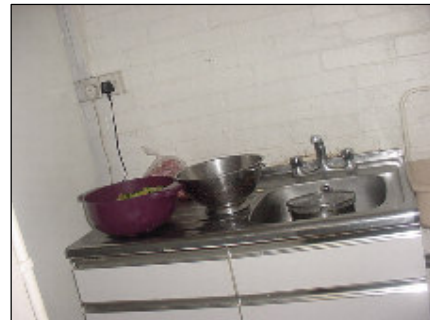
Prep area. Painted brickwork with electrics on to a damp wall

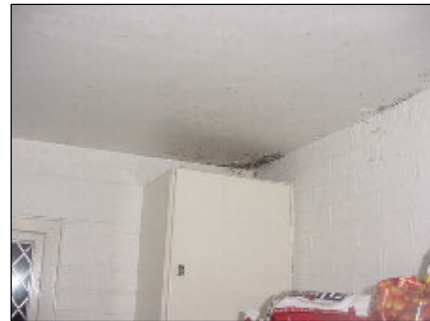
Mould visible throughout, not ideal for a food area, believed to be caused by condensation and the single brick construction nature of the property.

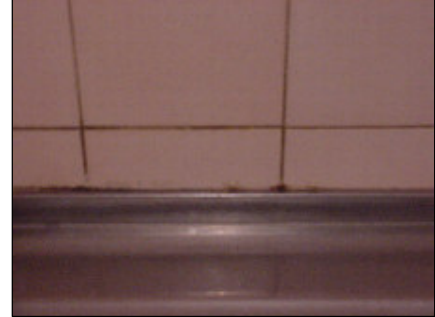
Ingrained dirt to the grout

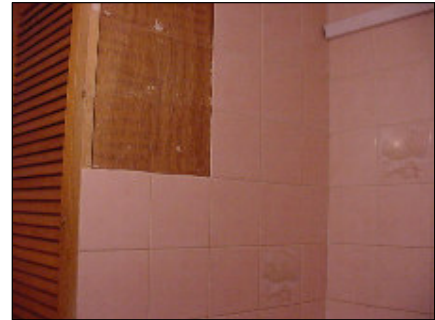
Missing tiles

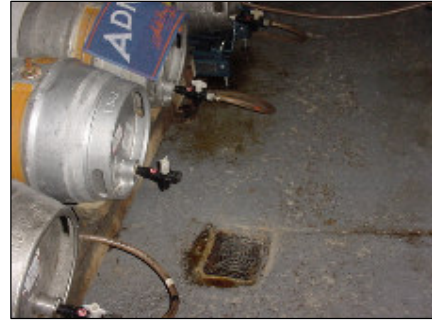
Rising damp from the floor

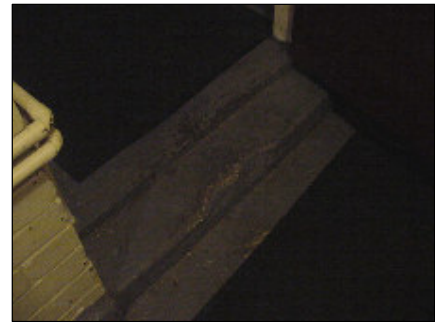
We also noted stored gas bottles within the access corridor, which is not ideal.

Ingrained dirt to concrete areas and damaged steps.
