# COMMERCIAL BUILDING SURVEY

of  
A Wet Trade Driven Public House

**GEM Associates Limited**

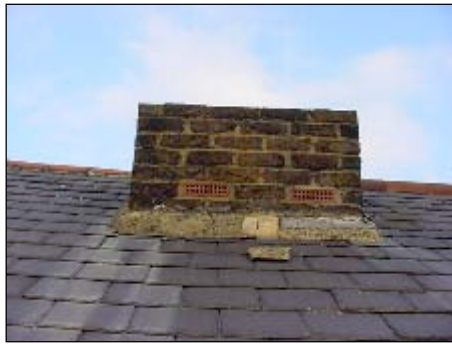
Rear chimney

Some of the chimneys have cement flashings. These need replacing with lead and the chimneys checking in general. We believe that some of the chimneys are leaking as temporary repairs have been carried out to them.

**ACTION REQUIRED:** Check the chimneys, there is likely to be some re-pointing needed and replace the flashings with lead.

**ANTICIPATED COST:** £3,000 (three thousand pounds). We recommend that you obtain quotes on this as a large part of the costs will relate to access to the chimneys it is difficult for us to estimate.

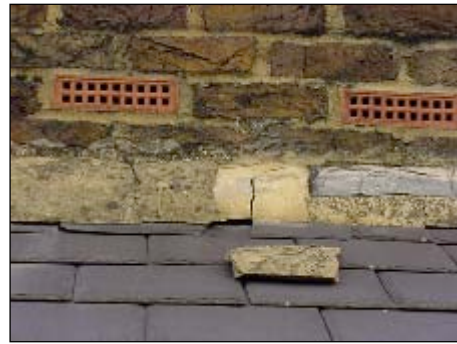
Close up. You can see the crack in the cement flashing and also to the right hand side there is a temporary repair in a product known as Flashband.

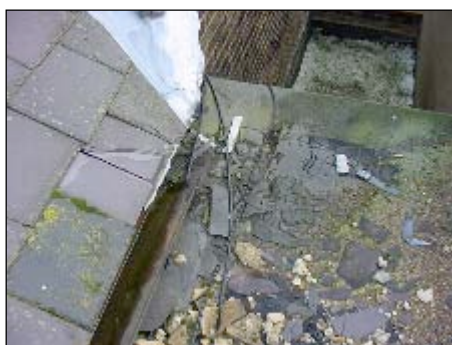
The pile of slipped and damaged slates.

**ACTION REQUIRED:** We have been advised that slate repairs will be carried out. As they are out of easy sight you really will need to have a ladder to check they have been carried out correctly. We do not believe that the present landlady appreciates the scale of the repairs required.

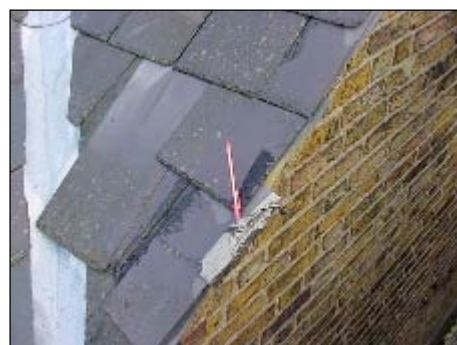
A bad temporary repair, note that my red pen indicates where a product called Flashband has been used.

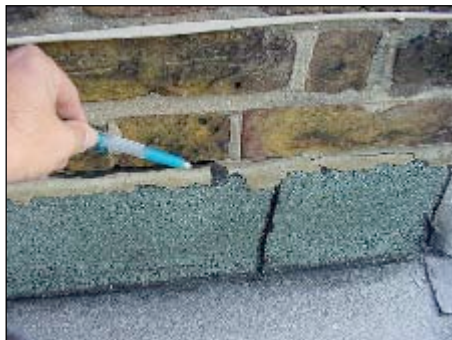
The flat roofs generally need all the felt flashings replacing as in some areas they are coming away – it is therefore probably more economical to replace them all. The right hand side roof and the rear roof over the cellar particularly need attention as we believe water is probably leaking in these areas. Although, when we had our question and answer session with the landlady, she advised that the only area where water was coming in was in the living accommodation.

Here you can see where the flashing is starting to come away from the parapet wall

**ACTION REQUIRED:** You probably need a roofer for the best part of a week to do the various jobs properly, who may when carrying out the work discover that the decking underneath the work is starting to rot and this may in turn need replacing.

**ANTICIPATED COSTS:** We would estimate a few thousand pounds to carry out the repair work, although it is very difficult to be certain with costs on this sort of ad hoc repair work.

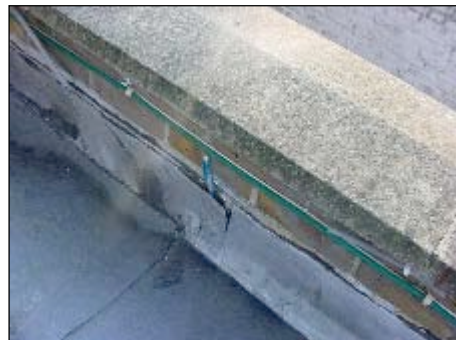
In other areas it has come away completely. Note the pencil to the centre of this photo, which is behind the flashing.

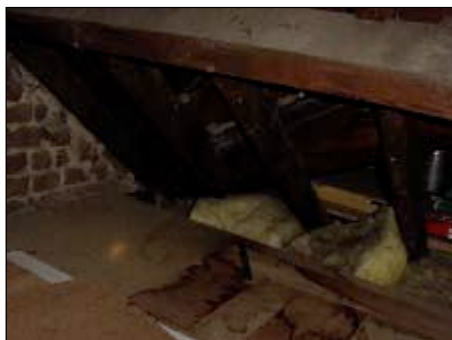
This photo is taken from within the roof, you can see the staining on the timber at the base of this photo indicating that dampness is getting in.

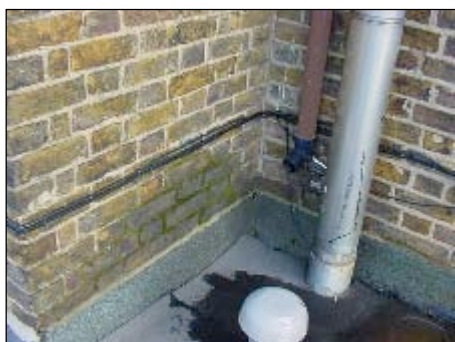
The Gutters and Downpipes are leaking in some areas, or simply directing the water against the walls etc which are causing moss and mould.

Downpipe discharging onto the wall, you can see the green mould to the left hand side of the photo.

**ACTION REQUIRED:** Repair Gutters and Downpipes.

**ANTICIPATED COSTS:** This depends very much on whether you replace in cast iron, which has a higher initial cost, but is meant to last longer, or if you replace in plastic it is cheaper initially but does not last as long. We would anticipate costs to be anything from a few hundred pounds up to a thousand pounds if you replace with cast iron.

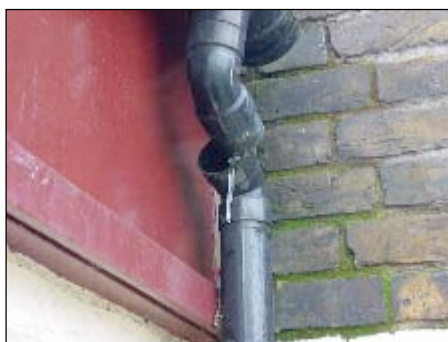
Swan neck displaced. Note the green mould on the walls, this has been like this for a long time.

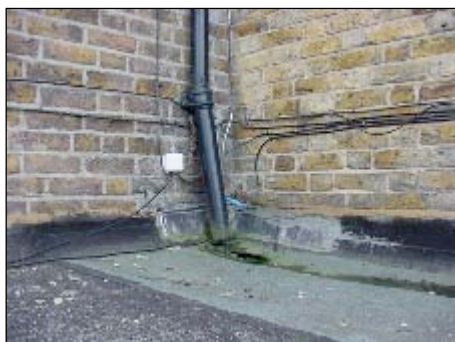
Rusting downpipe, you can also see where the roof has been repaired that there is a dip in this roof and the flashings have also been repaired many times.

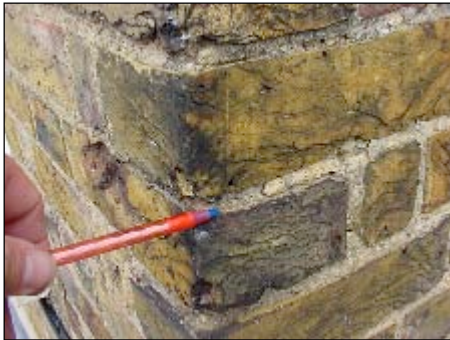
An example of the mortar starting to weather.

**ANTICIPATED COSTS:** This is very difficult to tell until you literally get onto a ladder and start raking out the existing mortar, but anticipate between £500 and £1,000.

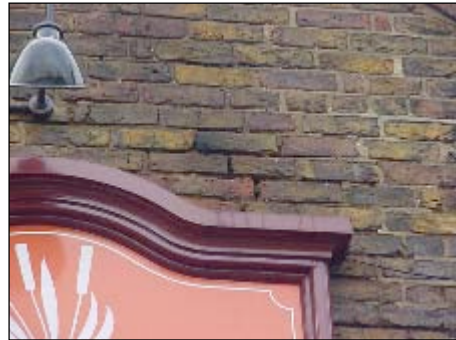
To the right hand side of the sign you can see where the mortar has weathered completely away.

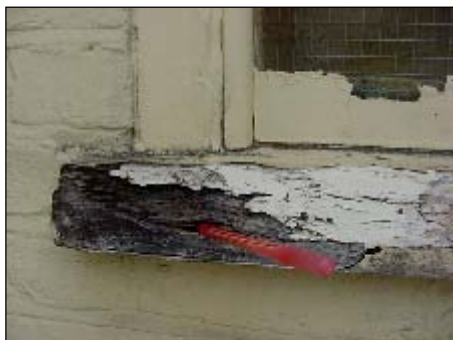
This is a close up of one of your windows, with our pen sticking into it.

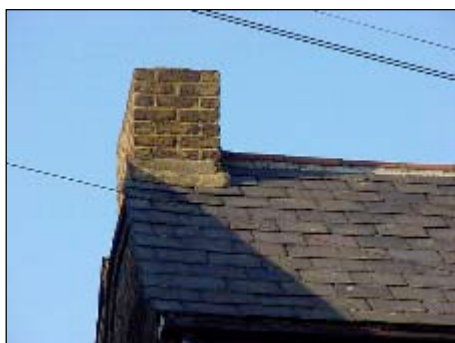
Here you can see the cement flashing.

**ACTION REQUIRED:** We would recommend that the cement fillet flashing is removed and replaced with lead and that the chimney is re-pointed.

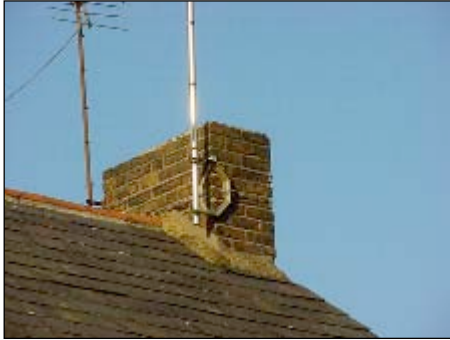
This chimney is in need of a lead flashing. Also note the aerials that are attached with wire. This tends to act almost like a cheese wire cutting through cheese and cuts into the chimney bricks, even though they have got corner pads in this instance. You should have this checked when you have any high level work carried out.

**ACTION REQUIRED:** Re-point chimney and check to see it has been capped if it is no longer in use and replace cement flashing with a

lead flashing. We also recommend that the aerials are checked to ensure they are still being used, if they are not they should be taken down. The property would appear to have three different aerials on it and a satellite dish.

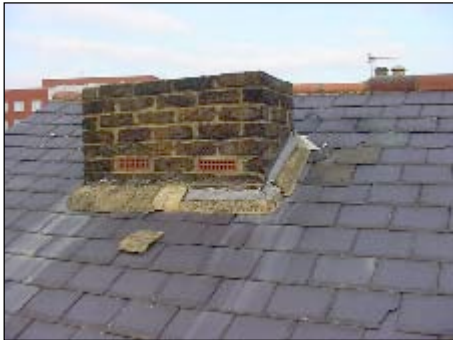
This is probably in the worse condition of the chimneys and needs a lead flashing.

**ACTION REQUIRED:** A lead flashing is essential in this instance as we could clearly see in the roof that the flashing is leaking.

**ANTICIPATED COST:** The difficulty here is getting access to the chimney. We would expect in the region of between £500 to £1,000.

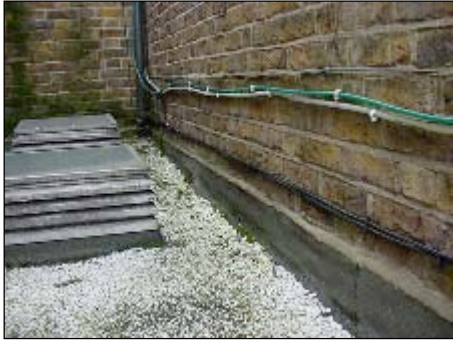
This was the best we were able to view them. They look in reasonable condition.

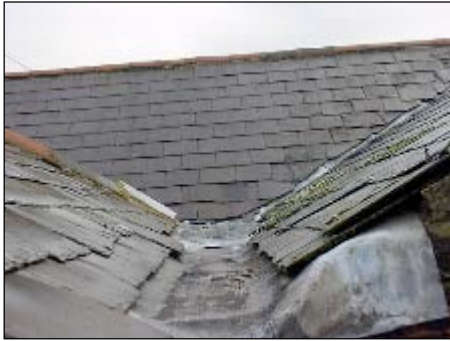
Our main concern here is the valley gutter, which are prone to leak, and the displaced slates to the rear.

You can see in this photo that some of the slates are being held on by lead tangles, which indicates that it is getting close to needing re-roofing in this area.

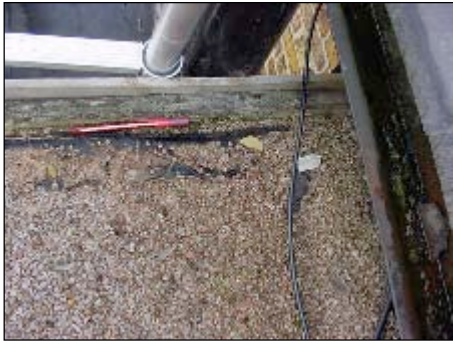
This is the rear corner of the roof. The pen indicates where the asphalt has come away from the fascia allowing water to go down behind it. This is over the first floor toilet.

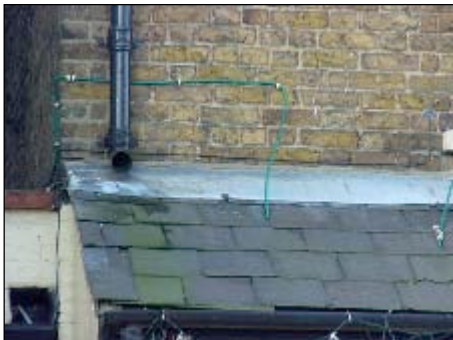
This is the low level pitched roof to the front. Note to the left hand side some of the pointing is starting to come away from the flashing.

**ACTION REQUIRED:** Generally within the next two to three years we would expect the right hand side roof to be renewed, including a new lead flashing, the rear roof to have work carried out to its perimeter at the very least and probably also to the box gutters. The front left hand roof will need to be checked and have a close inspection when roof work to these roofs is being carried out.

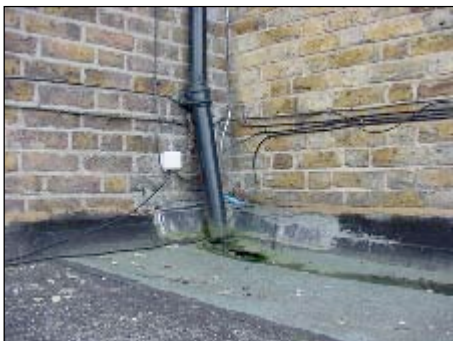
This is the low level right hand roof. It is difficult to see in this photo but there is literally a dip where the green mineral felt flashing is, also note various flashing repairs that have been carried out.

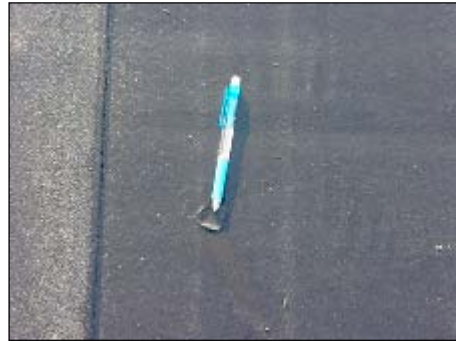
The pencil indicates indents in the roof where such things as chairs or tables have been sat in hot weather.

We are also aware that the landlord/landlady have used the roof to sit out on in the summer months. This puts point loads on the roof and if you intend to do the same we suggest that a walk way/sitting out area is added to the roof in the form of tiling.

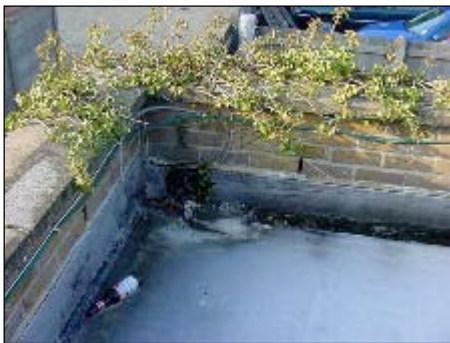
Close up of the box gutter, which is always a weak area on this type of roof.

**ACTION REQUIRED:** We recommend that the flashings be repaired at the very least, if not replaced in lead and we also recommend that the box gutters are checked at the same time.

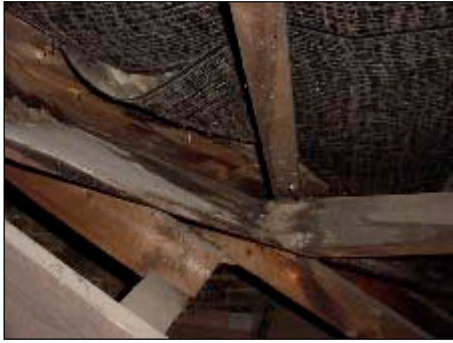
This is a picture of the underside of one of the valley gutters, you can see that dampness is getting through this area. This is why the roof work is necessary.

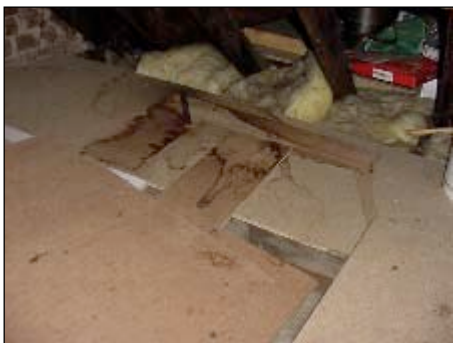
We have shown a photo similar to this already. This is water staining where rain is getting through the roof. These are basic things that need repairing.

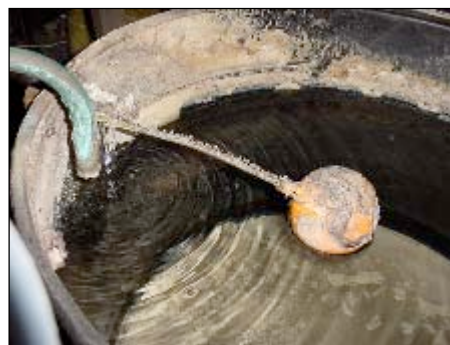
Water tank

Formed in plastic and assumed new. We noted that there were no lids to the tank, which means that all sorts of debris is getting into them. Please see our photo. We suggest you have these drained and cleaned before you clean your teeth with this water.

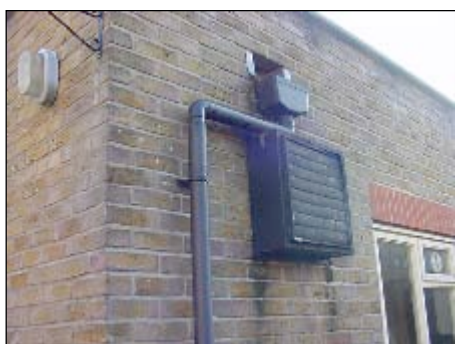
This hopper head is not man enough to take the water coming off the roof that overflows. Also the right angled joints are susceptible to leaking but there seems to be little choice due to the position of the extract fan

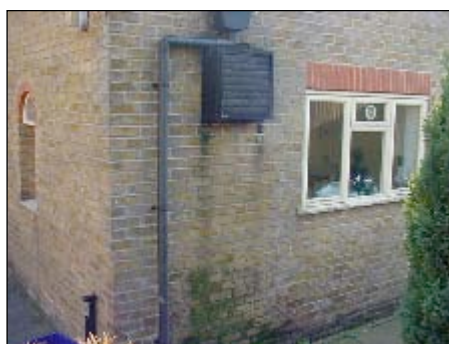
Taking a step back, the result is the green mould to the base of the wall.

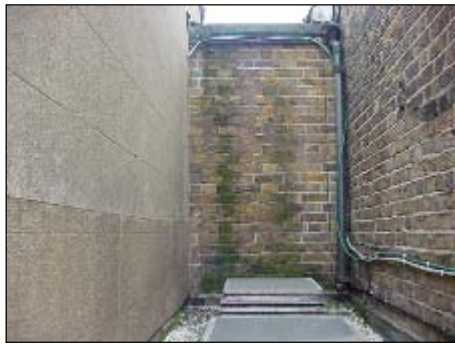
To this roof there is a complete lack of guttering altogether, which is why you have a green stain down the wall. From memory the downpipe on the right hand side is cast iron and rusting.

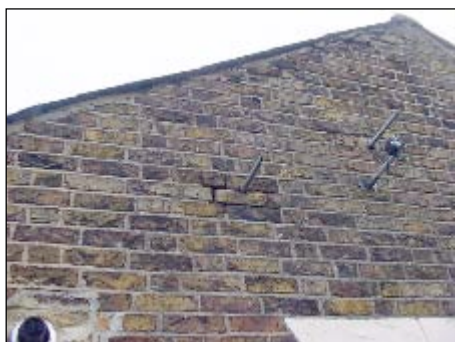
General view of Flemish bond.  
Re-pointing needed and also  
some pointing under the  
perimeter of the slate roof.

**ACTION REQUIRED:** Over the course of time gradually re-point the property with a lime mortar.

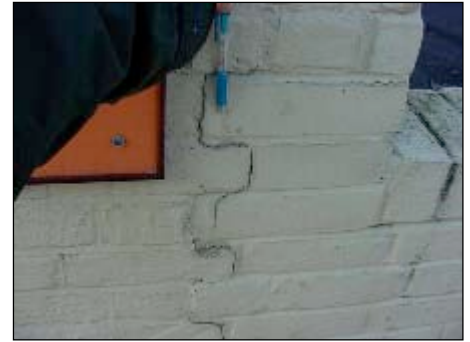
There is a step crack to the front right hand side wall, we believe this is simply differential movement between the main building wall and the door that sits to the left hand side of the entrance to the car park.

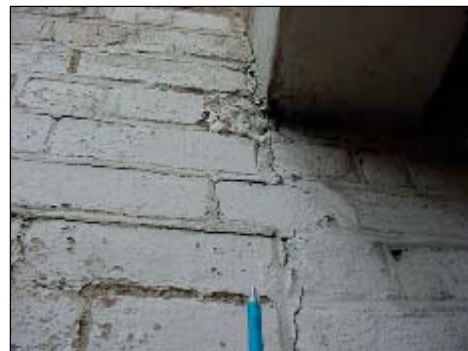
We went onto the adjoining land on the left hand side through the archway to carry out an inspection of the property. Here we found that a lintel has been built into the party wall. This has formed or caused a point load, which has resulted in a vertical crack.

Close up of vertical crack

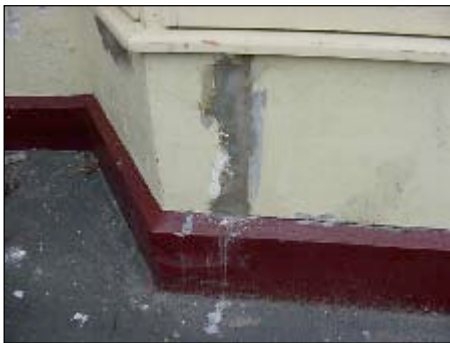
The render repair to the bay looks messy, as it has not been painted.

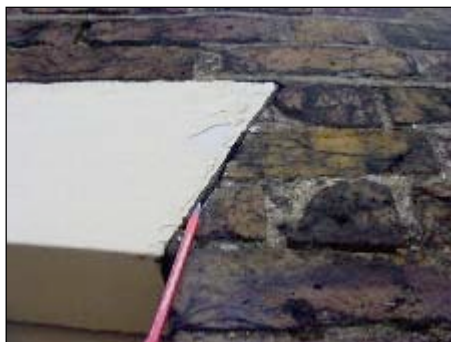
The lintels have been rendered over, there has been some movement in them as indicated by the red pen, but nothing unacceptable for the age of the property.

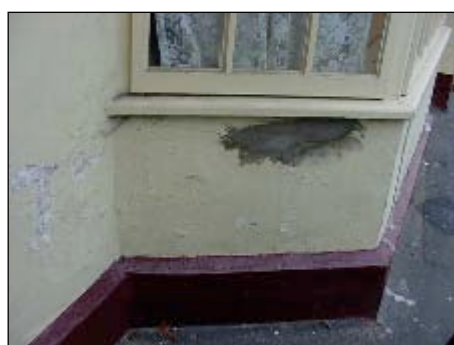
The rendered plinth in red. It is not unusual to find some dampness in properties of this age.
