COMMERCIAL BUILDING SURVEY

OF
A 17th Century Public House

FOR
Mr H

GEM Associates Limited

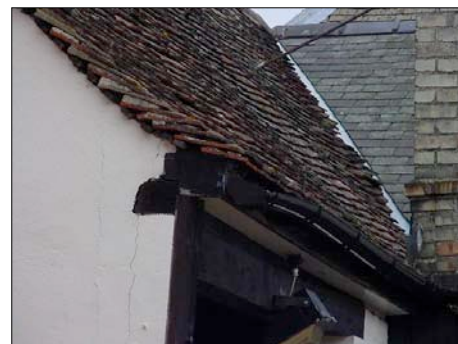
Much of the original cast iron has been replaced with plastic. Unfortunately, the brackets have been left at the original cast iron spacings and this, as plastic is not as robust as cast iron, has resulted in the guttering deflecting and discharging water down the buildings in some areas.

This shows the problem quite well; you can see the deflection in the guttering, and you can see the hairline cracking in the adjoining part of the structure.

ACTION REQUIRED: Additional brackets and/or the plastic guttering being replaced with cast iron.

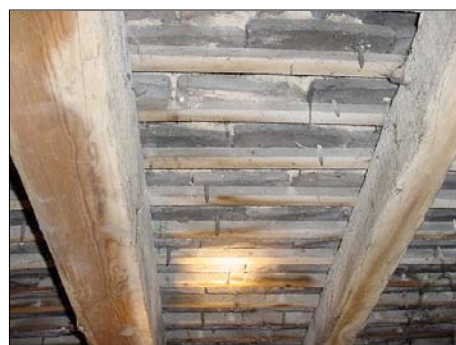
You can see the displaced peg tiles to the left hand side.

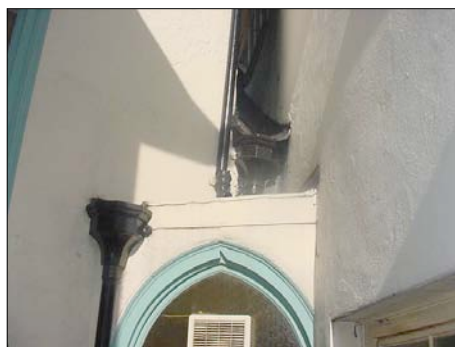
If you look closely in this photograph you can see a valley gutter, just above the window on the right hand side. We feel this very awkward gutter detail will allow water in sooner or later.

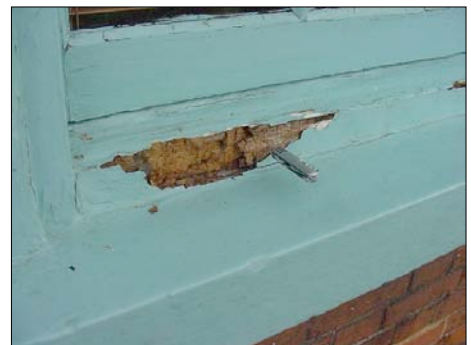
There is a fair amount of visible rot to the windows, which is bad but we would term the windows as saveable.

ACTION REQUIRED: Splice in new timber and repair and redecorate.

ANTICIPATED COST: We would expect costs in the region of £2,500 to £7,500 for the job to be done properly.

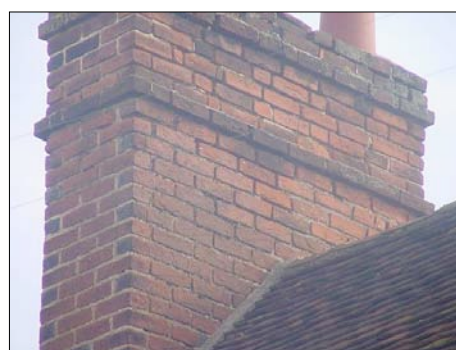
We noted one of them requires a lead flashing, as opposed to its present cement flashing.

Front chimney. Note also the cement flashing.

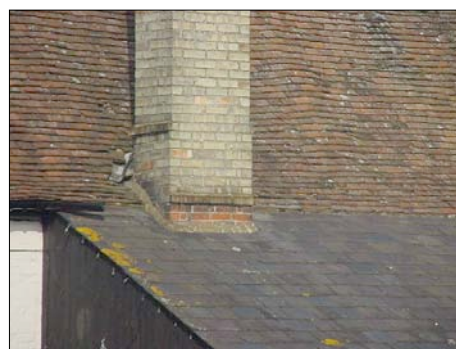
A lead flashing all the way round would be recommended.

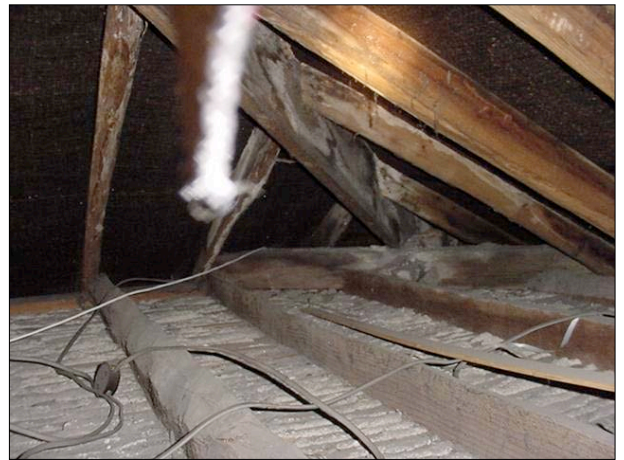
The property has a shallow pitched slate roof to the rear, as was a common design. Originally, the roof would have been self-venting as there would have been no underlayer. However, in more recent years, we believe this roof has been re-roofed and an underlayer added without ventilation. This has resulted in condensation occurring in the roof.

If you look closely, you can see the dampness in the timbers.

ACTION REQUIRED: Add ventilation to the roof, and also carry out a thorough inspection of all the timbers, and replace as necessary.

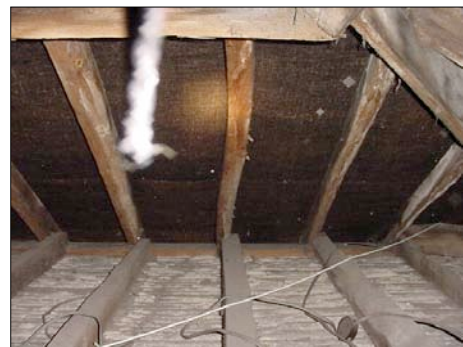
Here you can see the warping in the timbers.

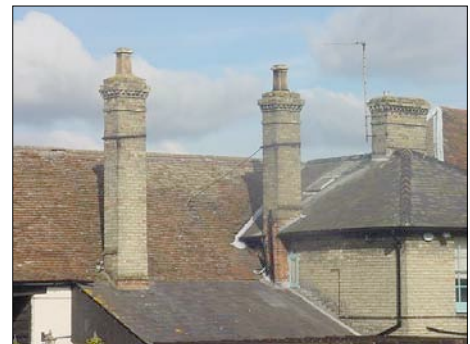
There are two substantial brick chimneys built in a white brick, each with one chimney pot. They are strapped; from the sides we could see they looked in reasonable condition, with the exception of the rear right hand one requiring the cement flashing to be replaced with a lead flashing.

ACTION REQUIRED: We would, given the size of them, recommend a close inspection before committing to the lease. You will need a builder with a set of long ladders to view them properly.

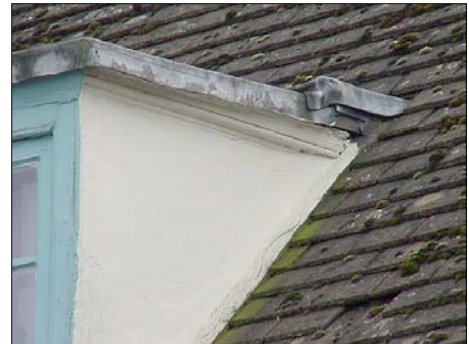
Close-up view of the dormer window

There are dormer windows to this property, they are formed with what looks to be a lead roof (although we could only see the side of it), and painted render cheeks / sides. It generally looked in reasonable condition, although we would add with the caveat of the flat roof; we were not able to see it.

ACTION REQUIRED: Inspect the flat roof to the dormer when you are carrying out the inspections to the chimneys.

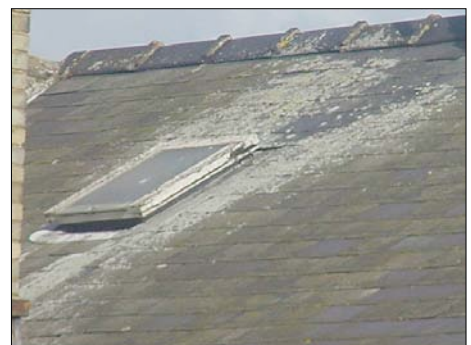
The property has a purpose made skylight, which looks to have leaked in the past. Often problems occur around the lead flashing; this should be checked. We literally could not see it.

ACTION REQUIRED: Check flashing and redecorate / repair the skylight.

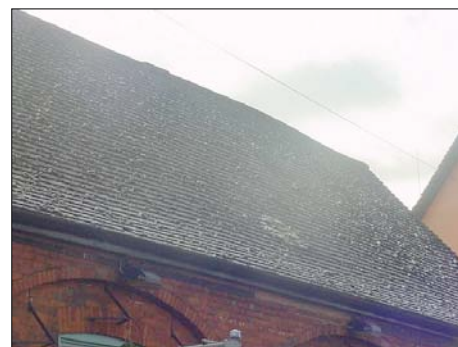
This generally looked in reasonable condition, although we would add there was a lot of moss sitting on the roof, which normally indicates that the face of the tile is starting to deteriorate.

Another problem with the moss growth is this can, in extreme cases, impede the run-off of rainwater, lead to gutter blockages and cause water penetration, which in turn may lead to rot or other defects in nearby timbers.

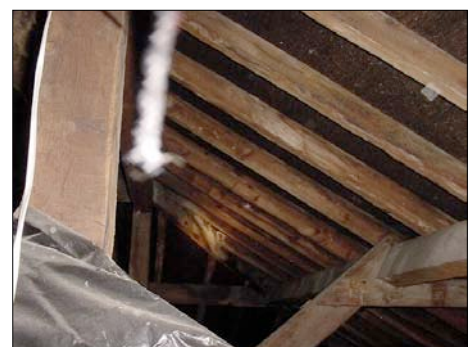
This roof is pitched and clad with slate. All things considered the roof looked in good condition as viewed from ground level, considering its age, type and style. However, this type of shallow pitched roof can often be a problem, originally because wind-driven rain could get underneath the slates. A problem that we have been coming across more recently is condensation can occur in the roof because there simply is not enough roof void for the dampness to dissipate.

Staining and dampness to the timbers beneath this roof.

ACTION REQUIRED: Add ventilation to the roof. At the same time the ridges should be checked of this roof and the main roof.

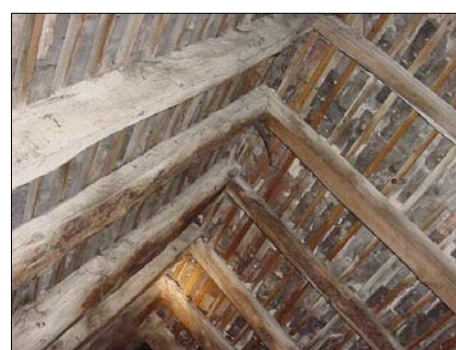
When we inspected the loft space we found there was no underfelt. It is therefore possible that during periods of heavy and prolonged driving rain some water penetration could take place through the roof coverings. At the time of our inspection this was not occurring.

Main Roof without underfelt

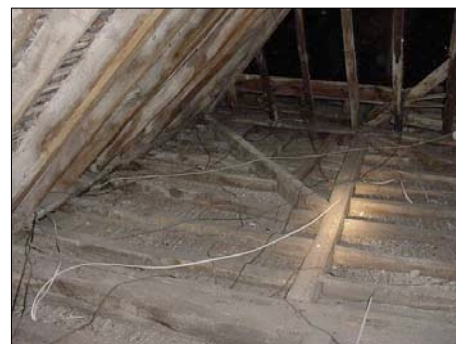
General view of the roof. You can see some staining to the timbers.

ACTION REQUIRED: Woodworm treatment may be required. We would need to re-inspect the roof in the breeding season (spring), and also some timber replacement may then be required.

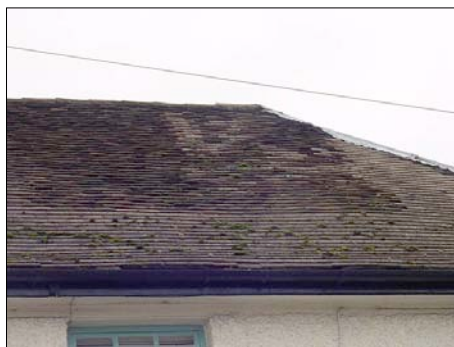
This photograph shows the roof has been repaired previously, with the different colours of it.

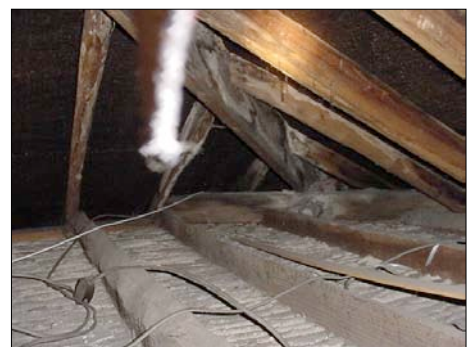
This type of roof structure is also known as a cut timber roof, although it is much newer. This roof was viewed from a ladder, as it was difficult to access, because of the water tank, etc, blocking the way into the roof. The general roof configuration is in line with what we typically see. We found woodworm present, though not as bad as the main roof in the areas we could see. The main problem in this area relates to condensation and lack of ventilation.

ACTION REQUIRED: Add ventilation and have a thorough check of the timbers for rot, particularly at the perimeter of the roof.

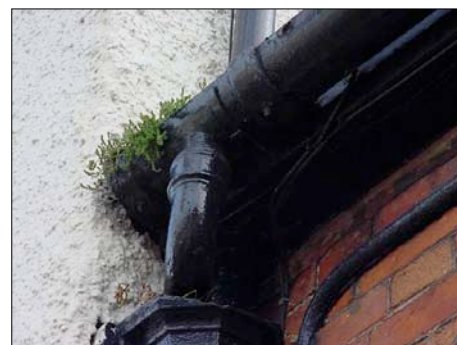
Rear right hand corner (all directions given from the front of the property), the brackets have not been spaced correctly which has resulted in the guttering deforming, which has resulted in water cascading down part of the building, which has resulted in cracking occurring in the timber frame in this area.

Blocked gutter

ACTION REQUIRED - We would always recommend that the rainwater goods are cleaned out, the joints are checked and the alignment checked to ensure that the gutters fall towards the downpipes.

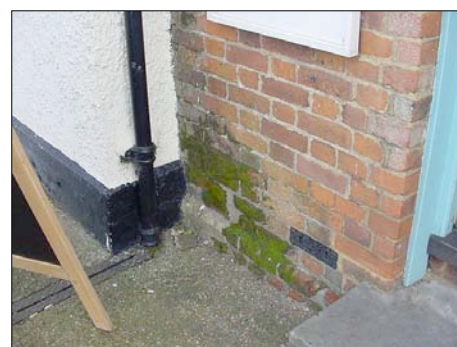
Deterioration beneath it

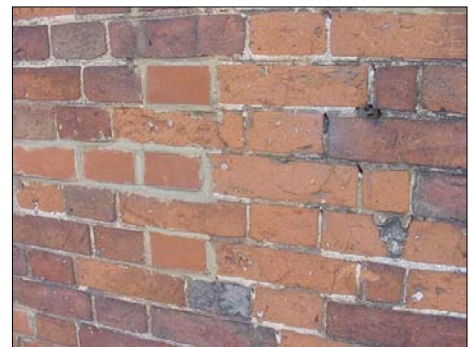
Taking into consideration the age, type and style of this property we would say that the brickwork and pointing overall is in below average condition.

Some spalling to the face of the brickwork, and you can see a mixture of lime mortar and cement mortar.

ACTION REQUIRED: Likely to require ad hoc repointing, which should be carried out in a lime mortar.

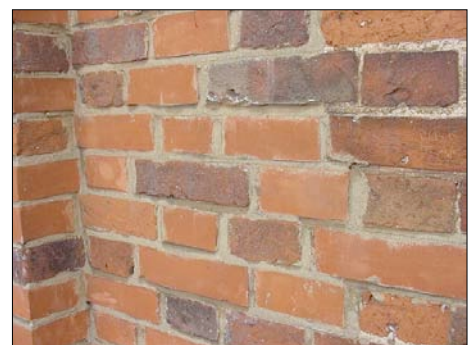
Unfortunately the re-pointing, whilst well meaning, is not appropriate for this type of construction. A cement mortar has been used rather than a lime based mortar. We recommend you use lime mortar in any future repairs regardless of what the builders say! Using lime mortar will limit further damage to the brickwork, which is almost impossible to repair successfully.

Poor repairs in the wrong type of brick and the wrong cement.

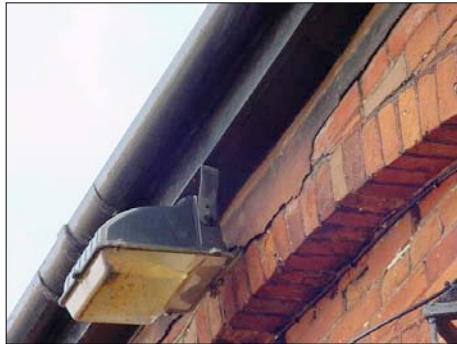
Previous repairs; if you look closely, you can see the render repair to the brickwork. We would take an educated guess this is due to old leaking gutters.

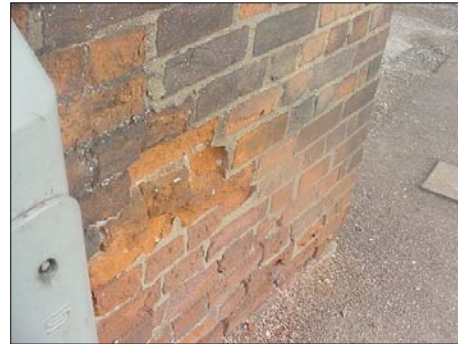
Here you can see the deterioration that has been caused due to the use of cement mortar.

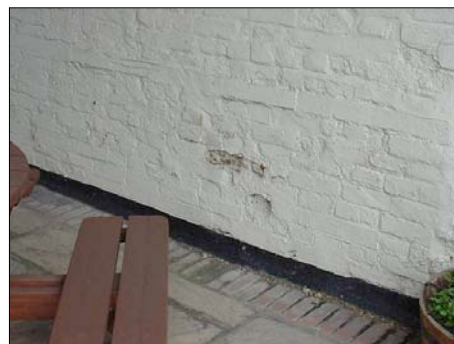
Base of the Wall

Minor deterioration to the brickwork is visible, as it looks to have been recently painted. The paint flaking here is a sign that there is rising damp in this section of the wall.

ACTION REQUIRED: Form a bell-mouth to the base of the render.

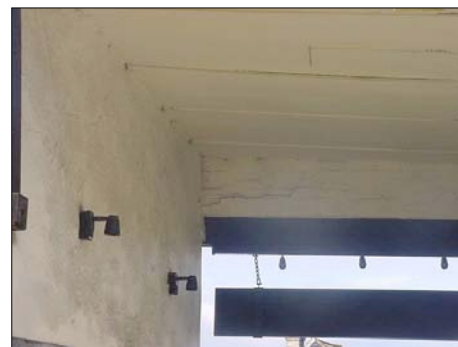
There is a timber framed structure to the right hand side of the property forming a canopy area. Due to the way the gutters have been replaced, water and dampness is getting into this part of the structure. We note there has been some movement to the front of the property, and there is cracking to the rear. We believe this relates to the guttering, although we would have to see the property on a rainy day to be certain.

If you look closely, you can see cracking to this structure. This is due to water getting in from the gutters.

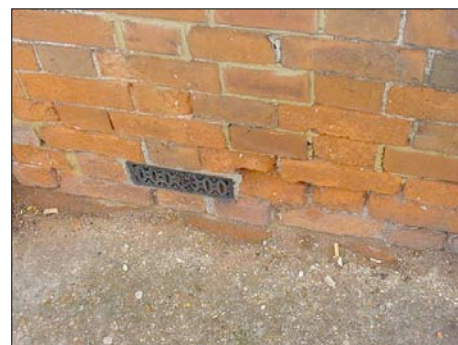
An airbrick to the centre of the photograph. Also, a good example of deterioration to the soft red brick that this property is built from.

ACTION REQUIRED: The property would benefit from additional airbricks being added.

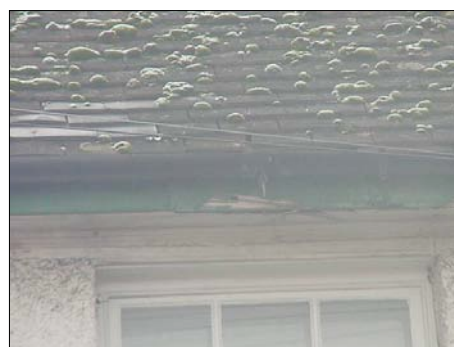
There is some flaking paintwork to the fascias and soffits.

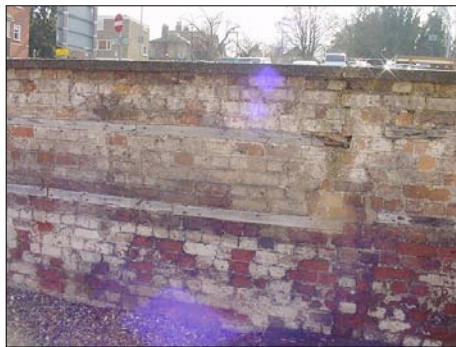
Here, if you look closely, you can see the bonding timbers in the wall.
