COMMERCIAL BUILDING SURVEY OF A Private 1960's Clubhouse

Mr A Client

GEM Associates Limited

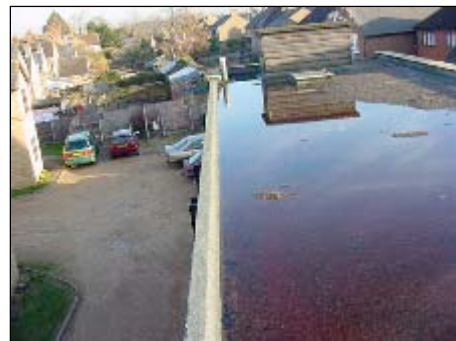
The main roof is a flat bitumen roof that is leaking and has deflected. There was also ponding on the roof at the time of our inspection. We believe the best way to resolve the roof issues are to use an insulation cut to falls (to aim any rainwater at the outlets) and then to re-felt with a high performance elastomeric-type felt. The flashings will also need checking, as will the parapet walls in general.

This photo shows nicely the amount of water sitting on the roof, none of which is actually getting to the rainwater outlets.

ACTION REQUIRED: The main roof needs re-roofing with falls adding to it, the lower roof can be patch repaired initially with future re-roofing and the lower right hand roof can also be patch repaired in the short-term.

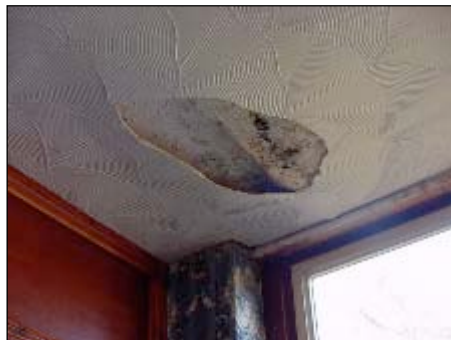
You can see part of the damage that has been caused internally.

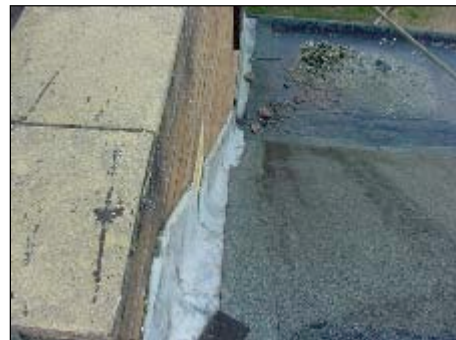
The roof to the stairway has also seen better days

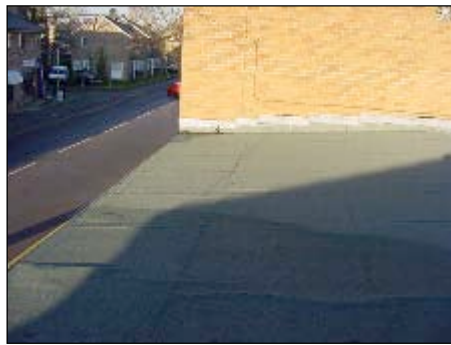
The lower roof has a traditional double-pitched roof, although with a fairly minor fall on it. This roof has a mineral felt covering, which has been put on fairly badly and has now blistered and it can be seen where repairs have been carried out, particularly around the junction where it meets the main building. In the long term this will need re-roofing, however we feel on a short-term basis that patch repairs can be carried out and new flashing work. However, it must be understood that the longer the roof is left the more repairs will need to be carried out, for example to the decking beneath it. We are advised that this roof was re-roofed approximately eight years ago, however the quality of the re-roofing is fairly poor, which is why the problems have occurred.

General view of the roof. Note the blisters, for example in the left hand corner of this photo.

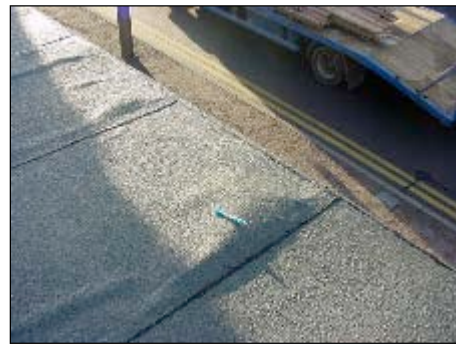
A close up of one of the blisters, the pencil is sitting on top of it, you can also see other blisters surrounding it.

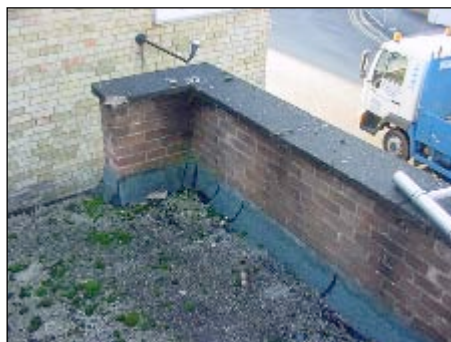
You can tell that the water is not running off of this roof because of the moss sitting on it.

This is a bitumen roof with a chipping finish. We recommend here that the flashings are repaired and that a layer of chippings are added to the roof to give it protection against the extremes of sunlight and frost.

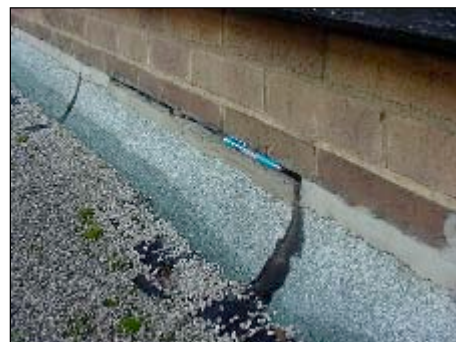
The pencil is sitting on the mortar, which has come away at the top of the flashing.

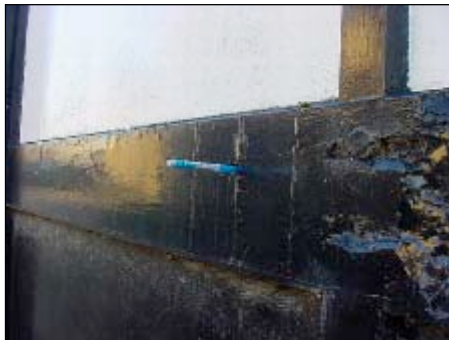
We found rot within the timber frame of the property. This is effectively a cladding because the strength of the property is set out within the steel frame and can be replaced, which does give you the opportunity to make the property more visually appealing/visually dramatic if you so wish, without major costs.

The pencil pushed straight through the timber frame.

ACTION REQUIRED: In due course repair work will be necessary, but first the roof issues and the drainage via the rainwater gutters and downpipes needs to be resolved. These are fairly basic in some instances, such as re-fixing the hopperheads and downpipes.

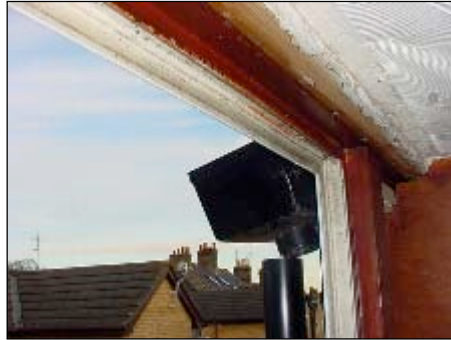
Note the bare timber frame. We think that possibly water is running through this area when it rains.

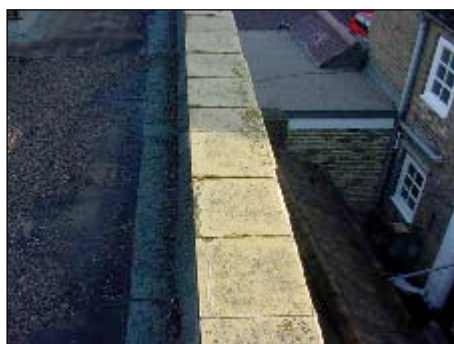
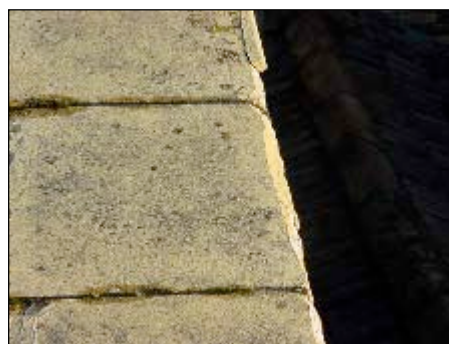
The edges have sheared off some of the copingstones.

ACTION REQUIRED: Ideally the entirety of the coping should be removed and replaced with copingstones with drips on either side and suitably bedded.

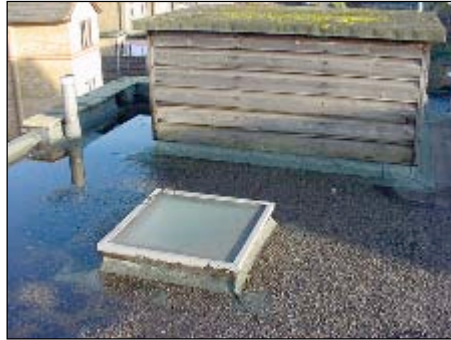
This would benefit from re-staining

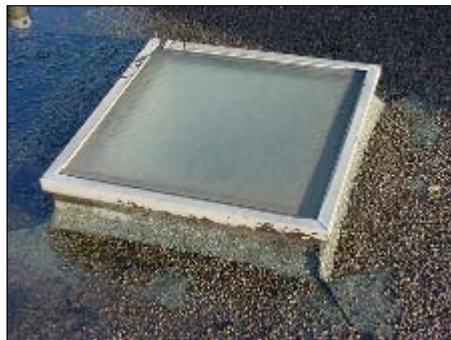
There is one roof light to the property. It is glazed with a Georgian wire polished plated glass as it should be, although it looks to be single glazed. From the tar that is around it we think it has probably leaked in the past and we tend to find that condensation occurs on these.

Note the tar around the edge of the roof light.

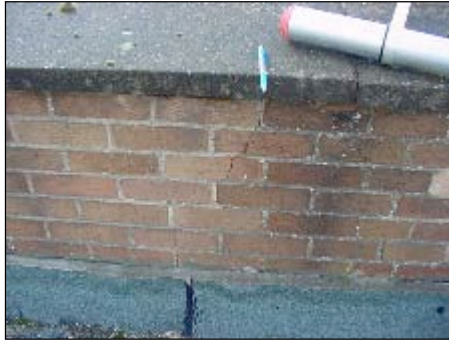
In some areas the parapet is exposed on both sides to the weather, this is why we believe the cracking has been caused. Also the drips are not ideal and there will be similar problems to the parapets on the main building.

The pencil indicates the hairline crack that runs down through the parapet wall.

ACTION REQUIRED: Re-bed the flashing or better still replace with a lead flashing.

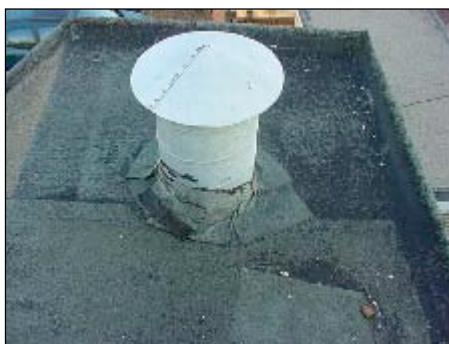
Between the far right hand roof and the main roof is a step or upstand that has been built in brickwork. This area has a defective felt flashing and needs re-fixing.

Not a very neatly cut flashing.

ACTION REQUIRED: Re-fix flashing and preferably replace with lead.

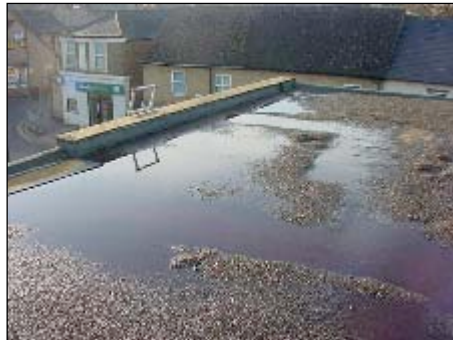
This is another general view of the roof. It shows quite nicely how the ponding is occurring. Yet to the far corner where the rainwater outlet is there is no water (this is approximately in the centre of the of the photo to the top end).

ACTION REQUIRED: On our second reading of this report we feel it is prudent if we open up the structure. We suggest it is opened in two areas. We could widen an existing opening to the roof where the water is getting through and we also need to do a second area at the base of a steel column to examine the condition of this to ensure it is not rusting or fractured in any way.

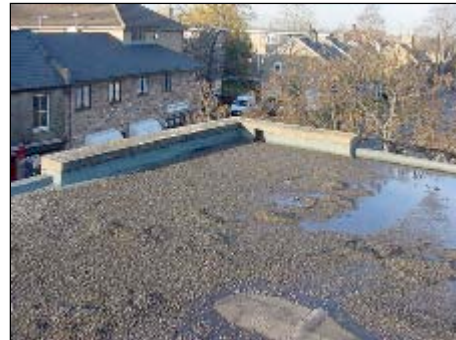
Again there is ponding on the right hand side and again the drainage outlet can be seen roughly in the centre of the photo. You can also see that the chippings have bulked up leaving some bald areas, for example at the front of the photo.

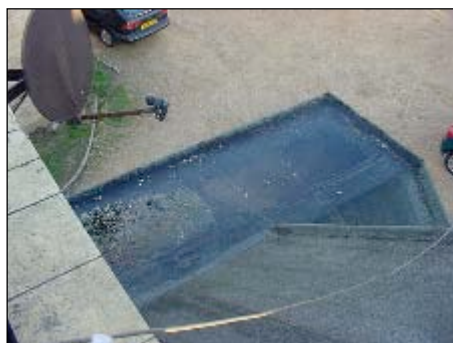
At the end of the main roof is the roof over the steps. This roof has a mixed finish, partly of mineral felt and partly of felt with a chipping covering. It is fairly worn and past its best.

This is looking down onto the return of the stairs. You can see that the black felt is exposed.

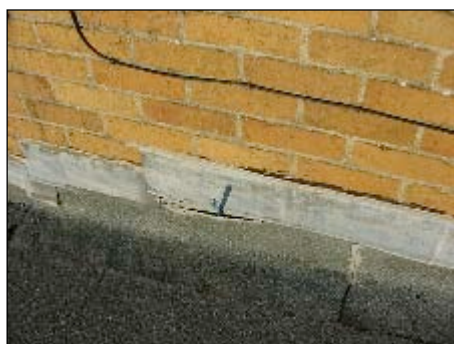
This photo shows a defective flashing, the pencil is literally stuck into the felt showing how it has come away.

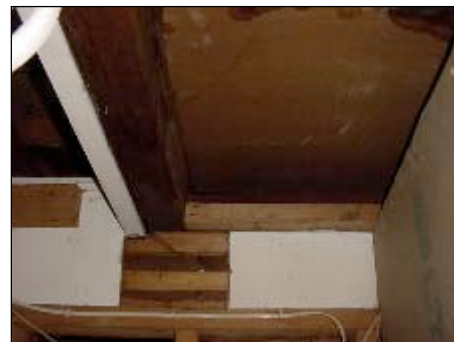
You can just see some dampness to the top edge of the photo.

ACTION REQUIRED: If you do decide to expose the structure we would also recommend that a selection of the ceiling tiles are removed to gain a better view of the lower roof structure.

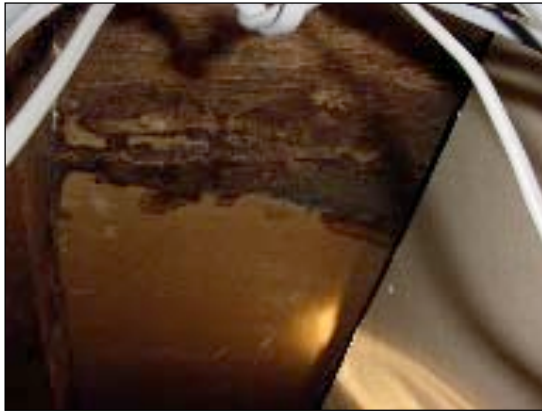
This perhaps shows more graphically how the water is getting through the roof into the decking.

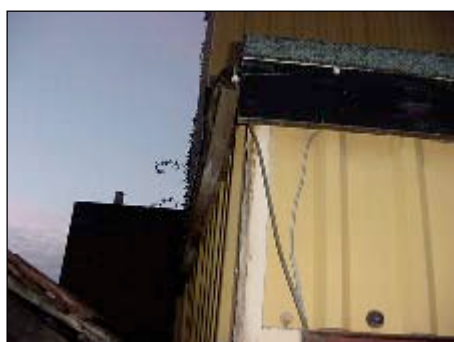
To the rear of the property, where the staircase is, the guttering in this section is missing.

Missing gutter.

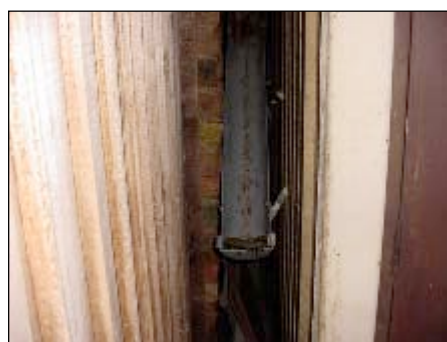
To be exact it is not missing as it has fallen down between the buildings.

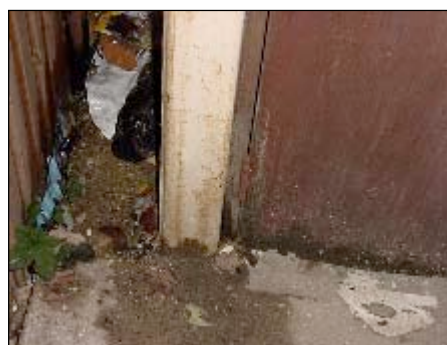
This is the reason why you need to open up the structure, you can see minor amounts of rust starting to occur on the bottom of this steel frame.

ACTION REQUIRED: We would ideally recommend that the structure is opened up, partly to the roof and partly at the base of the structure.

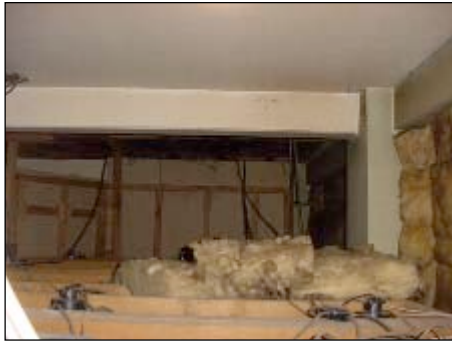
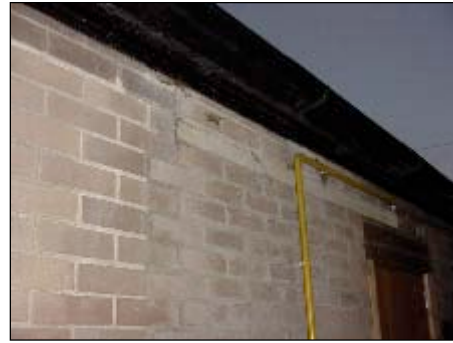
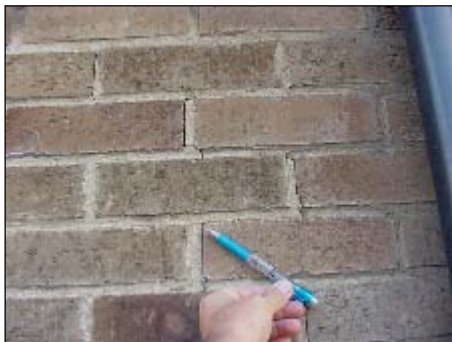
A step hairline crack.

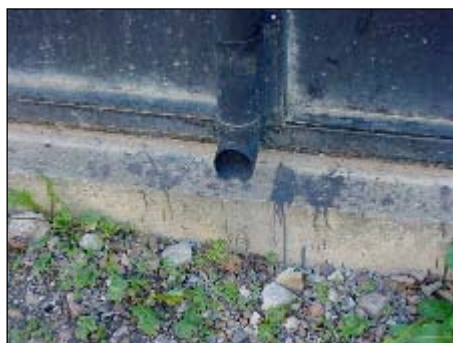
The damp proof course was not visible.

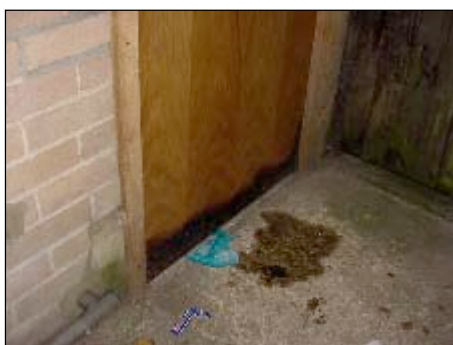
Note the dampness at the base of this door that will cause rot, and the door is untreated.

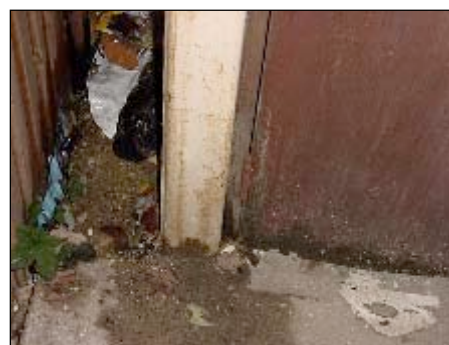
This is the rear door, you can see dampness at the base of it and rusting to the hinges.

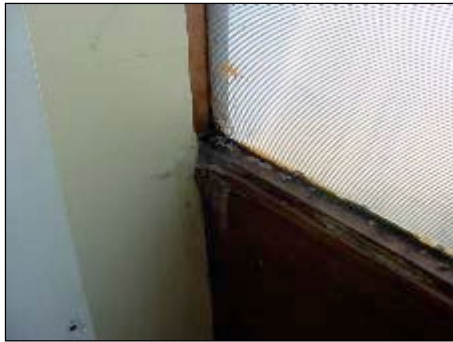
This is an internal view of the window where you can see that the dampness is coming through, causing wet rot to the timber.

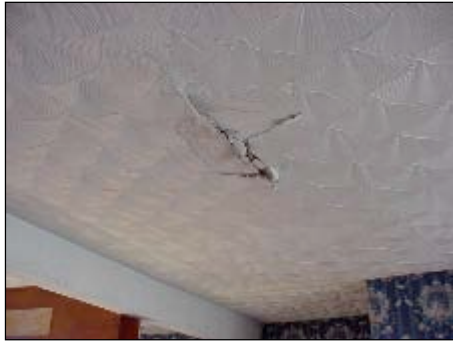
An example of the water coming through into the first floor room.

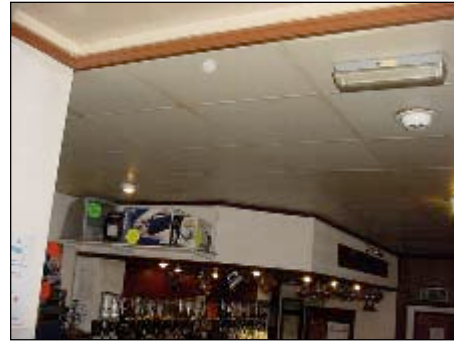
General view of the suspended ceiling. Note the light fitting on the right hand side, we are advised that water literally drips from this when it rains. An interesting, but not ideal feature within a public bar.

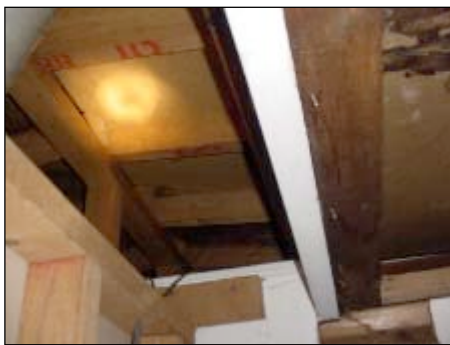
A view into the ceiling above the suspended ceiling system. The darker timbers that can be seen is where dampness is getting through from the roof above.

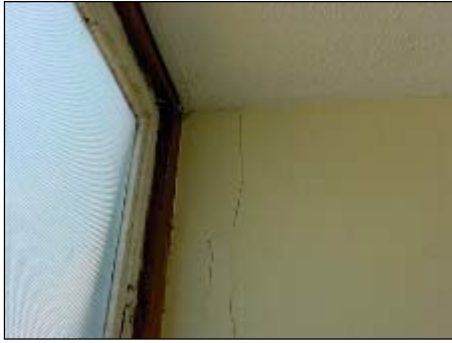
There are minor movement cracks to some of the internal walls, this we feel could relate to either dampness in the structure causing movement, or as a worse case scenario rust in the steel frame.

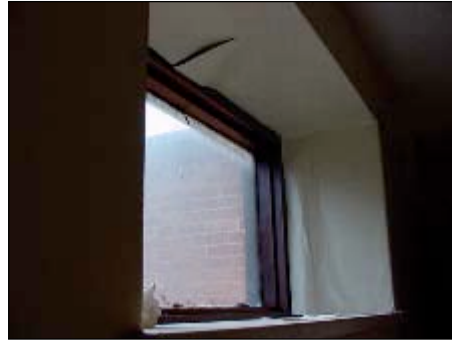
Further dampness can be seen to be coming through around this window.

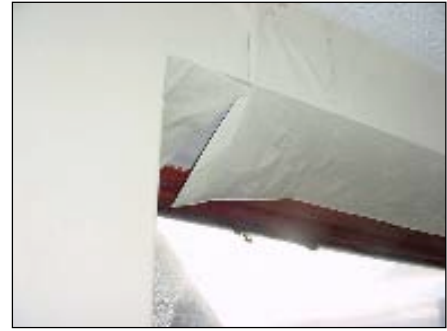
The paper literally coming off the wall. Internally we believe this to be via the roof, rather than via the walls

You really need to work from the top of the structure down to make it watertight, preparing the roof as we have mentioned earlier, then the gutters, then looking at the cladding. This should then resolve the lateral or penetrating dampness.

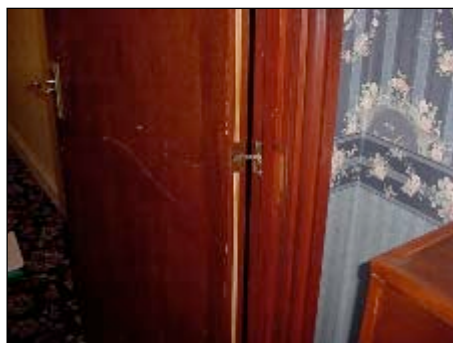
General marking and scuffing to the door. Also this door closer was not working.

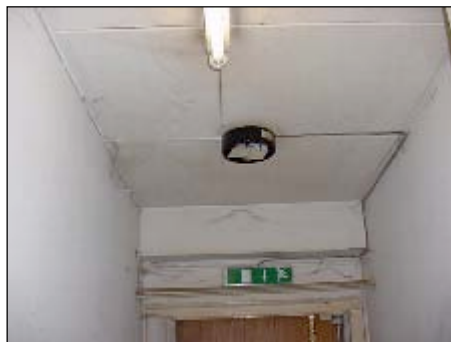
We do not think this smoke/heat detector is working.

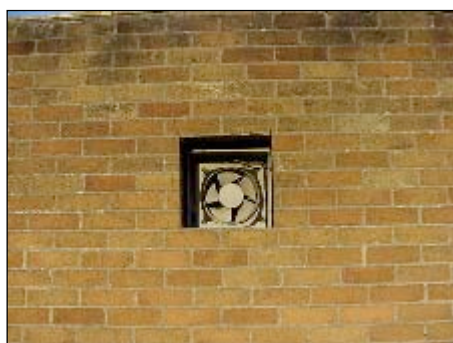
There is an extract fan to the first floor bar; the outer cowling is missing, which is likely to allow water in. When we tried to get the fan to work via the control panel behind the bar it did not appear to be working.

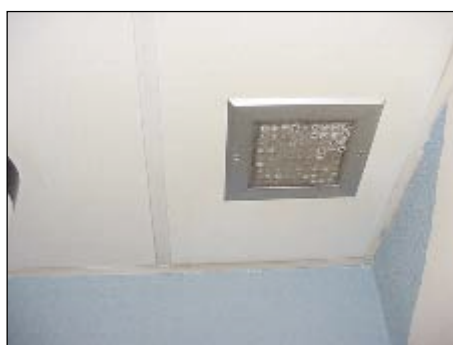
There is also a general air circulation system to areas with the suspended ceiling. The vents to this are desperately in need of a clean.

Clean the vents.

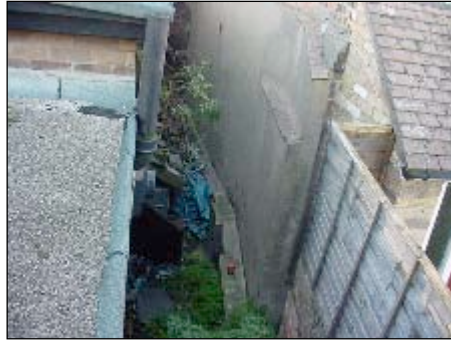
The pipe here we believe is the soil and vent pipe. Note also the ally way behind it that needs a general clear.

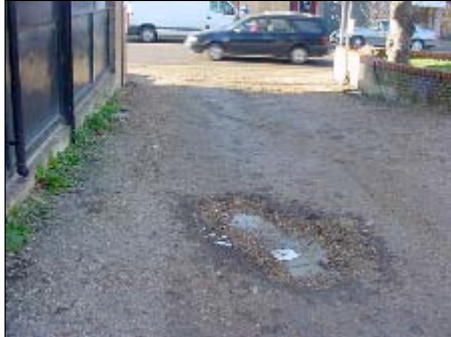
There is a road running up the left hand side of the property. This is worn. We are advised that there is a right of way and you should check to see if there is a responsibility to pay towards the maintenance or even maintain the road.

Road in need of maintenance.
(Note the wall to the far right hand side has a step crack in it. This has been caused we believe by the close proximity of the tree.

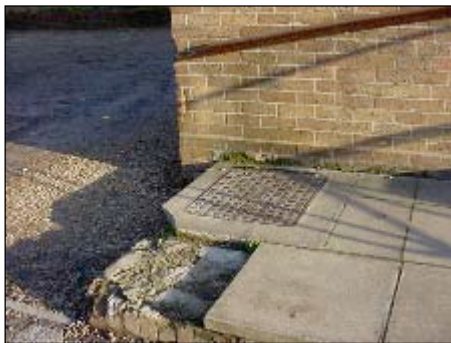
Missing and damaged steps.

We would suggest that a day or so is spent on the steps to the front entrance of the property re-aligning and levelling these and also replacing the missing step.

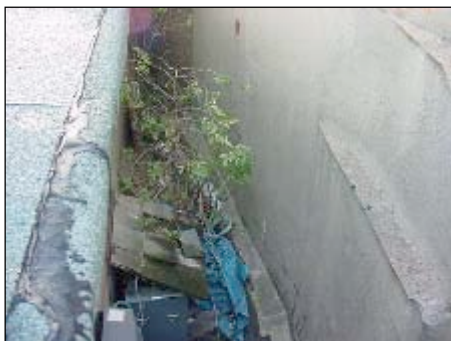
Needs tidying. Note also the messy detailing to the mineral felt, that indicates to us that it was never a particularly good job.

The alleyways need clearing that give access to the side and rear of the property.
