RESIDENTIAL BUILDING SURVEY

Semi-detached

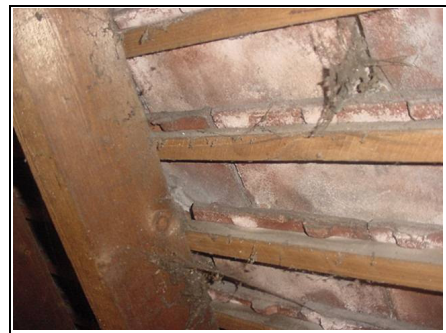
Close up of back of tiles, lighter areas are where dampness is getting through

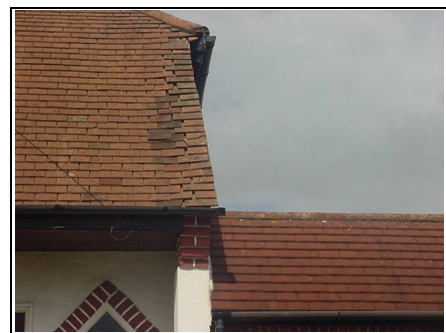
We could see in some areas that the tiles were slipping and in some areas the tiles were spalling. Although it is letting in some rain water as we can see by the staining to the rear of the tiles, we do not think it is excessive.

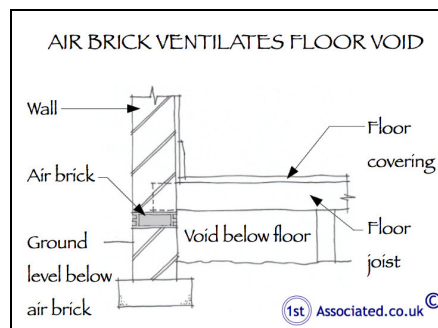
ACTION REQUIRED: You need to clear the existing airbricks and add new airbricks.

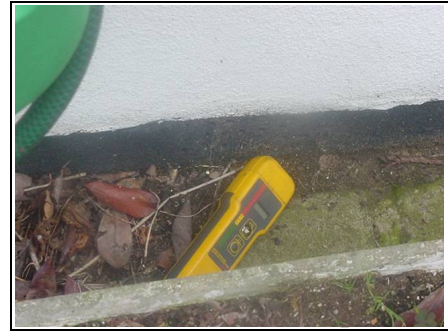
Airbrick to rear not adequate

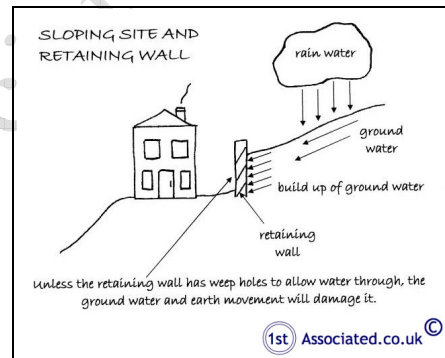
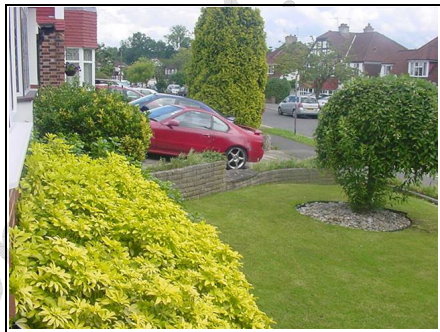
Any property on a sloping site is more susceptible than one on a flat site; it is simply the laws of gravity. Foundations normally allow for such occurrences, particularly in new properties. There can still be some minor movement.

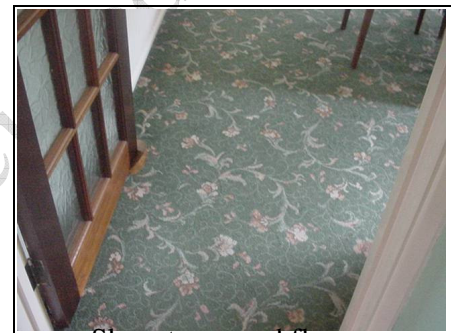
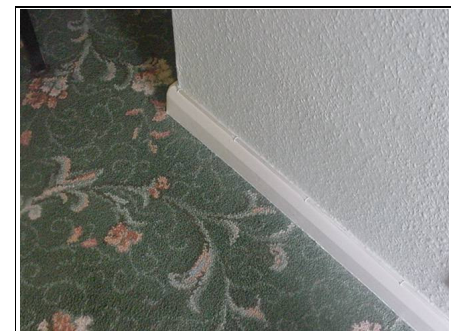
Please see the Floors Section of this Report.

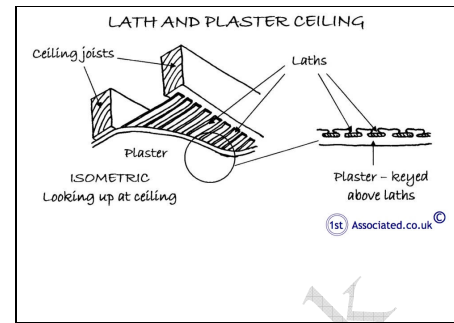
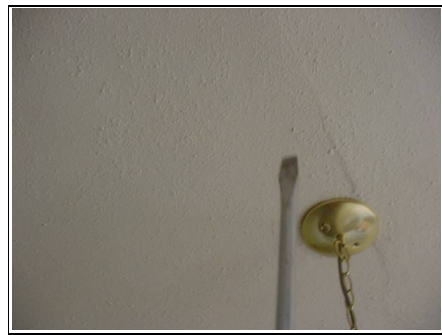
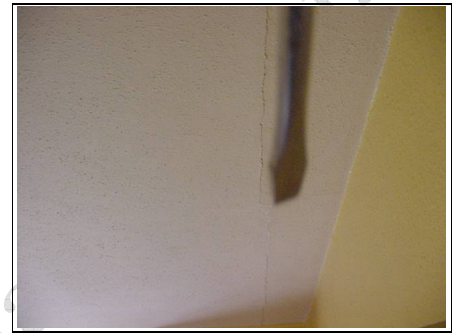
Hairline cracks to plaster

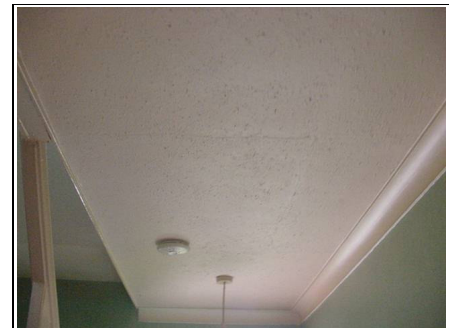
The ceilings are old and of an era when the artex contained asbestos. Although we believe this to be minor, please be careful and do not rub down the ceilings.

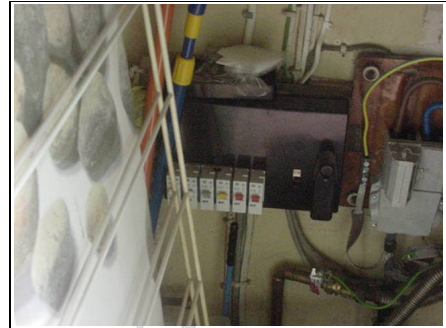
ANTICIPATED COST: In the region of £200 - £400; please obtain quotations.

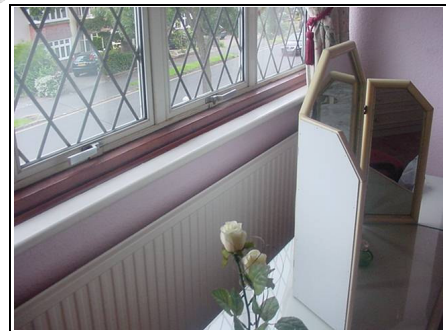
Single panel radiator

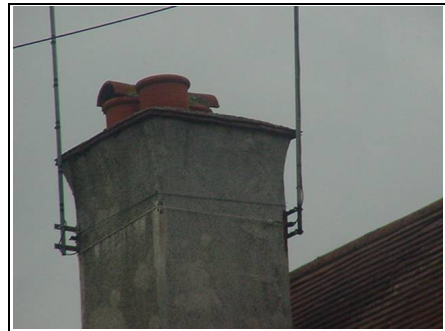
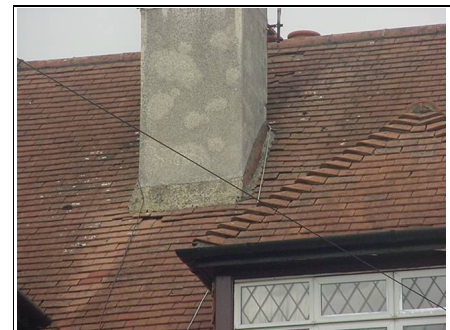
We are unsure if it has a flashing at all. It possibly has a tile on edge flashing which is a type of flashing that we are not very keen on as dampness does ultimately get into the property.

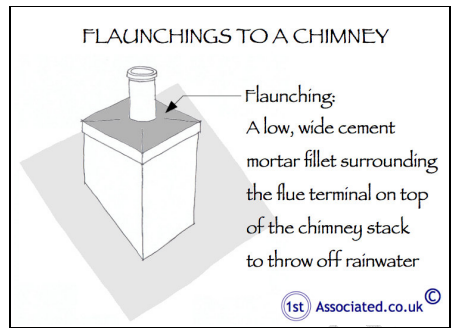
Chimney Two – located to the rear

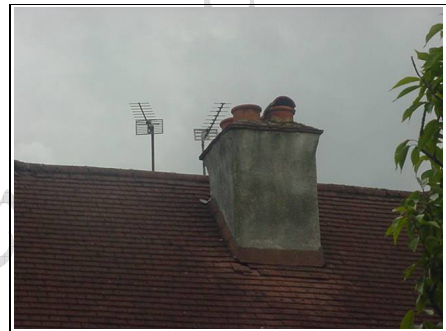
ACTION REQUIRED: Redecoration required in the summer of 2013. Periodically inspect the chimney.

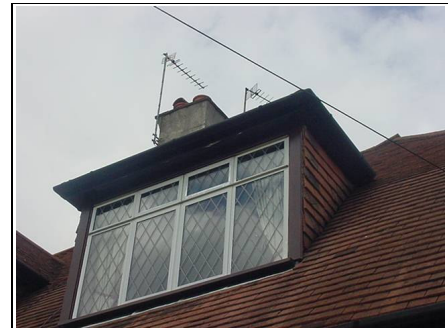
Finally, Dormer windows have been viewed from ground level and literally from the dormer windows themselves.

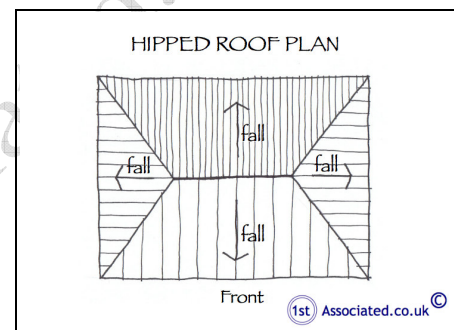
Due to the construction of hipped roofs, they are prone to slipping or to dropping which can, in extreme cases, push the walls out of vertical. In this case we saw no signs of significant wall movement.

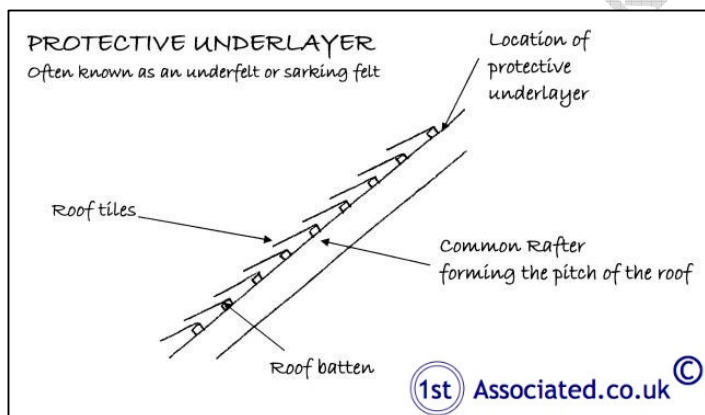
In this case there is no protective underlayer and we can see the back of the tile.

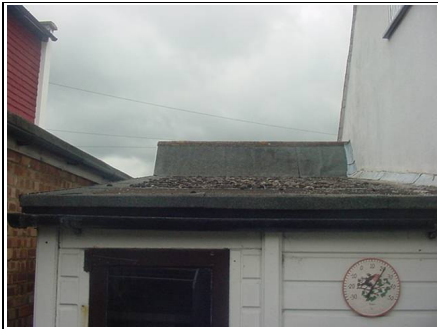
We were pleased to see that the rear felt roof has a reasonable fall on it, albeit that moss is still sitting on it. Please note we did not access the garage; if you haven't accessed it, then we would recommend that you do view it internally.

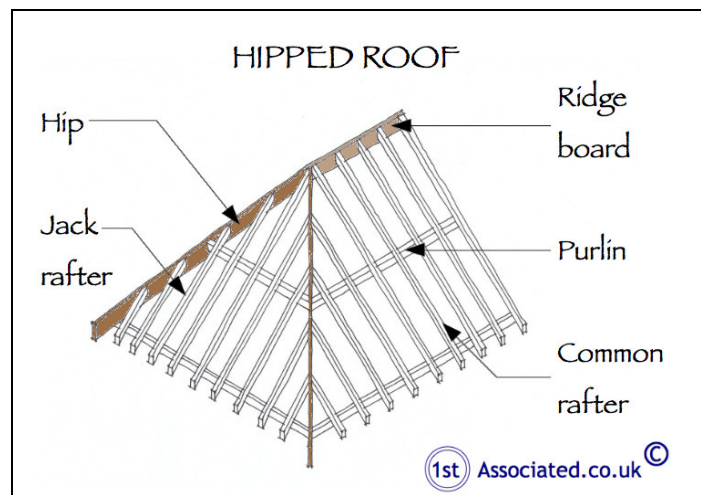
This type of roof structure has what is known as cut hipped roof. This is a roof that is purpose made and hand built on site. Without the original design details we cannot categorically confirm that there are no defects; however it is in line with what we typically see.

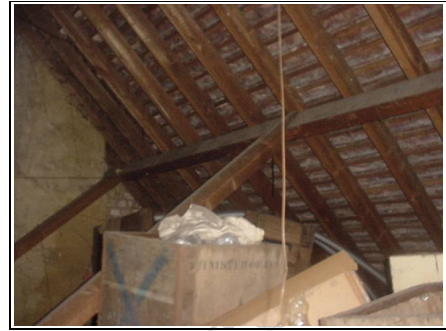
- Serious active woodworm
- Structurally significant defects to the timbers
- Structurally significant dry rot
- Structurally significant wet rot

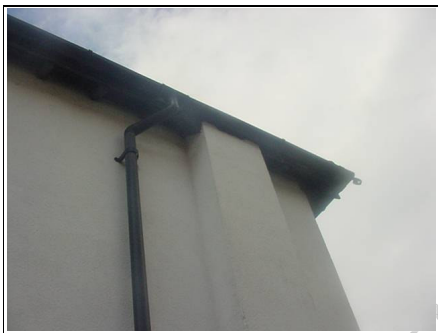
Plastic gutters and downpipes

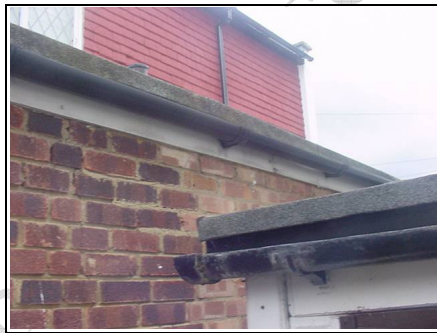
Gutter to the garage looks like it is leaking and hasn't got a fall on it towards the downpipe

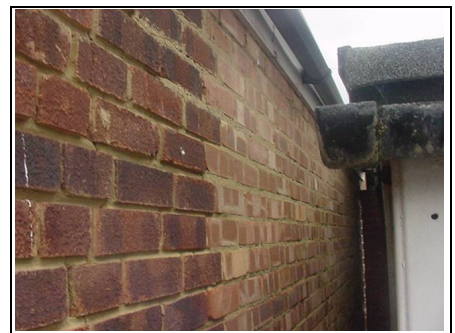
Cast iron gutter to rear of garage

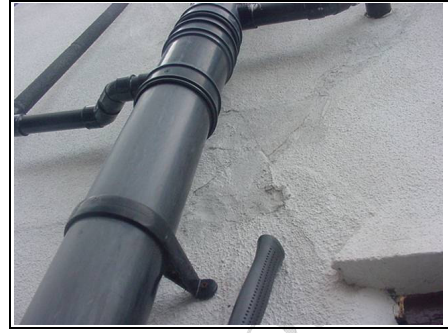
The property has plastic soil and vent pipes.

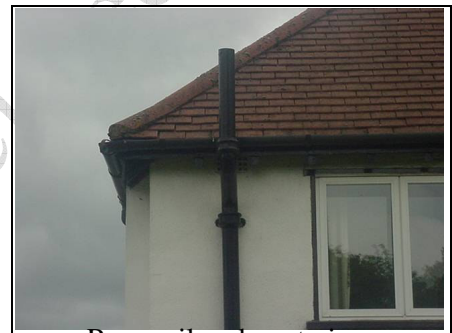
Rear soil and vent pipe

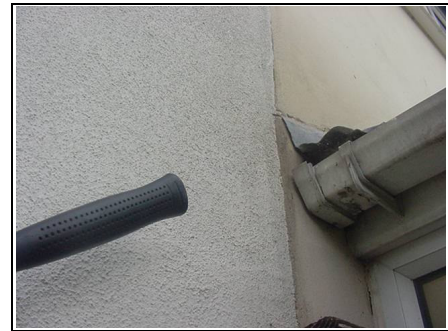
We have carried out a tap test to the render at low level (literally hitting the render with the back of a hammer to try to establish if there are any hollow areas in it) and we feel in this instance that the render is in average condition for its age, type and style.

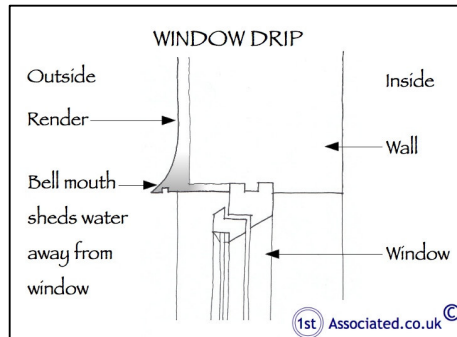
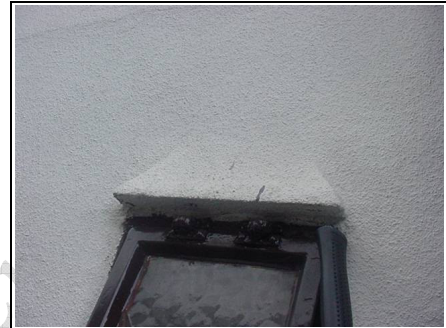
In this case we found a drip detail to the windows.

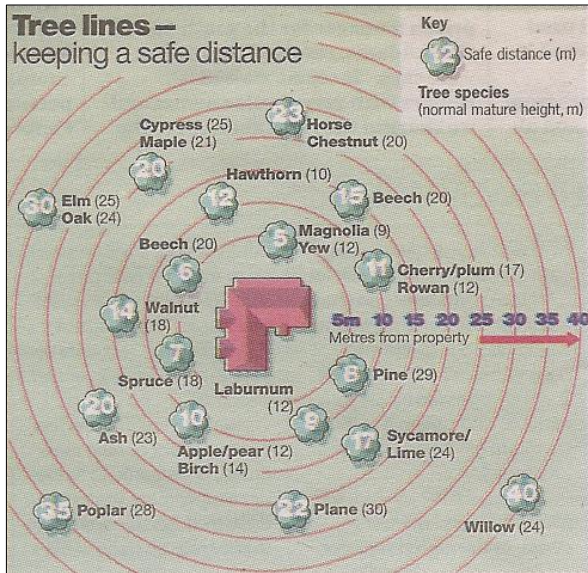
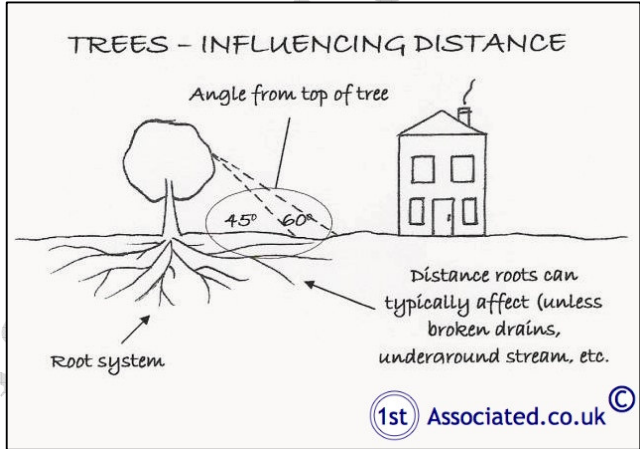
Influencing Distance Defined

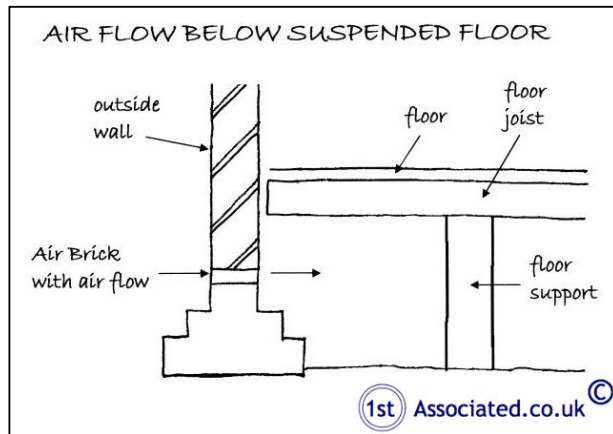
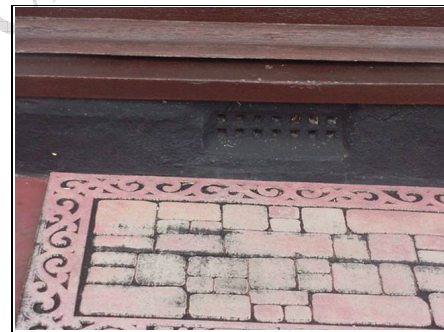
ACTION REQUIRED: Please see our comments in the Executive Summary.

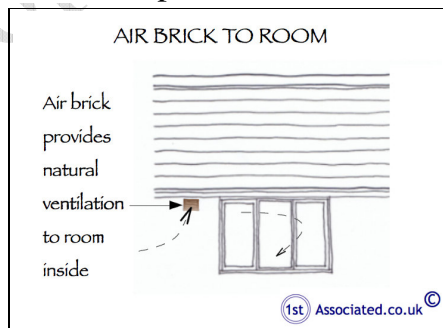
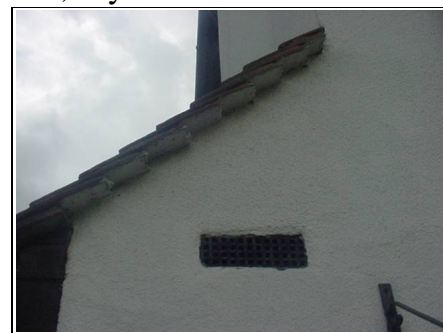
There are vents at high level. Air bricks are essential to have a through flow of air as this helps to reduce the chances of wet rot, dry rot and woodworm.

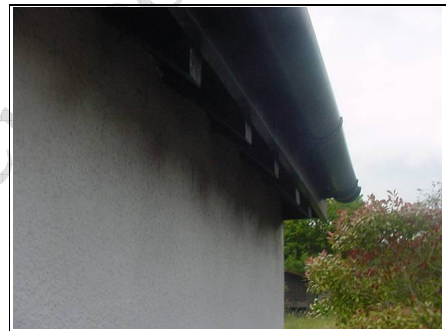
The fascias, soffits and exposed rafter feet are timber. We would comment they are in average condition for their age, type and style. We generally find exposed rafter feet are never decorated properly and therefore rot can occur.

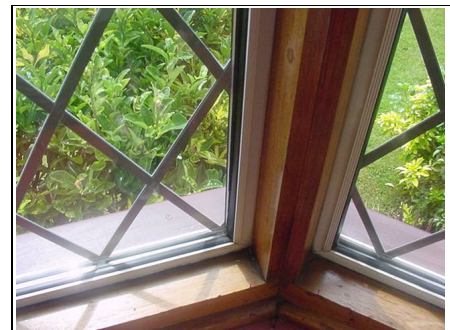
Aluminium windows within timber frames

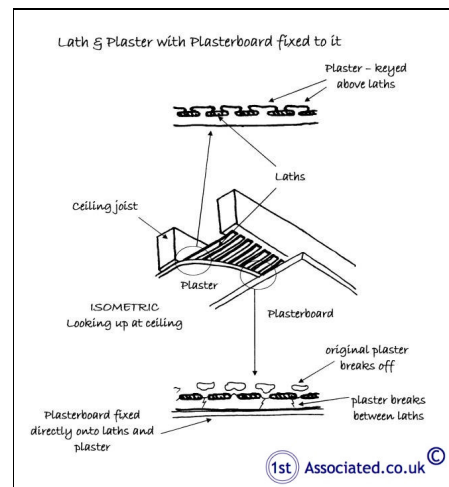
The usual name for Gypsum plasterboard which is building board with a core of aerated gypsum, usually enclosed between two sheets of heavy paper, used as a dry lining.

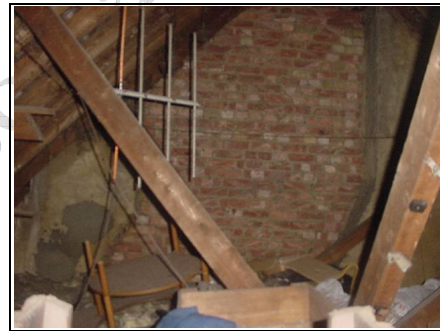
Patch repairs to rendered chimney

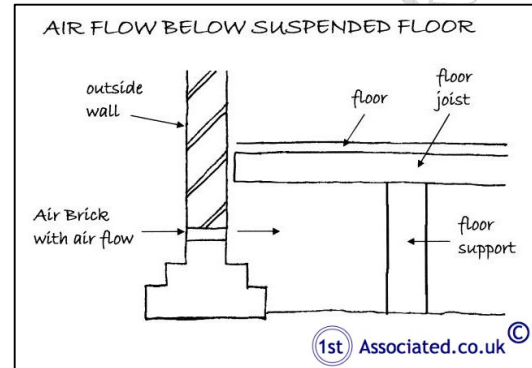
ACTION REQUIRED: We would recommend that you open up the floor. Please see our comments within the Executive Summary with reference to the slope on the floors.

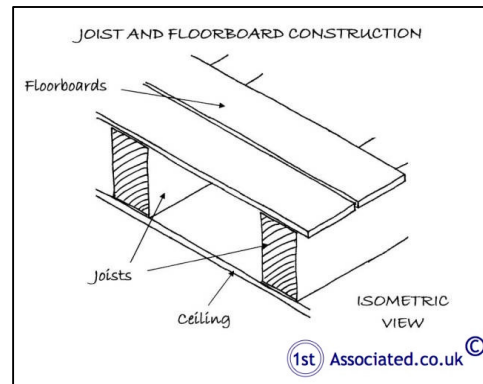
Finally, we have not been able to view the actual floors themselves due to them being covered with fitted carpets, etc. Please see our earlier comments about our theory that there is hardboard underneath them which could mean that the floorboards underneath that are damaged. The comments we have made are based upon our experience and knowledge of this type of construction. We would emphasise that we have not opened up the floors in any way or lifted any floorboards.

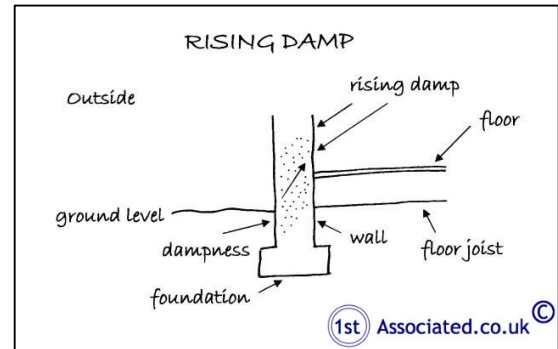
A visual inspection and tests with a moisture meter have been taken to the perimeter walls.

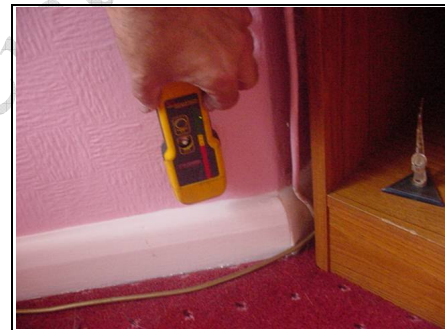
Testing for rising damp

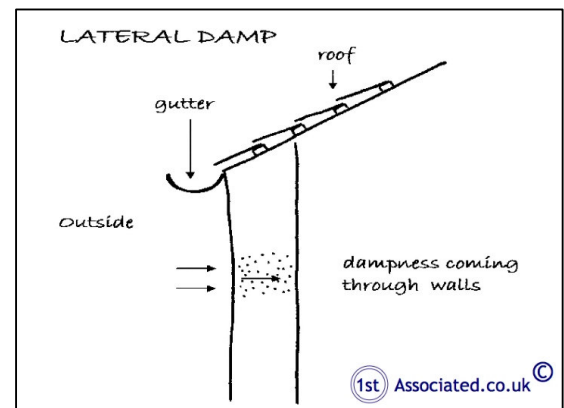
ACTION REQUIRED: Please see our comments in the Executive Summary.

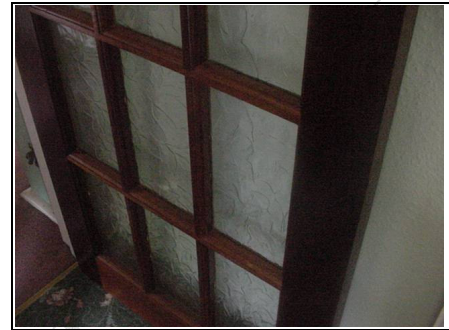
Door with no safety glass

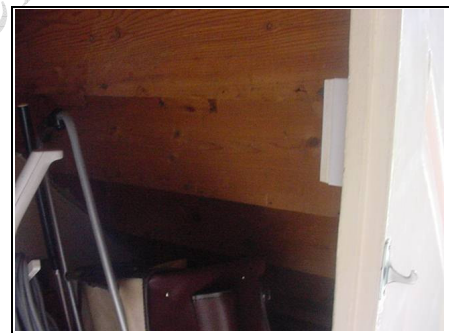
We noted that the underside of the staircase was exposed. It is more normal today to have a half hour fire barrier to stop fire spreading from the ground floor to the first floor in a worse case scenario. You may wish to take a view on whether you add this.

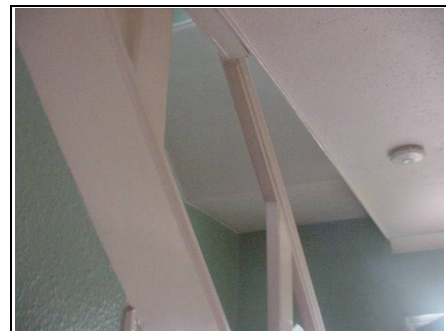
Handrail openings on stairs are wider than is now acceptable.

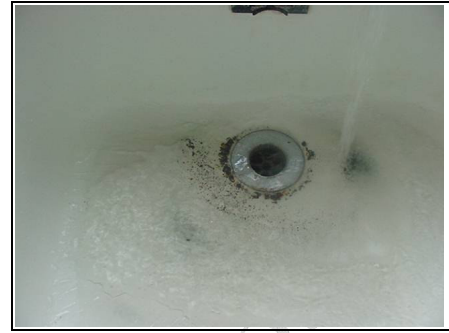
Deterioration to kitchen sink –
needs replacing

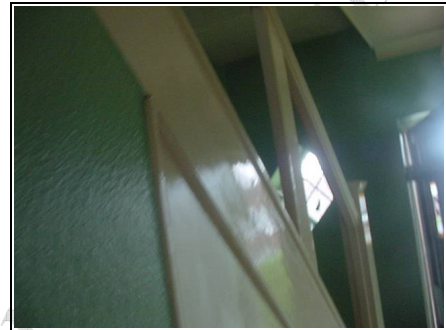
ACTION REQUIRED: Nicotine stains need sugar soaking down and a lot of elbow grease and then repainting.

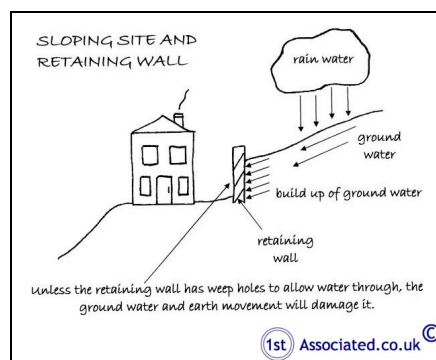
ACTION REQUIRED: Please see our comments in the Executive Summary.

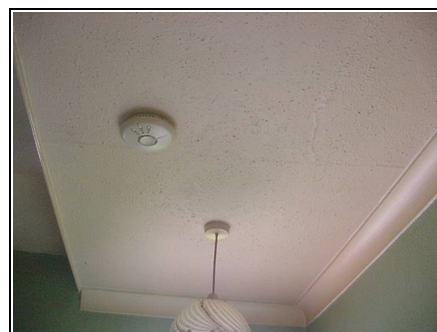
ACTION REQUIRED: We would recommend, for your own safety, that smoke detectors be installed. We would always recommend a hard wired fire alarm system and are also aware that some now work from a wireless signal which may be worth investigating. Whilst fire is relatively rare it is in a worst case scenario obviously devastating.

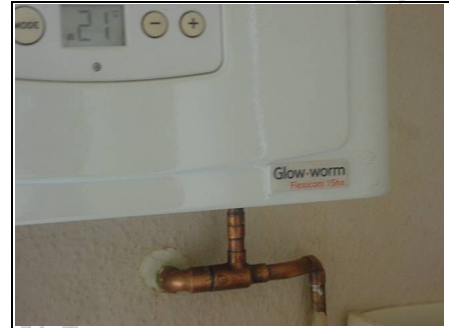
Our limited inspection of the hot water and central heating system revealed no evidence to suggest any serious defects but we would nevertheless recommend that the system be tested and overhauled before exchange of contracts and that a regular maintenance contract be placed with an approved heating engineer.

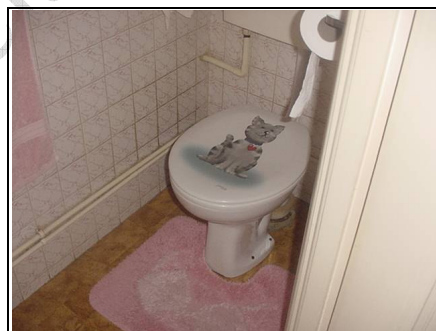
The cloakroom is situated under the stairs and comprises a WC with cat toilet seat and wash hand basin.

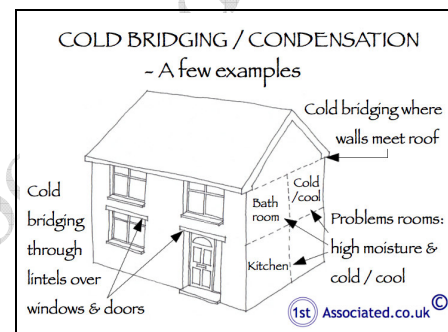
Cold Bridging isn't just about condensation on mirrors

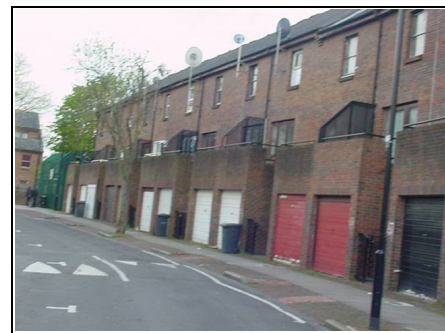
1960's properties built with concrete lintels that can cause Cold Bridging

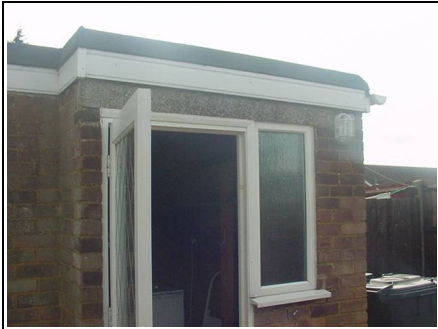
A rear door to a 1970's building.
Can you tell where the cold bridging would be in this photo?

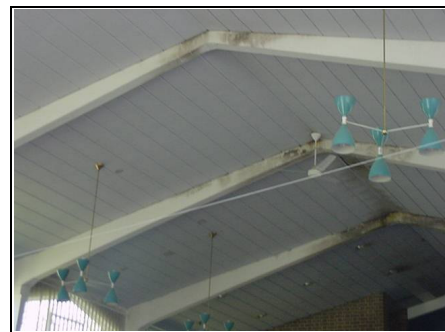
Cold Bridging in a commercial property with a concrete frame.

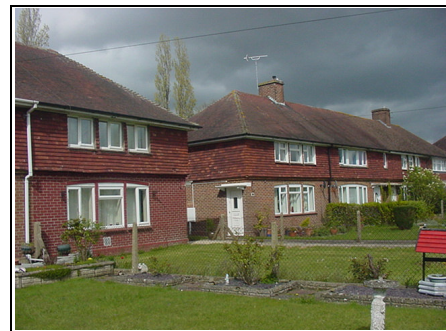
Post war 1960's properties with plastic double glazing without trickle vents that have been added can cause condensation.

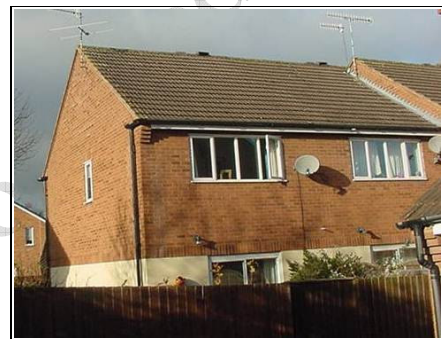
1980's property, cold bridging was found in the lintels

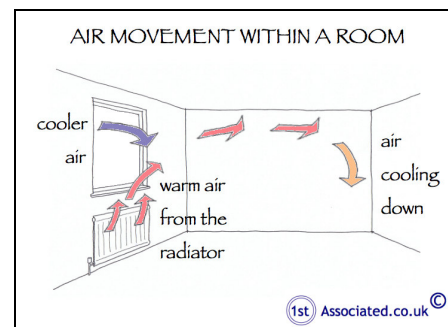
Where do we most commonly find Cold Bridging?

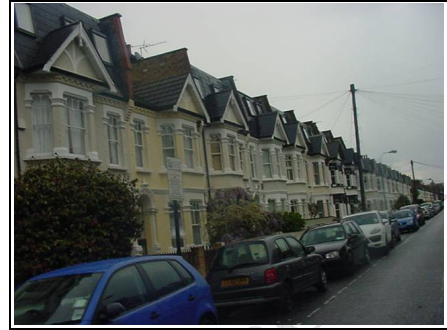
Victorian properties that have been extended and altered over the years with new thermal properties that can cause Cold Bridging because of the mix of old and new standards

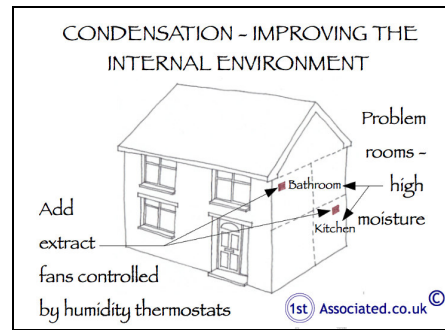
Things to remember about an air brick

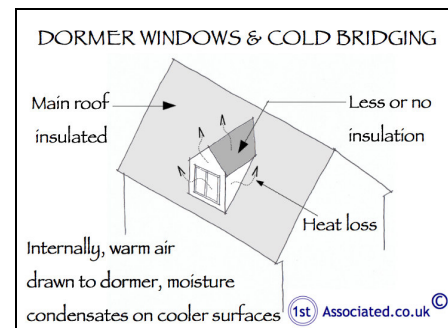
A more technical answer

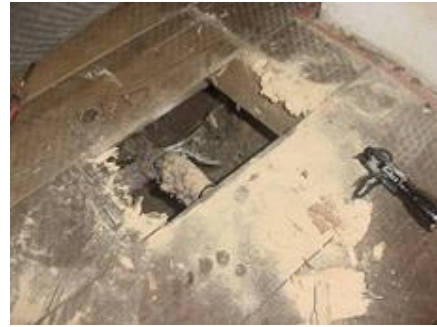
Opening up a slightly larger section

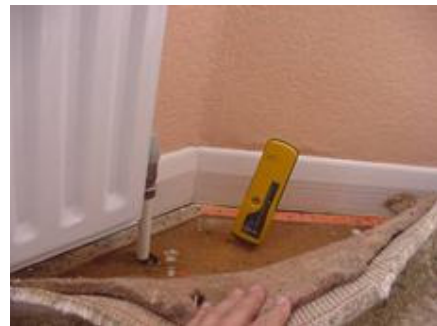
Getting the damp meter reading

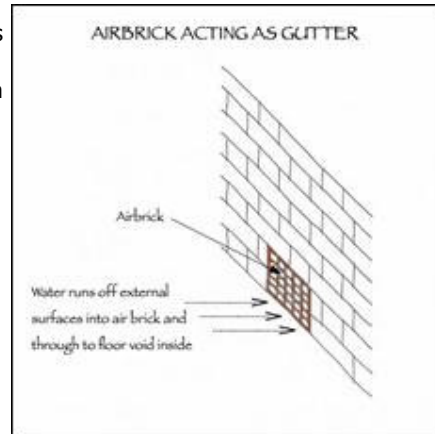
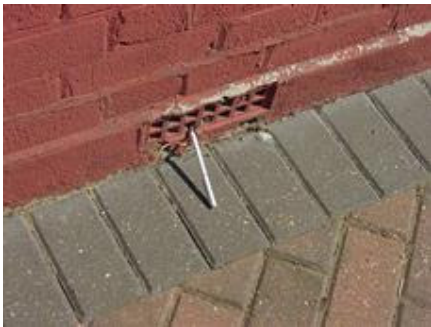
Airbrick allowing water into the building

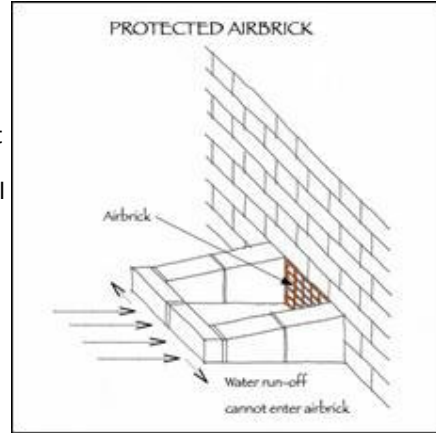
What is a French drain?

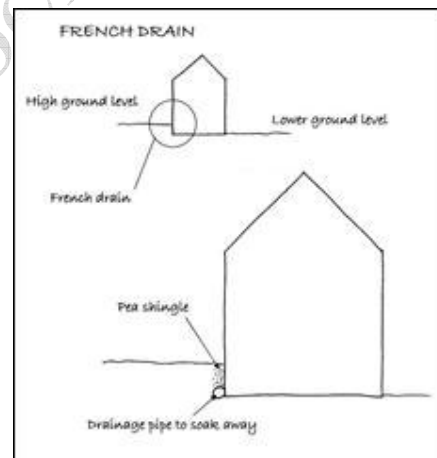
This is an area dug out by the side of the property and a perforated pipe placed in the base and shingle on top of it. This then means that any dampness that does come towards the building transfers through the shingle and into the perforated pipe and then ideally into a drain. You do need to make sure that the French drain is a proper French drain and doesn't cause you more problems by just positioning all the rain in one area.
