RESIDENTIAL BUILDING SURVEY

Weston Super Mare,
Somerset BS23

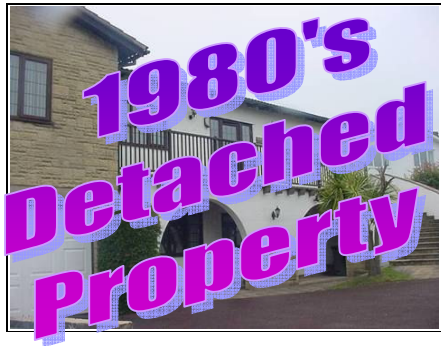
EXTERNAL PHOTOGRAPHS

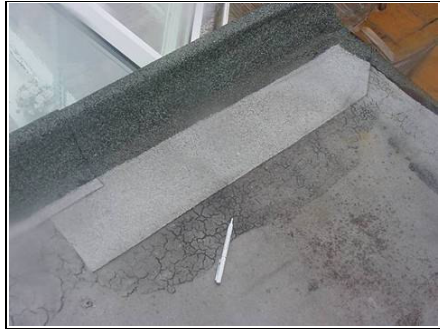
Old patch repair and crocodiling

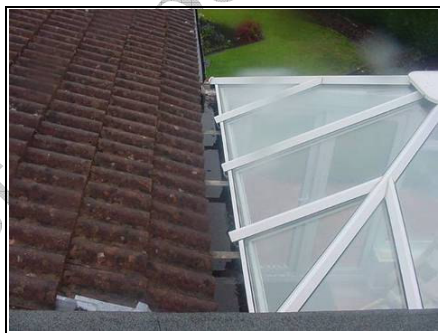
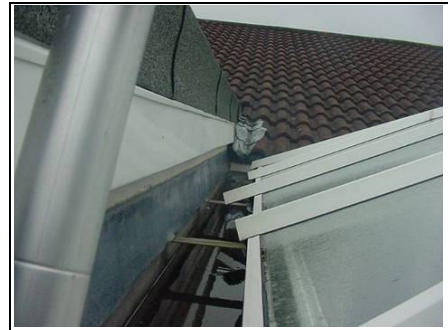
Awkward box gutter detail between main roof and conservatory roof

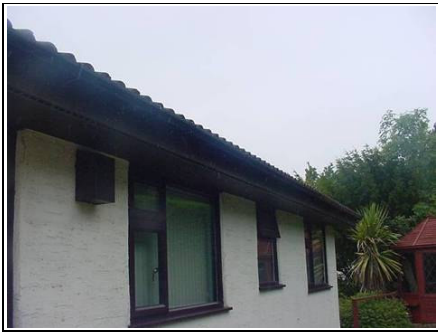
Cracks to blockwork of the property

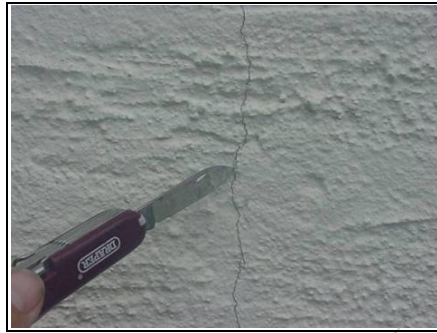
Hairline crack left hand side — marked by the penknife

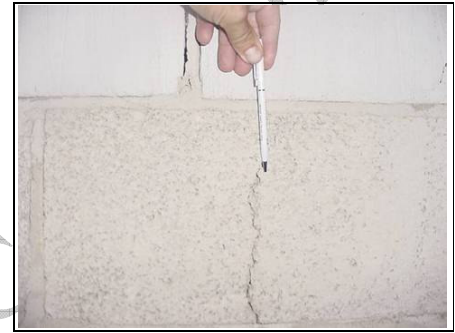
Crack to gable end on right hand side, taken within roof space. We also noted there was a different type of brick from the top to the bottom

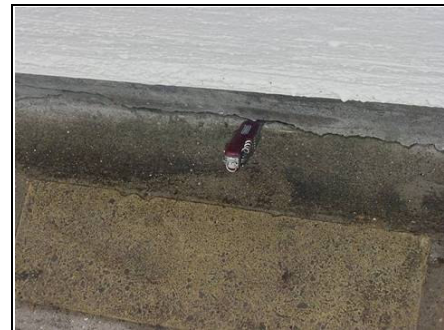
Cracking to balcony areas that need to be re-masticed

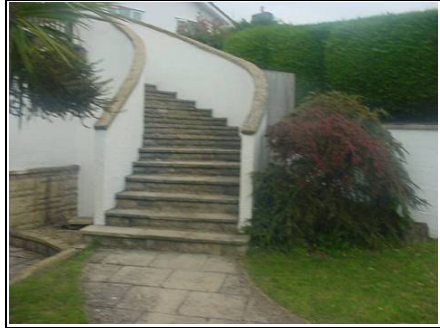
We can see signs of cracking to the staircase and movement to the steps. We simply do not know what their construction is. We have discussed this with you, whether it is rubble, rubbish or concrete beneath. Either way, there is some movement in the staircase and it will need constant repair.

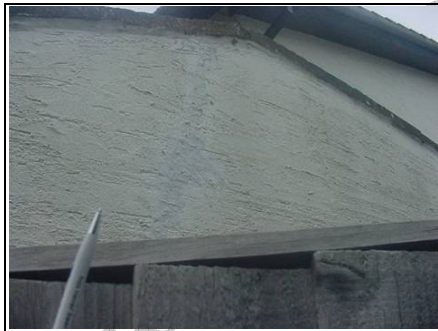
Staircase cracking/movement

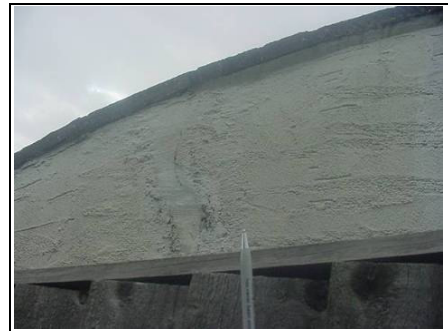
Movement visible to right hand side

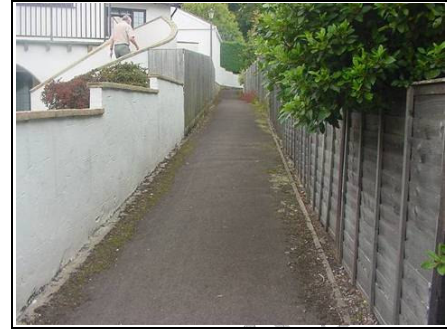
To the right hand side of the property you have a public footpath and you have a boundary wall. The boundary wall is built with a single thickness of brick or block. These type of walls, in our experience, are susceptible to movement and impact damage and it would not be pleasant if it fell towards the public footpath.

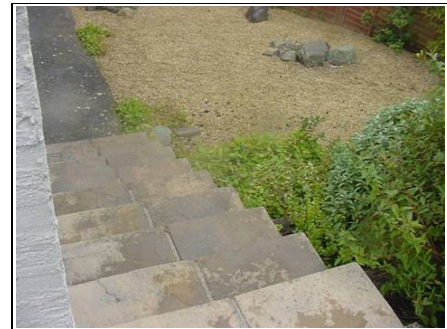
Slope down the stairs to left hand side

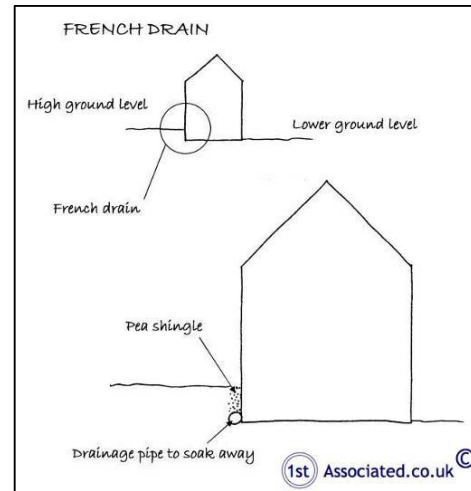
ANTICIPATED COST: Water penetration into the property could be reduced and improved but at a considerable cost, and by this we mean tens of thousands of pounds to sort out the cause and thousands of pounds to sort out the effect (i.e. a deep French Drain and external tanking and internally a false wall and membrane). The choice is yours but we do feel that you could spend a lot of time and energy to make this property watertight.

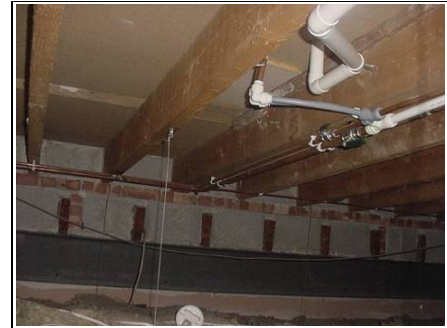
Looking above ceiling

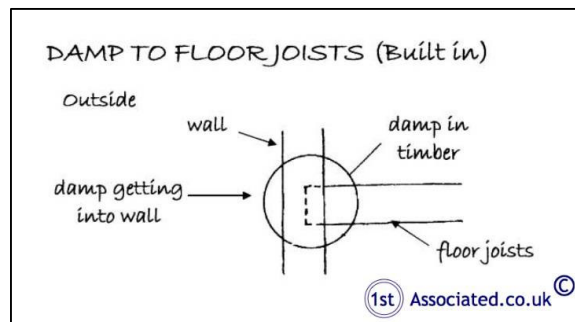
ACTION REQUIRED: We recommend some opening up to check the condition of the timbers. We can see that extra preservative has been put on the ends of them but the basic concept of building them into the wall is flawed.

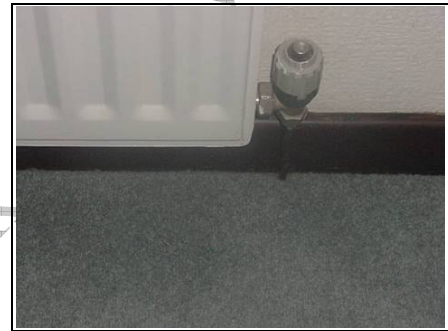
Microbore pipe system

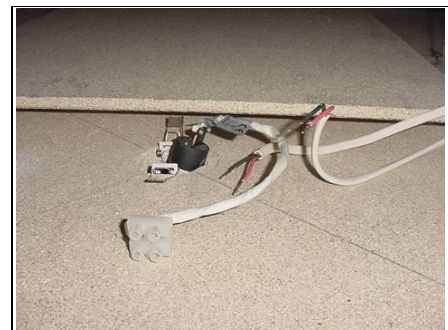
DIY electrics –cable connector hard core undone

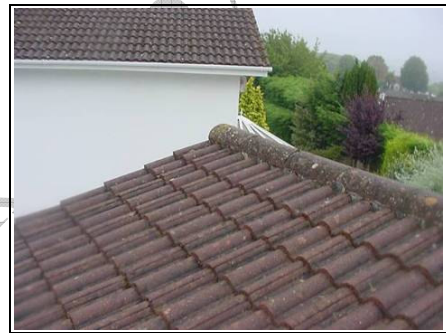
The main roof has a relatively shallow pitched concrete Roman tile which looked true and level and in average condition for its age, type and style.

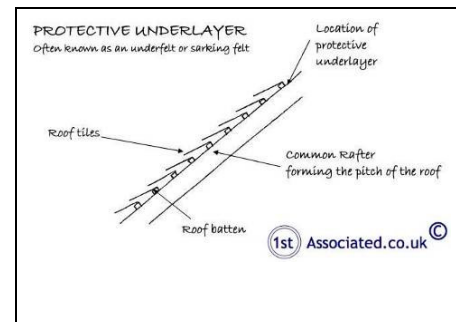
We could see a Hessian base sarking felt. This type of membrane has been used since the 1960s. We generally found it to be in average condition.

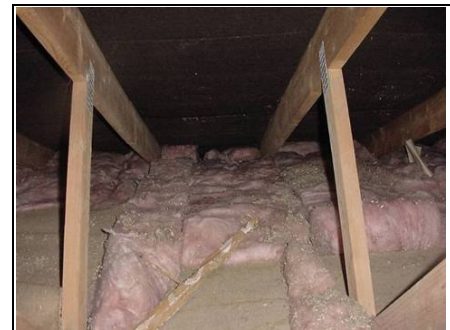
This photo shows the common rafters (the ones that form the pitch of the roof) and the dark area between is the underlayer. 26

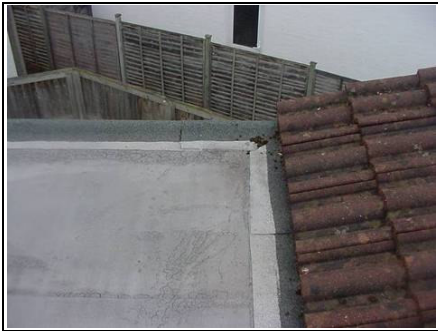
Please see our comments in the Executive Summary.

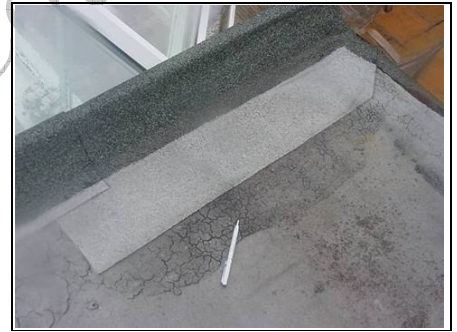
Ponding on flat roof

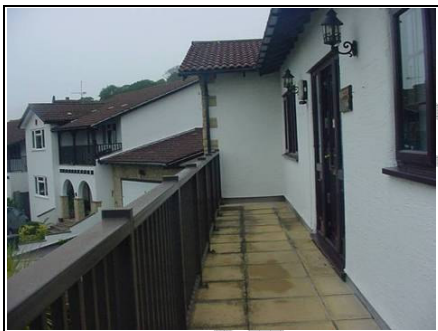
Do not forget that the balcony areas effectively act as roofs as well. We have commented that we feel there is water ingress via the balconies due to the hairline cracking; please see our comments. This in part is due to the single brick balcony wall having some movement in it and in part due to our comments in relation to the sheer mass of render without expansion joints, which would not be a recommended method of building today.

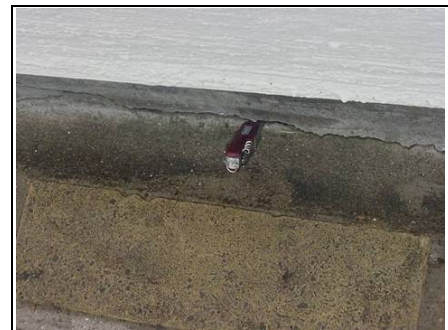
Cracking on left hand side of balcony

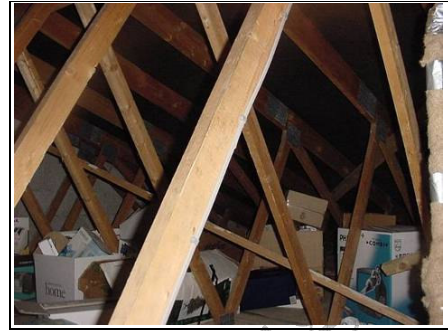
- Serious active woodworm
- Structurally significant defects to the timbers
- Structurally significant dry rot
- Structurally significant wet rot

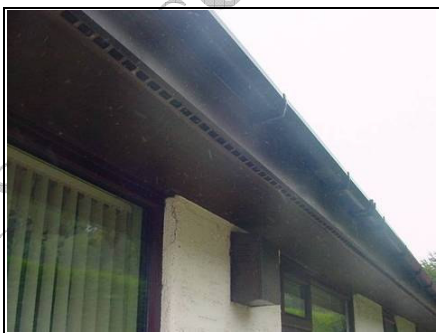
Plastic profile guttering

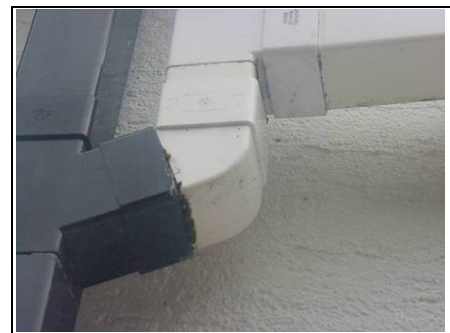
Leaking downpipe from conservatory roof

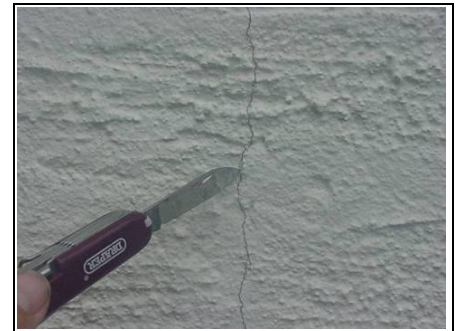
Hairline cracking to left hand side of property which runs all the way

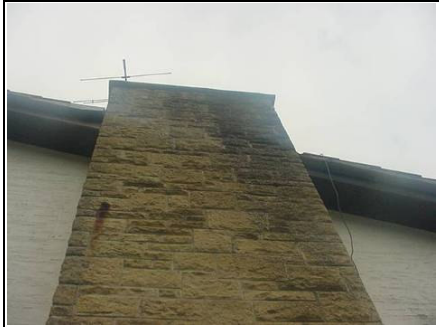
There is some stone cladding present. Some has staining, as you can see in the adjacent photograph, and there is some repair work necessary.

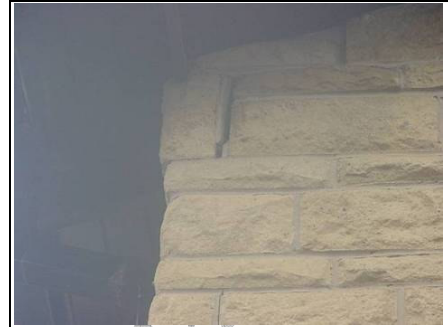
Stone work coming away

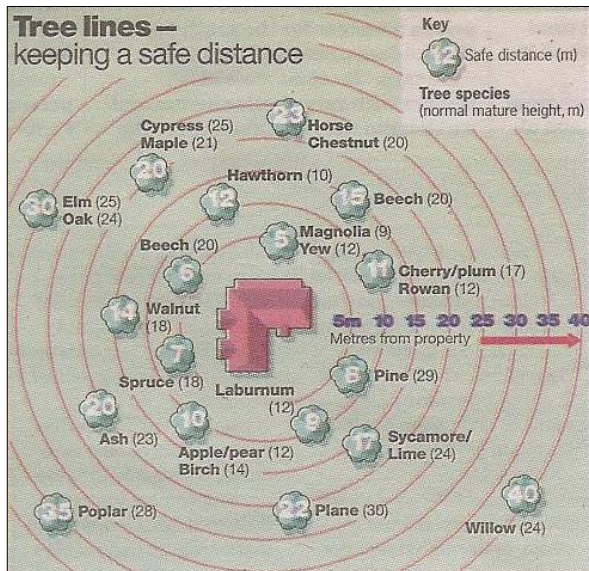
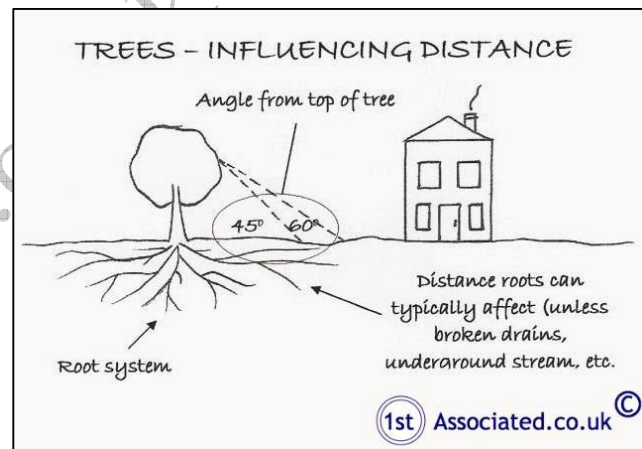
Influencing Distance Defined

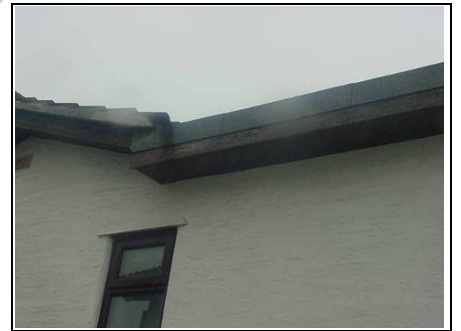
Minor deterioration to fascia board to the flat roof area

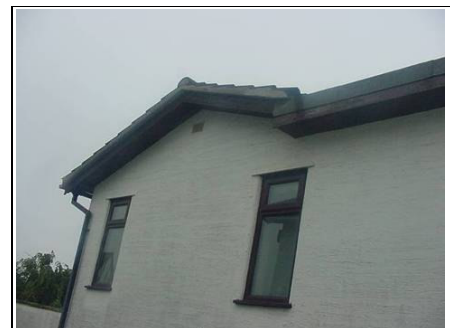
Two plastic double glazed windows to front of property

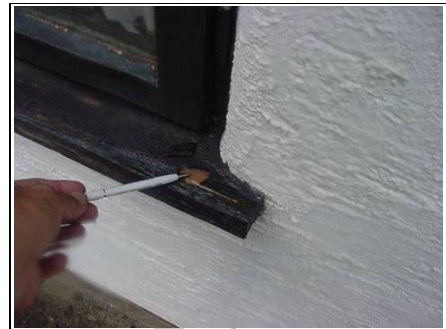
ACTION REQUIRED: Redecorate before winter of 2011.

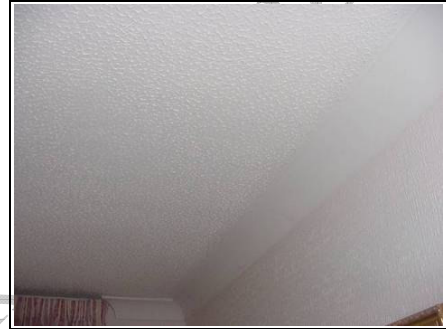
Textured ceiling finish

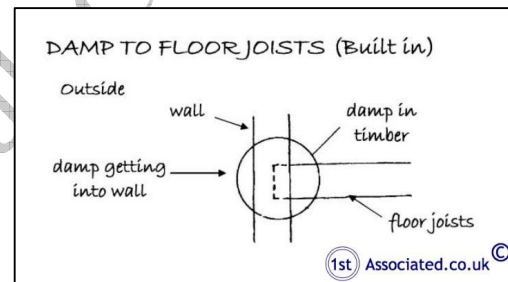
ACTION REQUIRED: We would suggest a section of the wall is opened up to check the condition of the timbers.

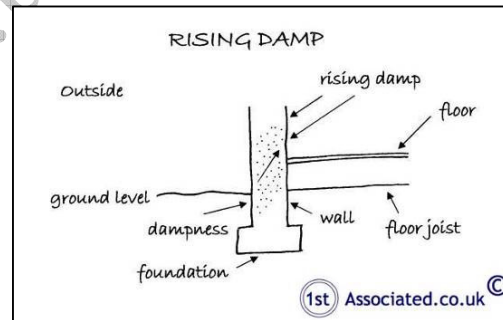
We carried out tests with out damp meter. We did find some rising damp on the internal walls on the ground floor that we showed to you, where the paper is starting to come off the walls. We believe we would have got damp meter readings to the rear wall if it had not been dry lined. You need to be aware that this property is being sold during the summer which are traditionally the driest months and as such you are seeing it in its best condition.

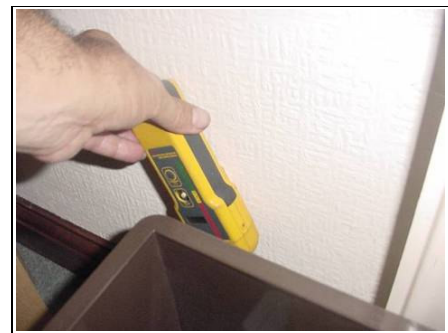
Checking for rising damp

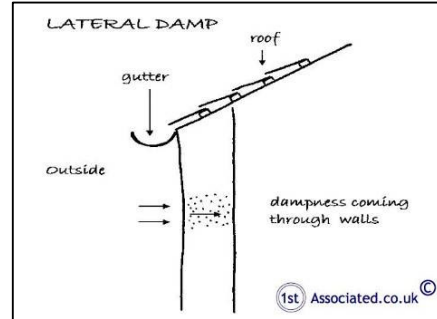
We obtained damp meter readings to the rear wall under ground, as you would expect.

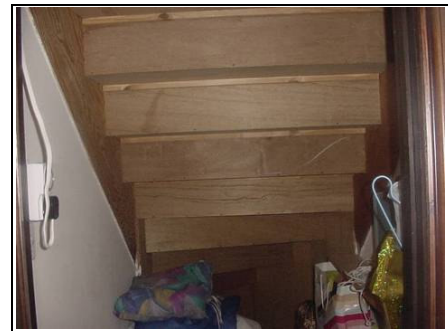
We noted that the underside of the staircase was exposed. It is more normal today to have a half hour fire barrier to stop fire spreading from the ground floor to the first floor in a worse case scenario. You may wish to take a view on whether you add this.

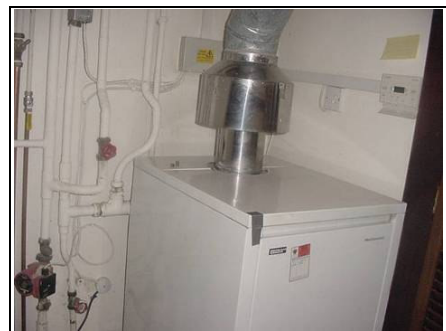
Our limited inspection of the hot water and central heating system revealed no evidence to suggest any serious defects but we would nevertheless recommend that the system be tested and overhauled before exchange of contracts and that a regular maintenance contract be placed with an approved heating engineer.

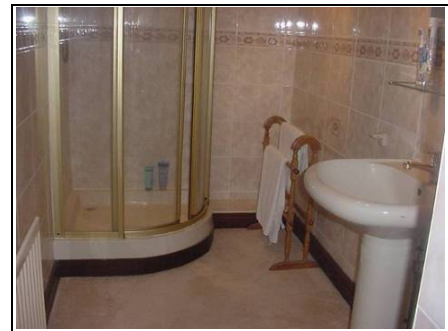
There are numerous en-suite shower rooms and bathrooms throughout the property. Some of them are looking slightly dated now and you may wish to upgrade these, but this is purely a personal choice.

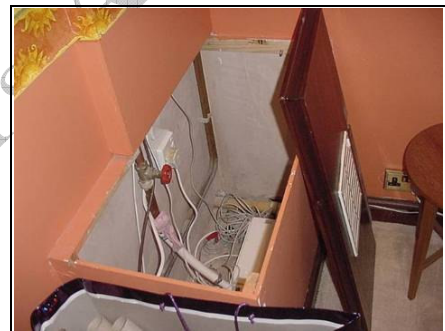
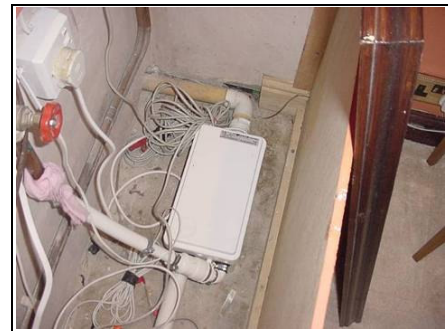
Pump for en-suite shower room which goes into the room without a window on lower ground floor

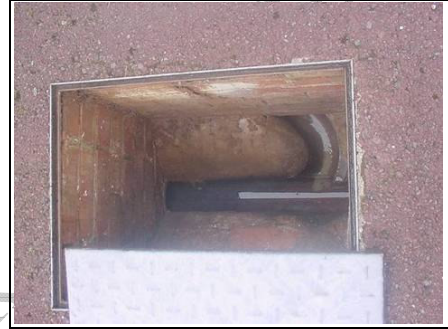
From what we could see it is brick built.

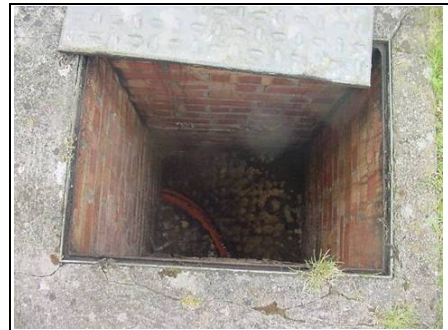
Manhole to rear left hand corner

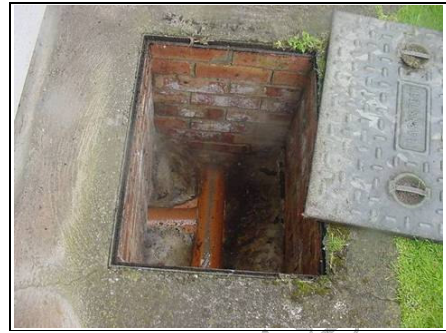
Manhole to rear middle of property

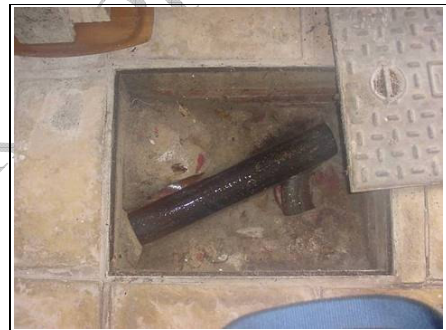
Manhole to front, near study

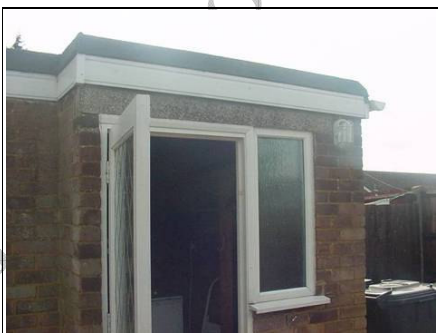
Example of a concrete lintel – can you notice where the cold bridging would be in this photo?

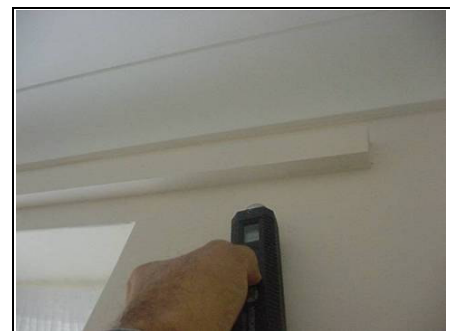
Dampness and condensation around the concrete window lintel
