DEFECTS REPORT

Middlesex.

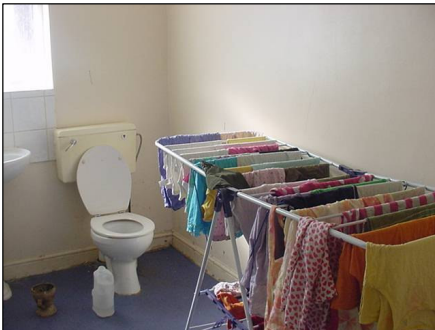
Washing being dried in bathroom

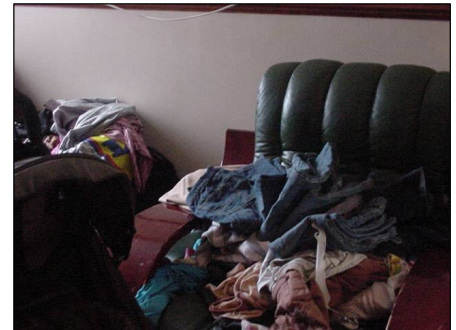
Washing drying in front room

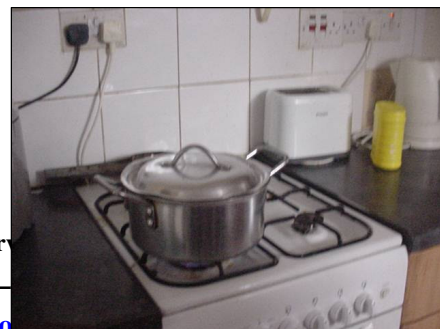
Independent Chartered Surveyors

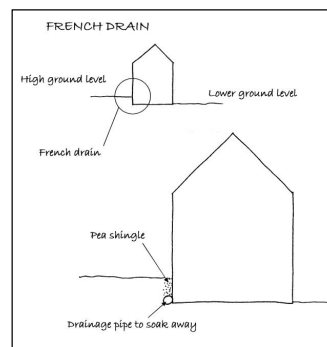
Independent Chartered Surveyors

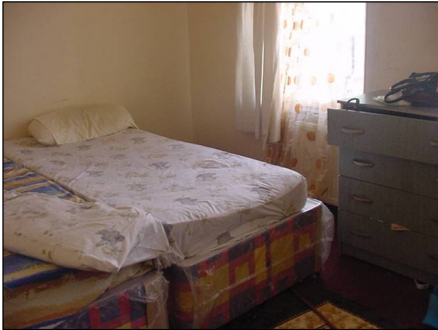
- g) Drainage check needs to be carried out on properties of this age to ensure that there are no leaks from the drains.
- h) There appears to be, based on the number of beds and clothes in the property a high level of occupancy of the property and we would limit the number of occupants of this property in its present condition to two adults and two children.

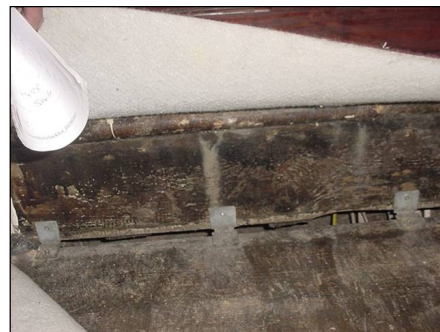
Gaps to steps that allow access under the suspended timber floor

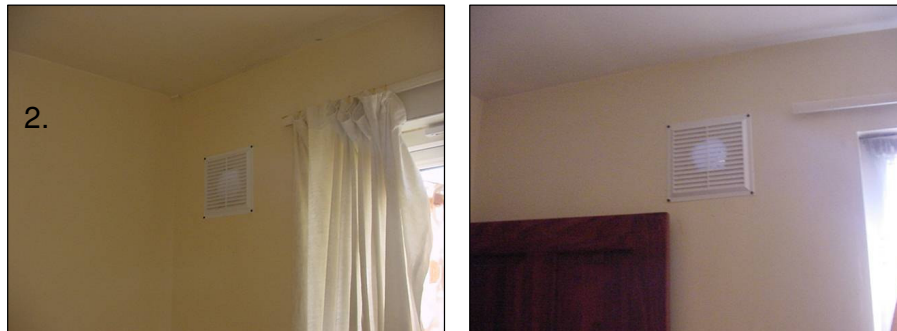
Vents within bedroom

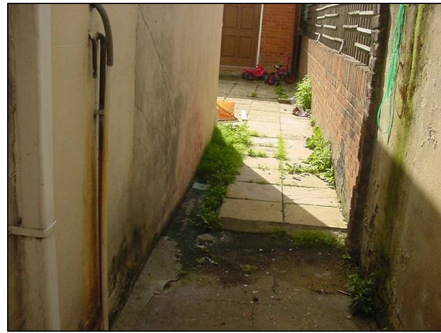
Water sitting against property due to the high level of ground requires a French gully

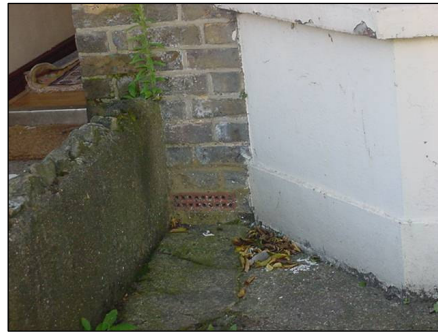
High ground level to front of the property requires lowering

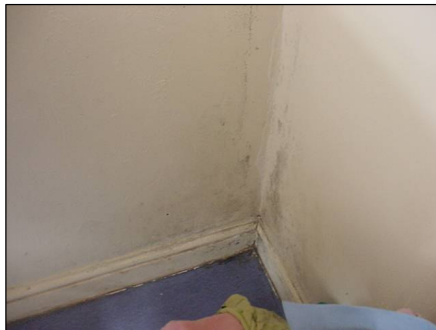
Damp in front right hand corner of bathroom

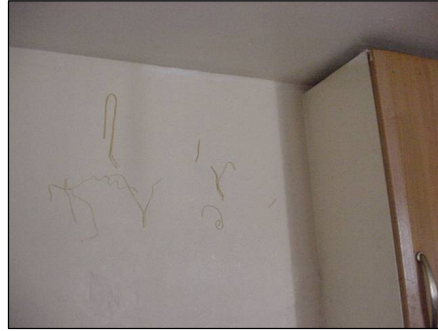
2.6 We noticed use and abuse of the walls and ceilings for example marks and writing on the walls and food staining on the ceiling.

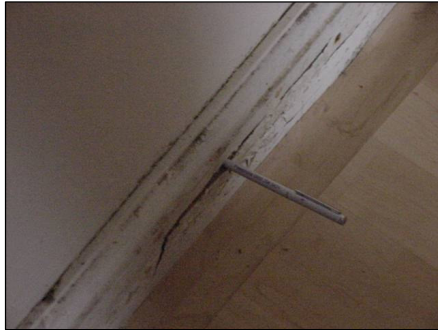
Possible wet rot to the skirting between the front lounge area and the rear kitchen/bathroom needs further investigation

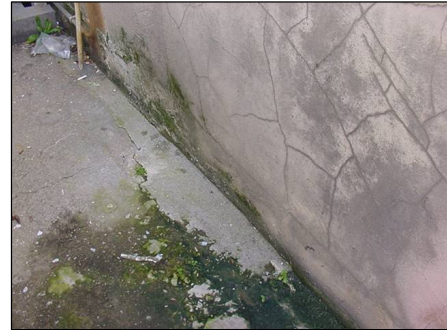
Hairline cracks to render to rear of the property needs to be redecorated and sealed

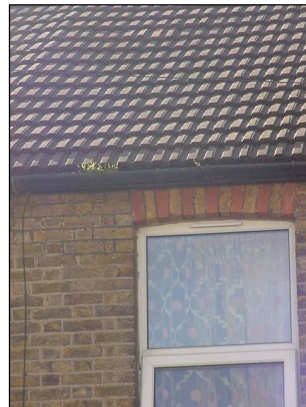
Gutters require cleaning
