SPECIFIC DEFECTS REPORT

Relating to Settlement

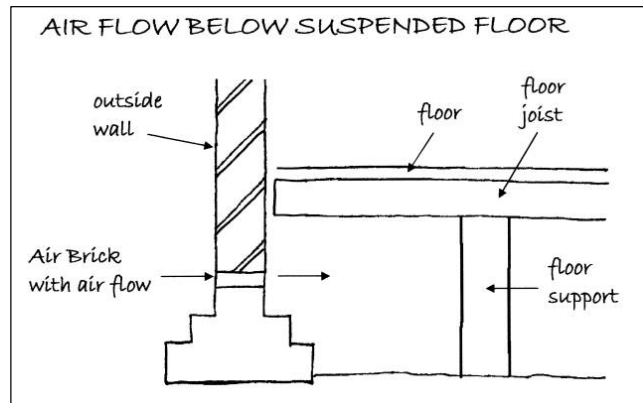
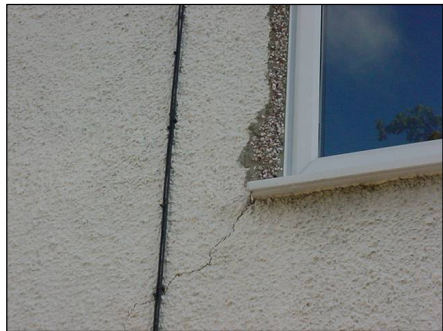
Cracking to render at the rear of the property to the corner of the plastic window

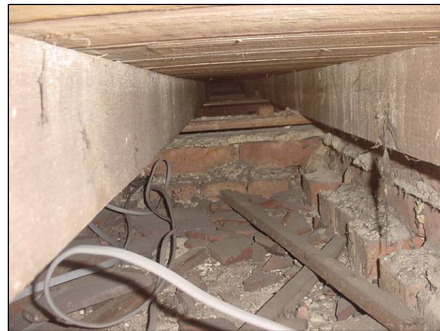
Suspended timber floor sitting on to the sleeper wall

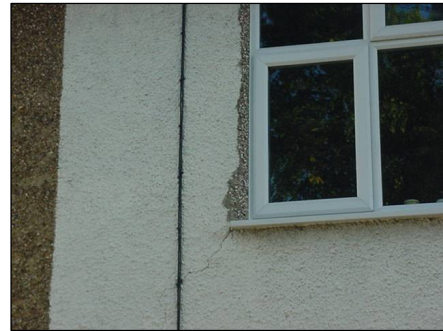
Cracking to the lower right hand corner of the rear right hand window

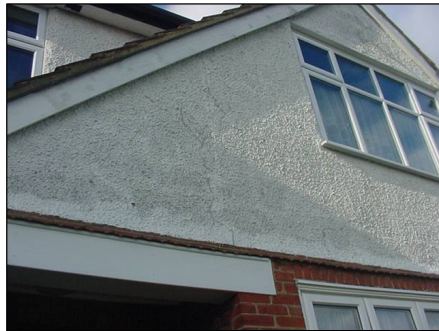
Cracking to render at the front of the property where water will be getting in

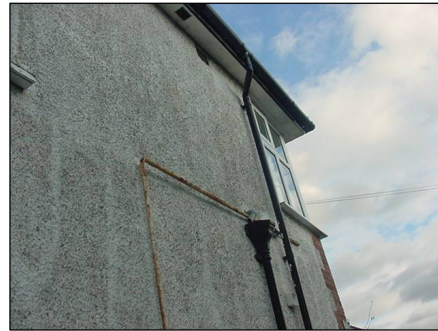
Paint has literally weathered away

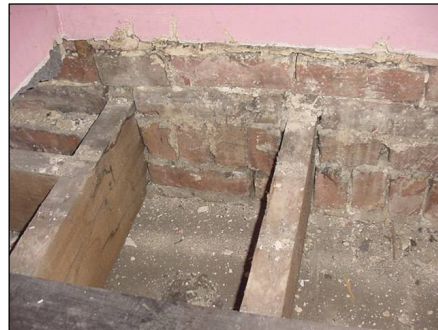
The likely rot to the joist ends will cause, with the additional weight from the roof and the lack of

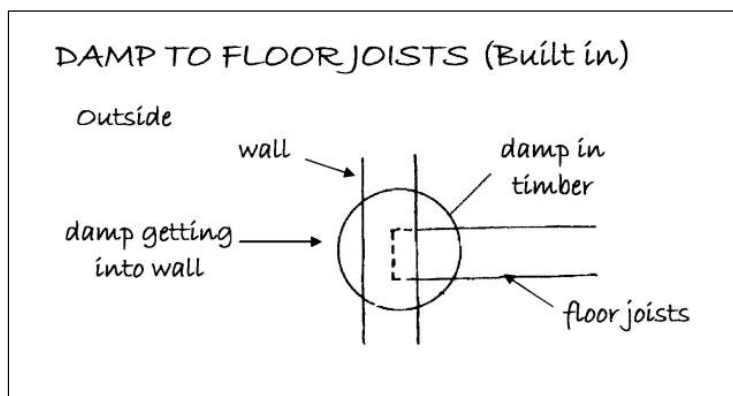
(think of the walls having large holes punched into them) will cause movement at the floor level.

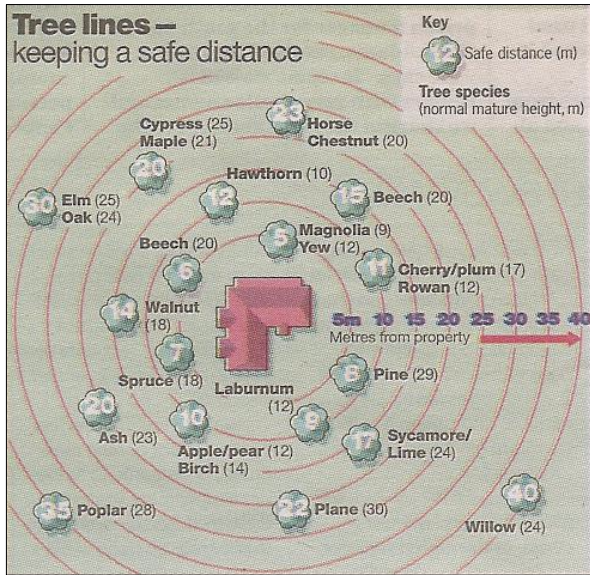
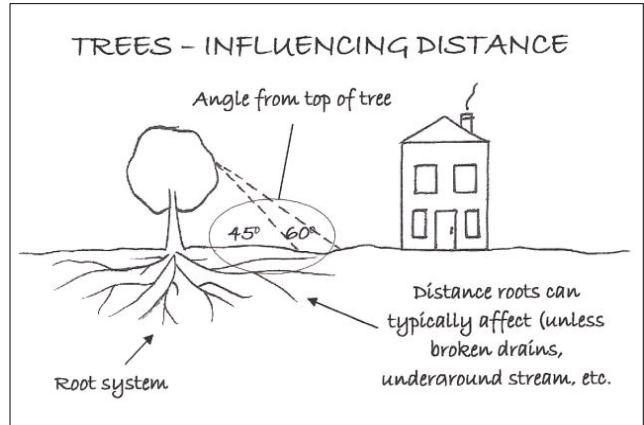
Influencing Distance Defined

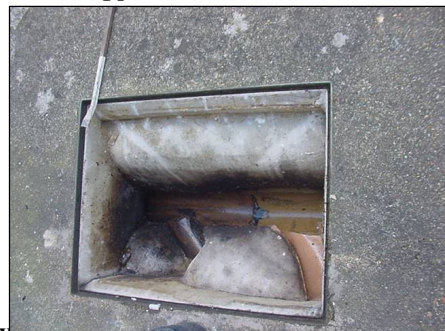
Independent Chartered Surveyors

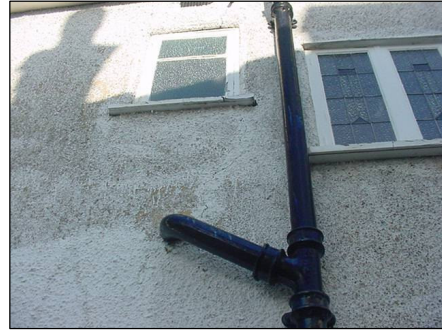
Cast Iron soil and vent pipe

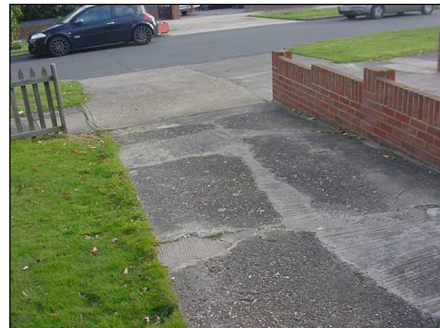
4. Trees – we recommend that you have an Arboriculturist Report carried out and carry out the recommendations of this which we suspect would be to maintain the tree.

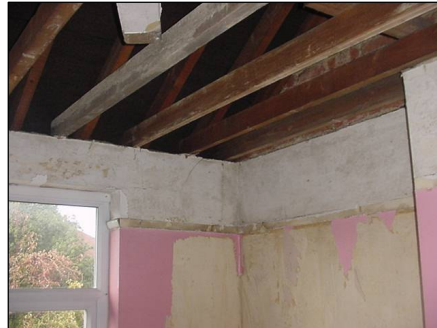
3. Roof space, this was viewed, it had been opened up with the ceiling removed.
4. Surrounding areas
 - i. front area, including cracking driveway.
 - ii. rear area, including tree.
 - iii. overview of area, we did not get access to any other properties
5. We did not have access to the ground floor
